ADDRESS: 1717-19 MOUNT VERNON ST

Proposal: Demolish rear ell, party wall and garage, construct side and rear addition with parking

SITE OBSERVATION REPORT

Project: 1717-19 Mt Vernon St, PA 19130		
Project No:	Report Reviewed by: Sunil Saigal	Weather: Clear
Report No: 01	Issue Date: July 29 th , 2022	Observation Date: July 28 th , 2022

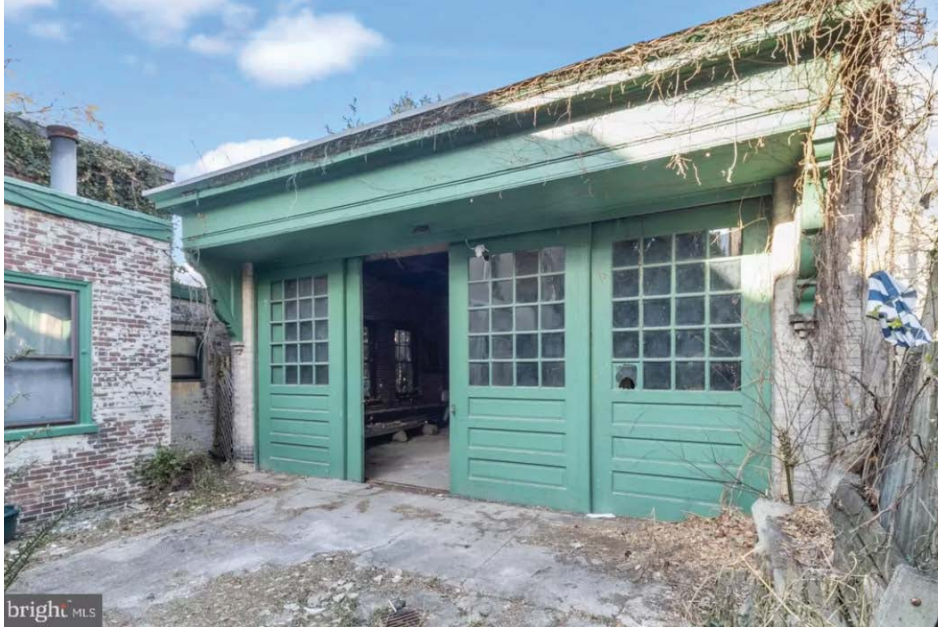
- The application claims that the side wall of the rear ell is beyond repair, but does not propose to replace it in kind. The application does not provide information on the condition of the existing garage also proposed for removal. The application fails to satisfy this standard.

Figure 4: Garage at rear of property. Source: BrightMLS, Trulia.com.

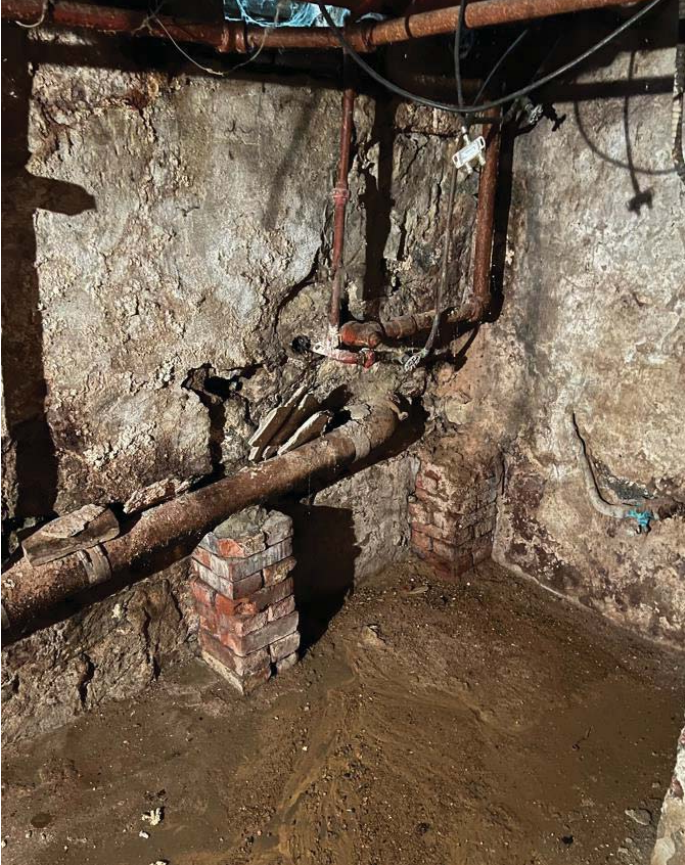
Sr. No	Image / Description	Location/Remarks
1.

Issue 01: Foundation Settlement:

There are signs of water infiltration around the foundation walls. This water infiltration is caused by poor drainage and the soil conditions around and under the foundation. Water infiltration introduced into previously consolidated soil can induce secondary consolidation of the soil that will result in settlement of the foundation.

<ul style="list-style-type: none">• Basement Northeast corner

Repair/Replace Main Line. Check the main sewer line for damage that is allowing water to seep out of the line and into the soil around the foundation. Any cracks allowing water to infiltrate into the soil around the foundation must be repaired or replaced.

French Drain. A french drain is a perforated pipe just below the ground's surface. Water will soak into the soil and percolate up and into the french drain. As the water enters the drain it is then transported away from the home. Installing a french drain along the exterior perimeter of the home will help keep water from saturating the soils around the foundation and help to alleviate any additional pressures caused by water infiltration.

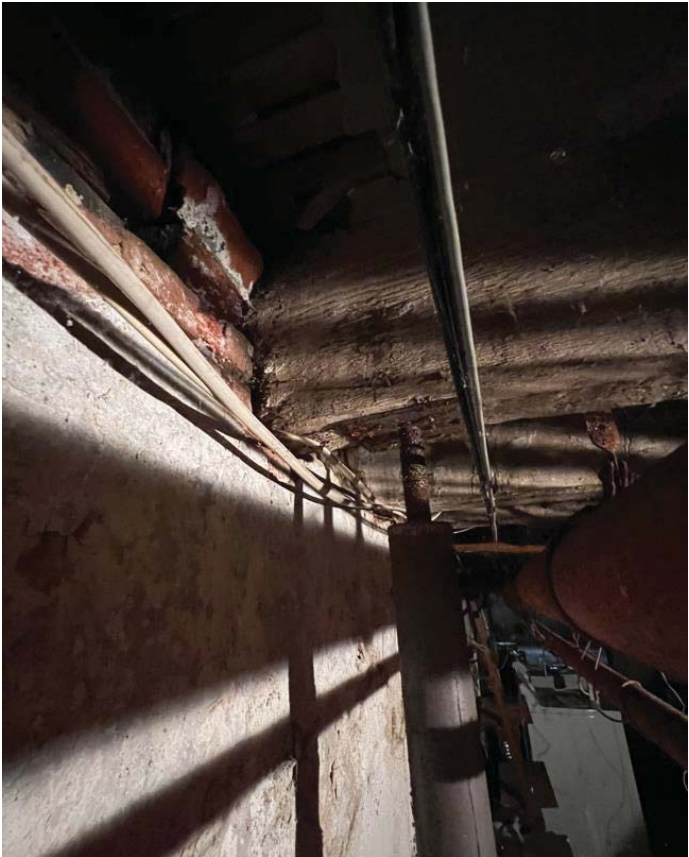
Sr. No	Image / Description	Location/Remarks
2.

Issue 02: Joists Bearing Failure

The joists on the sidewall side of the basement are compressing where they rest on the exterior wall. This type of failure is called a bearing failure and is the result of water infiltration on the exterior wall that is damaging the joists and causing it to compress. As a result of this compression the floors above the joists are starting to deflect and sag.

<ul style="list-style-type: none">• Basement

Beam/Column/Footer. Install a 2-2"x12" Beam that spans a maximum of 10' The beam should be supported on either side by a 4"x4" wood post on top of a 18"x18"x12" concrete footer with 4-#4 reinforcement bars going each way

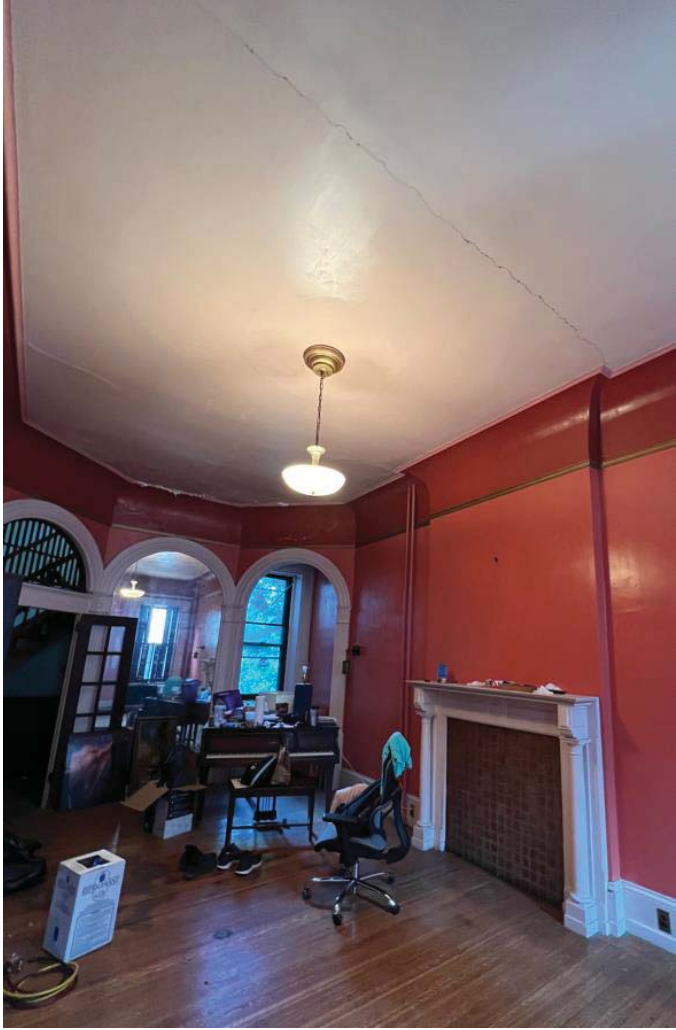
Sr. No	Image / Description	Location/Remarks
3.

Issue 03: Undersized Floor Joists

The joists above the level 01 living room are undersized and not properly supported given the size, spacing and span of the floor. As a result of the undersized joists the floor itself is starting to sag along the corners. Oftentimes improperly supported rafters will exert a lateral pressure on the exterior walls and cause them to deflect, which will sometimes cause floors to sag.

<ul style="list-style-type: none">• Level 01 living room• Visible crack in ceiling

Sister every other rafter with a 2x10 member

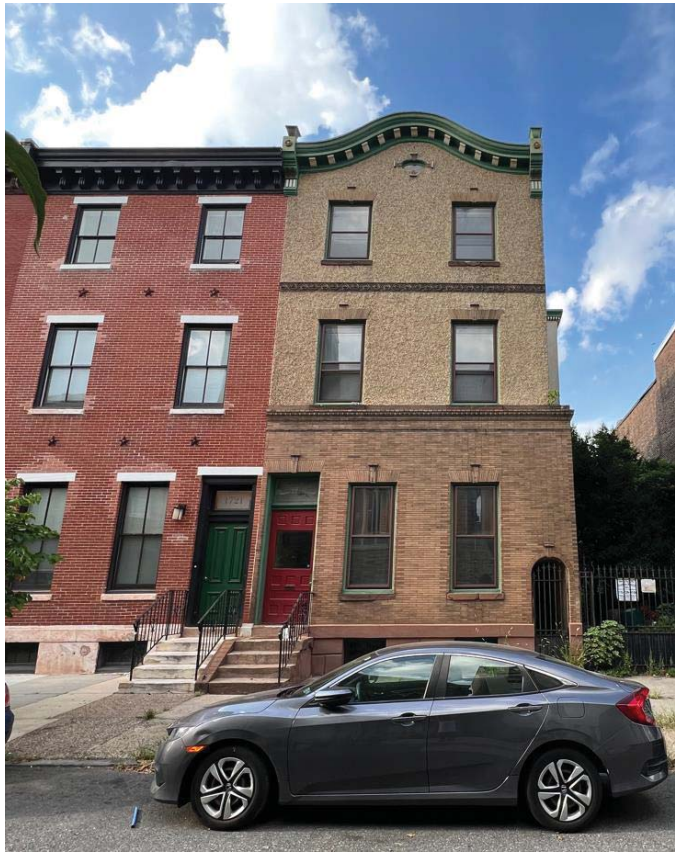
Sr. No	Image / Description	Location/Remarks
4.

Issue 04: Facade Bowing

Front wall in not laterally secured by the floor joists (very common in this type of constructions). Additionally, the foundation on the front corner of the house is settling and causing the brick facade in the corner above it to separate. This settlement is the result of secondary settlement caused by water infiltration. The voids/cracks begin to open in the layers of brick and is visible from inside. If this remains un-attended the water will infiltrate those voids and will freeze and expand in the winter slowly separating the layers of brick.

<ul style="list-style-type: none">• The front elevation from the street• See the photos below from the inside at multiple levels showing how the front wall is coming apart

Install 3-star bolts on the front façade at both the levels. These star bolts should be spaced evenly along the front facade both vertically and horizontally

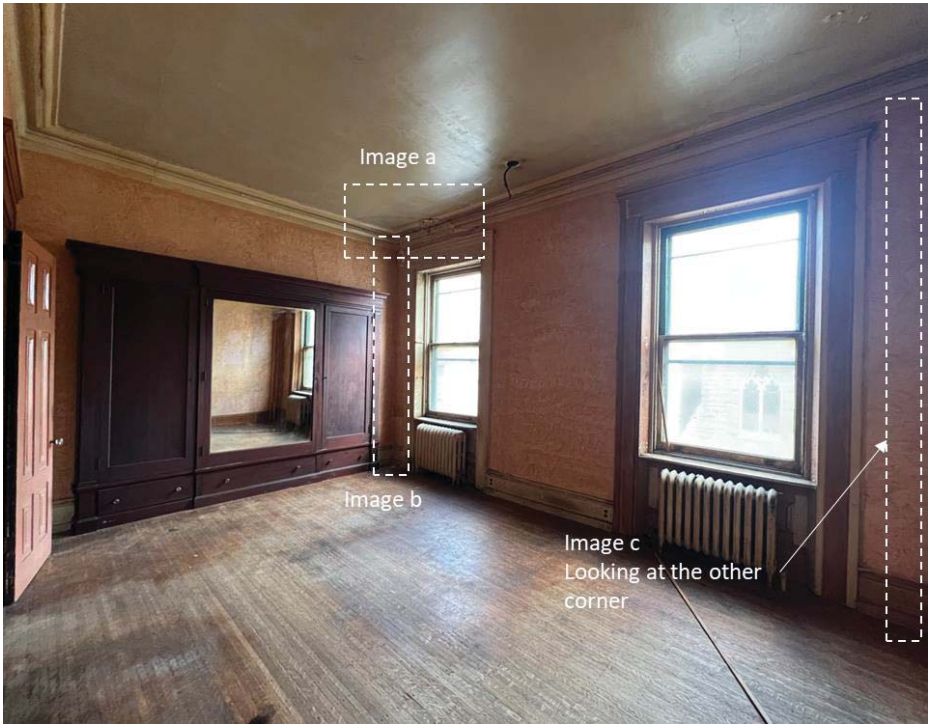
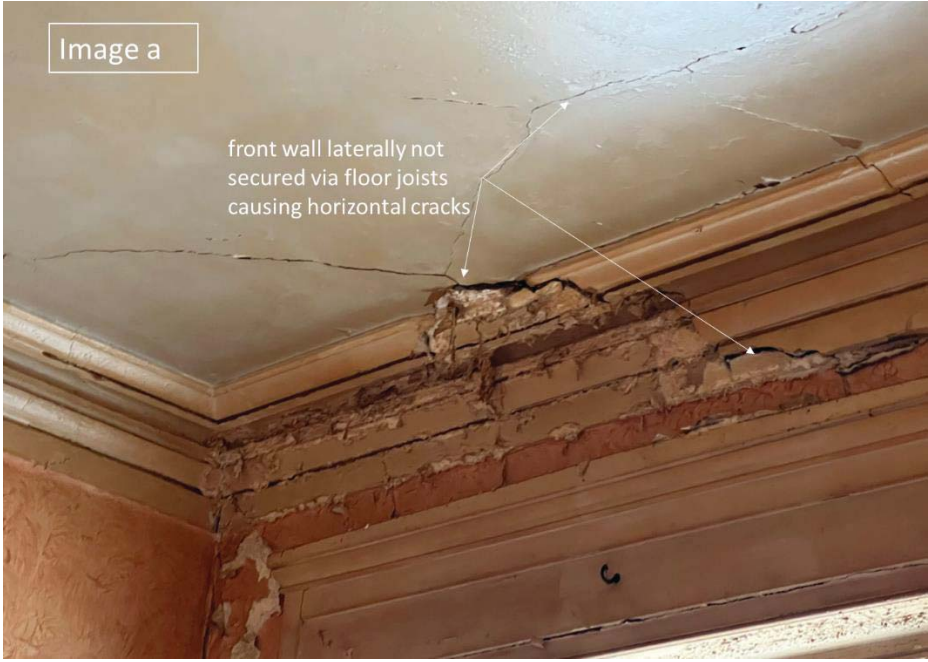
Sr. No	Image / Description	Location/Remarks
5.

<p data-bbox="1214 281 1438 390">Level 02 Image a, b and c locations</p> <p data-bbox="1214 1058 1438 1436">Horizontal cracks emanating at the ceiling level damaging top cornice along the entire length of the front façade at level 02</p>

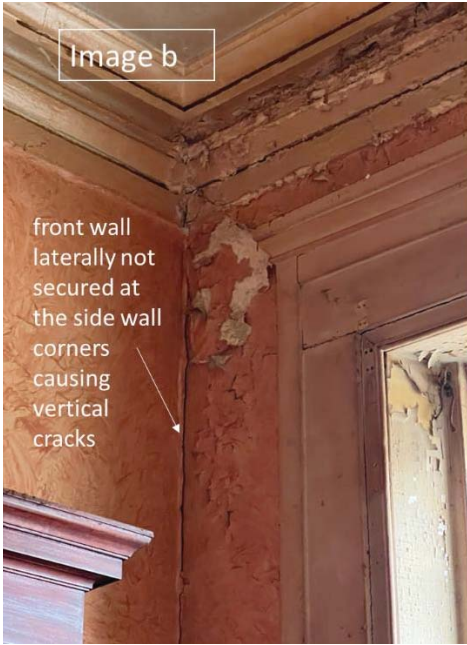
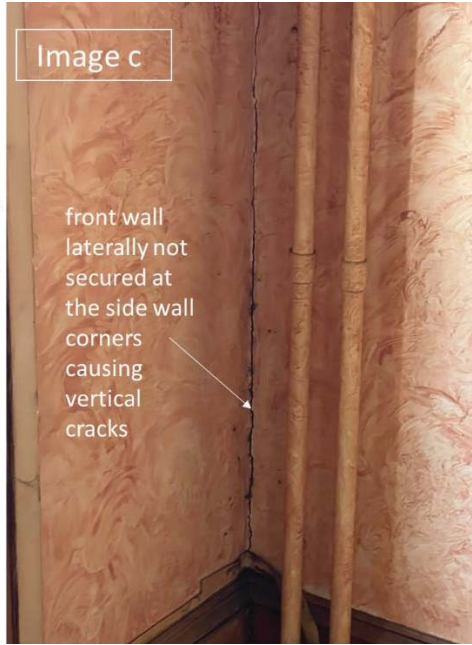
Vertical cracks visible along the entire height of level 02 at the front wall location.

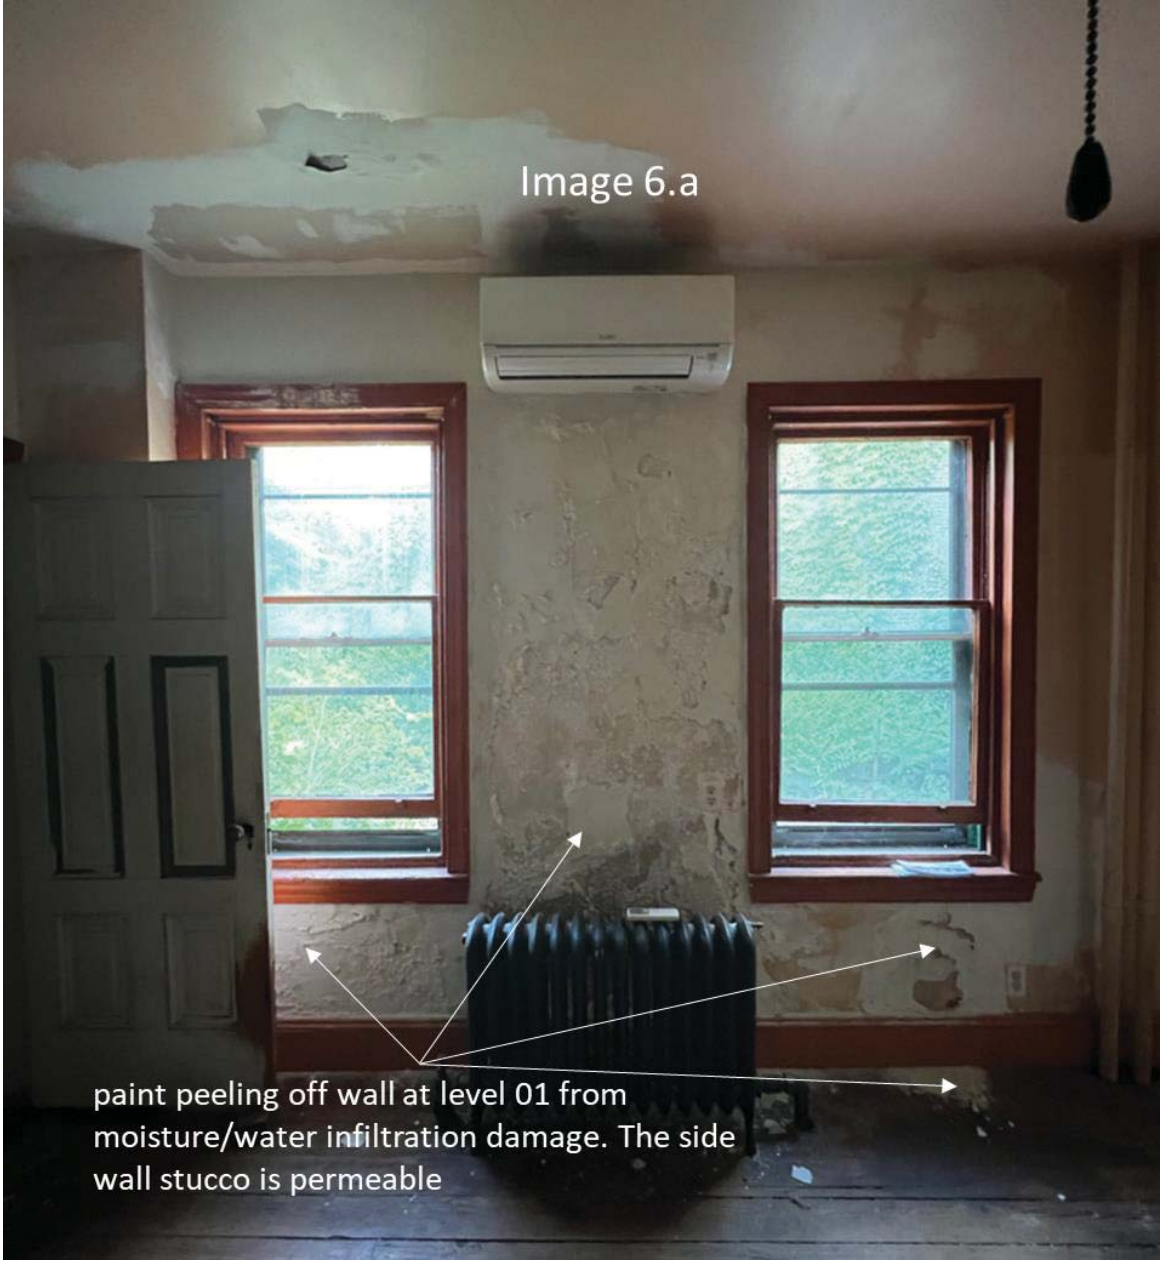
Sr.No.	Image 6.A
6 continued

The side wall has lost its water-resistant characteristic and has become water/moisture permeable. The prolonged water/moisture infiltration has compromised the structural integrity of the entire side wall at all the levels. The following photos of the wall from inside documents the damages caused from water infiltration at different levels and locations. Since the side wall is load bearing and supports all the floor joists, these damages present a dangerous situation. In case if the side wall fails the floors that it supports will also fail.

<p data-bbox="841 478 1019 527">Image 6.a</p> <p data-bbox="415 1392 1057 1507">paint peeling off wall at level 01 from moisture/water infiltration damage. The side wall stucco is permeable</p>
Remarks	Water/Moisture infiltration damage at level 01 is causing paint to peel along the entire length and width of the wall. Prolonged exposure to moisture undermines the structural integrity of masonry/wood framed wall

The structural integrity of existing side wall is compromised and is beyond salvageable (needs to be demolished/cannot be repaired).

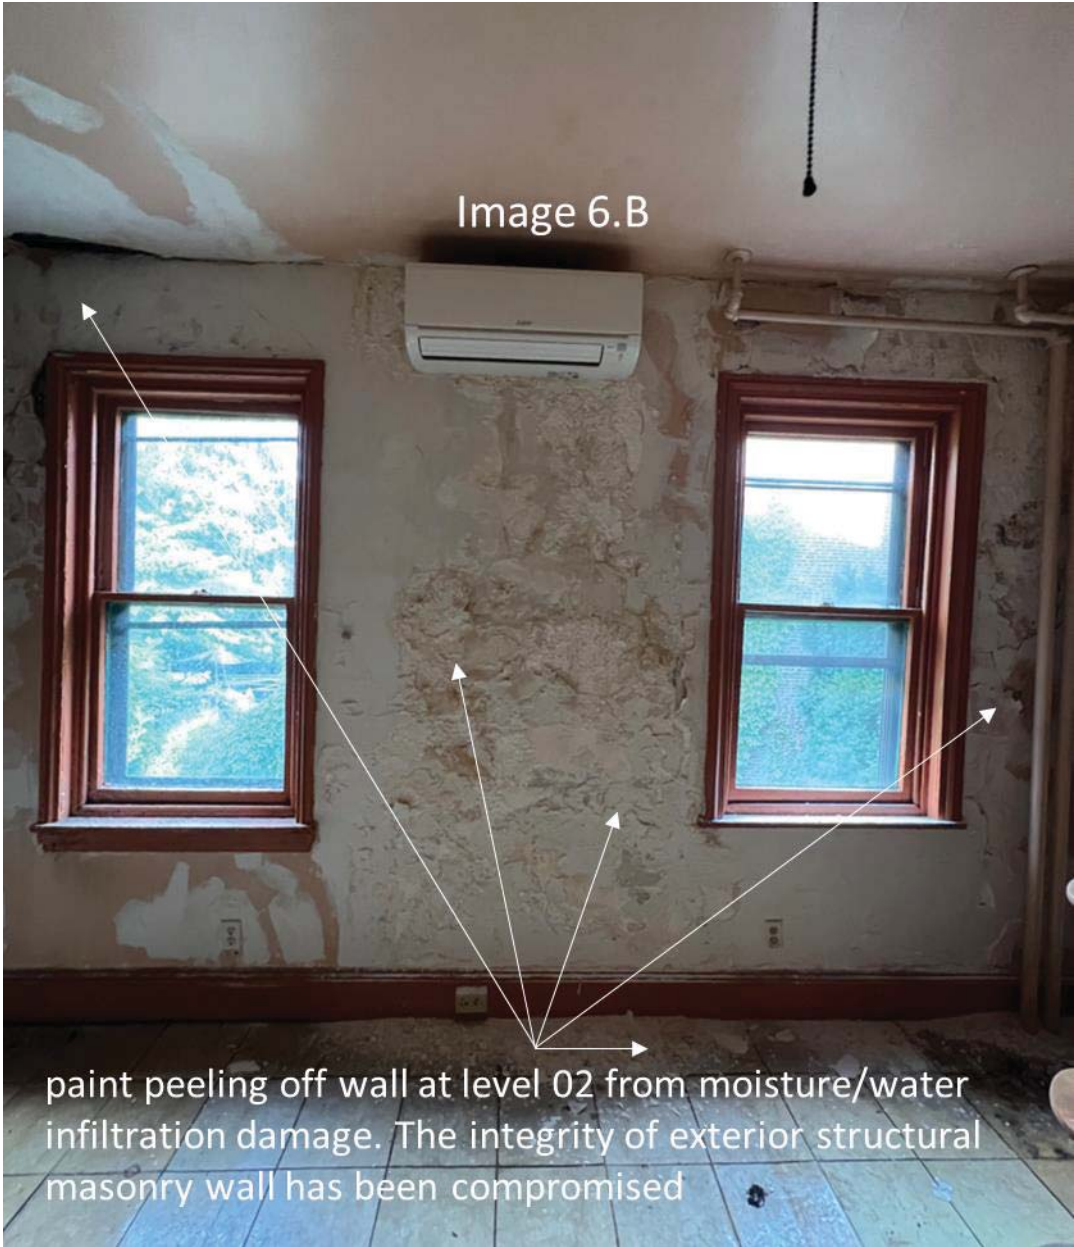
Sr.No.	Image 6.B
6 continued

<p data-bbox="787 510 982 556">Image 6.B</p> <p data-bbox="378 1377 1312 1520">paint peeling off wall at level 02 from moisture/water infiltration damage. The integrity of exterior structural masonry wall has been compromised</p>
Remarks	Water/Moisture infiltration damage at level 02 is causing paint to peel along the entire length and width of the wall. Prolonged exposure to moisture undermines the structural integrity of masonry/wood framed wall

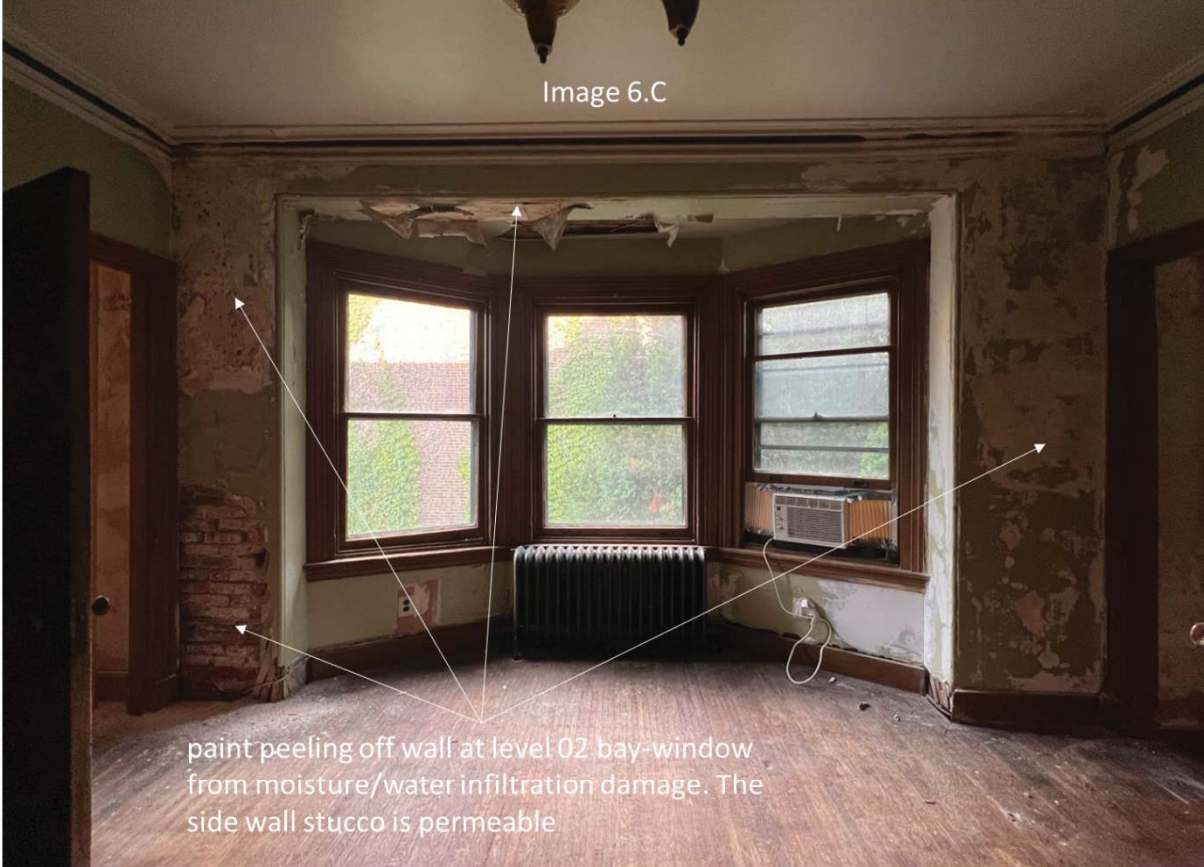
Sr.No.	Image 6.C
6 continued	<p data-bbox="867 426 992 457">Image 6.C</p>

<p data-bbox="513 1077 1089 1178">paint peeling off wall at level 02 bay-window from moisture/water infiltration damage. The side wall stucco is permeable</p>
Remarks	<p>Water/Moisture infiltration damage at level 02 bay window is causing paint to peel along the entire length and width of the wall. Masonry wall is exposed at the corner and its deterioration is evident from crumbling bricks. The structural integrity of masonry wall is compromised.</p>

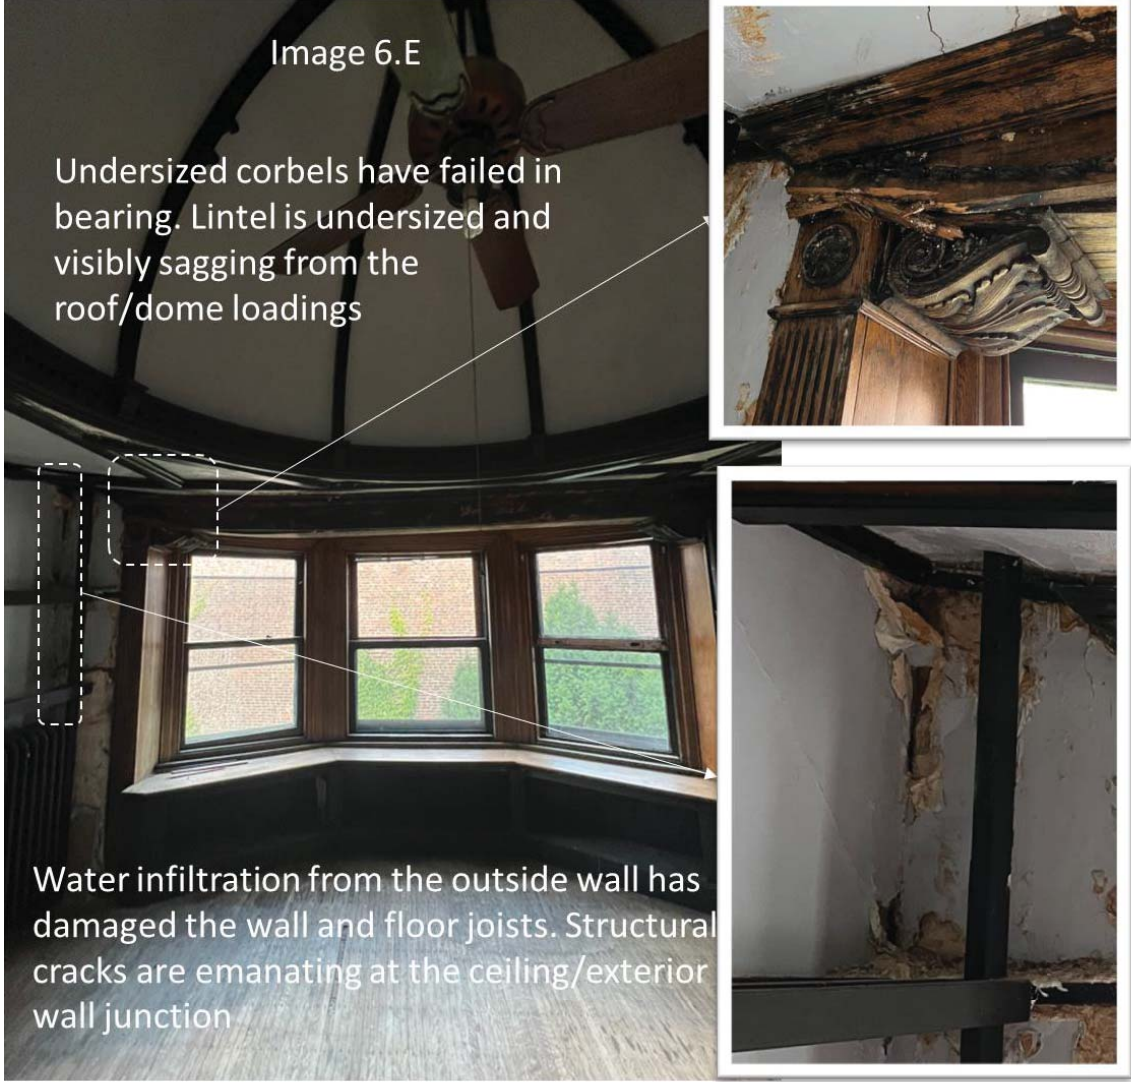
Sr.No.	Image 6.E
6 continued	<p data-bbox="613 327 764 365">Image 6.E</p> <p data-bbox="396 447 906 621">Undersized corbels have failed in bearing. Lintel is undersized and visibly sagging from the roof/dome loadings</p>

<p data-bbox="375 1150 1057 1325">Water infiltration from the outside wall has damaged the wall and floor joists. Structural cracks are emanating at the ceiling/exterior wall junction</p>
Remarks	Water/Moisture infiltration damage at level 03/roof is causing paint to peel along the entire height/sides of bay window. Undersized lintels/corbels have failed in bearing.
