Submitted by:
TranSystems Corporation
March 15, 2024

Trail Feasibility Study for Repurposing **THE MULE BRIDGE** **OVER SCHUYLKILL RIVER**

City Of Philadelphia, Philadelphia County and
Lower Merion Township, Montgomery County

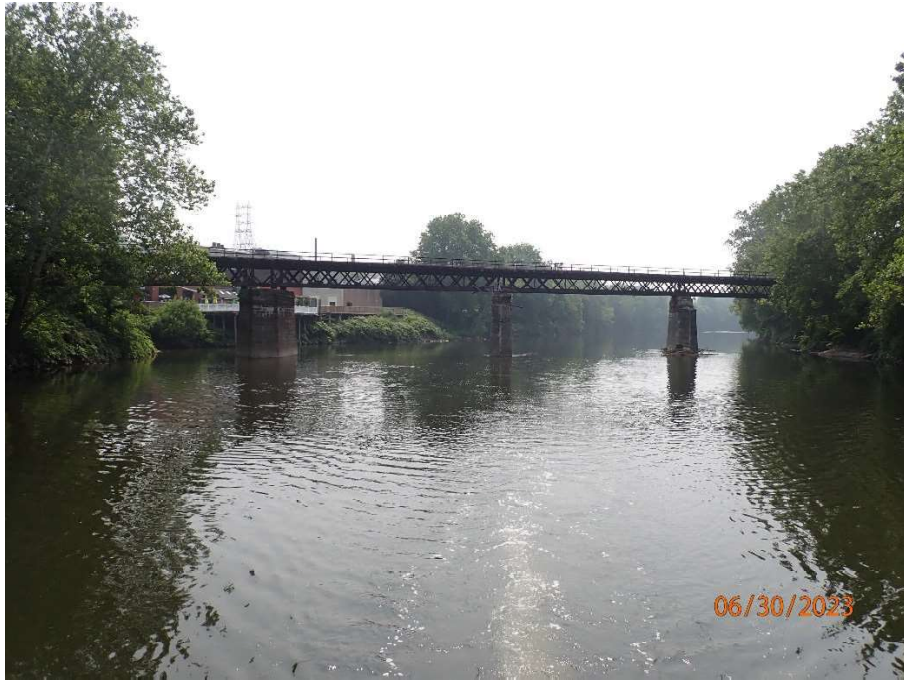
Photo 1

Upstream elevation, Spans 4-7, looking east.

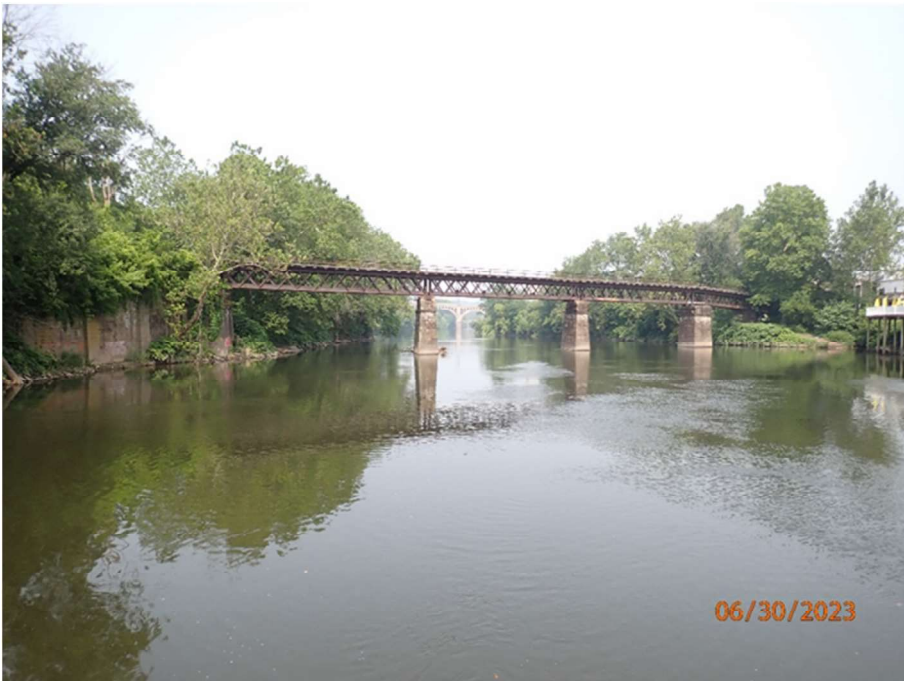
Photo 2

Downstream elevation, Spans 4-7, looking west.

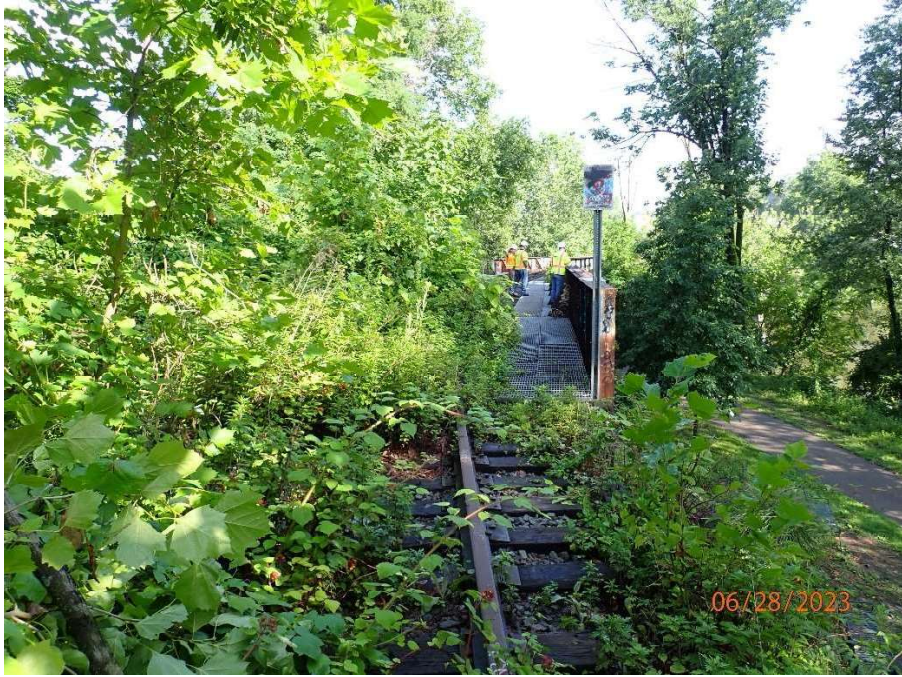
Photo 3

Lower Merion approach, looking north. Heavy vegetation growth.

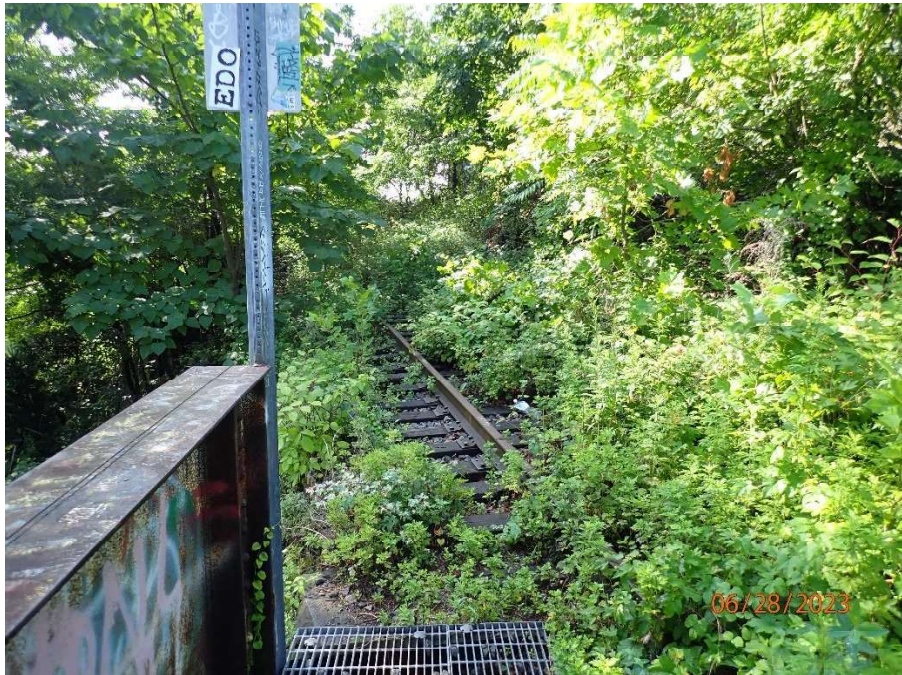
Photo 4

Lower Merion approach, looking south. Heavy vegetation growth.

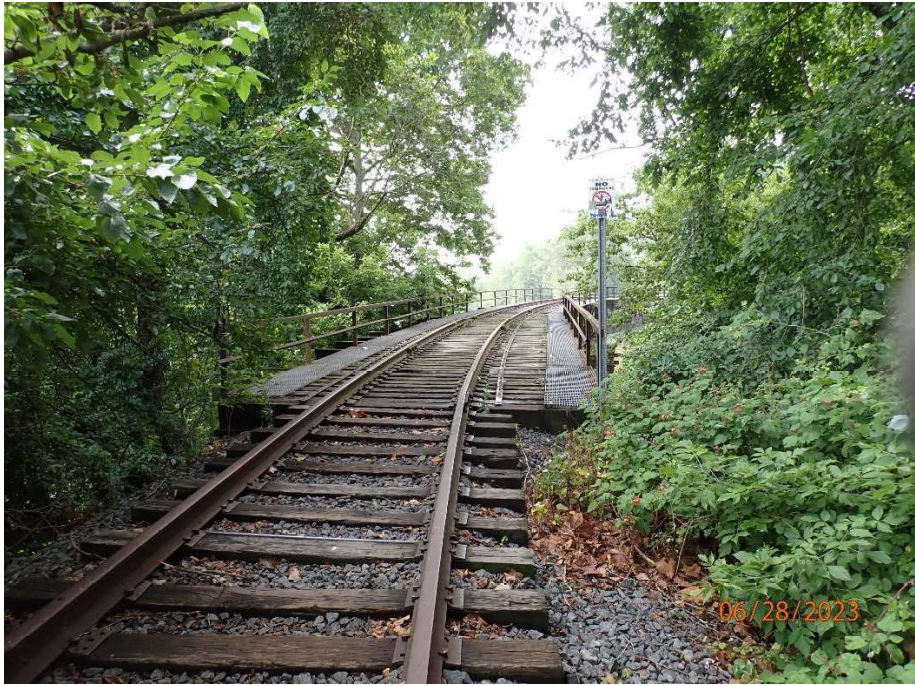
Photo 5

Manayunk approach, looking south.

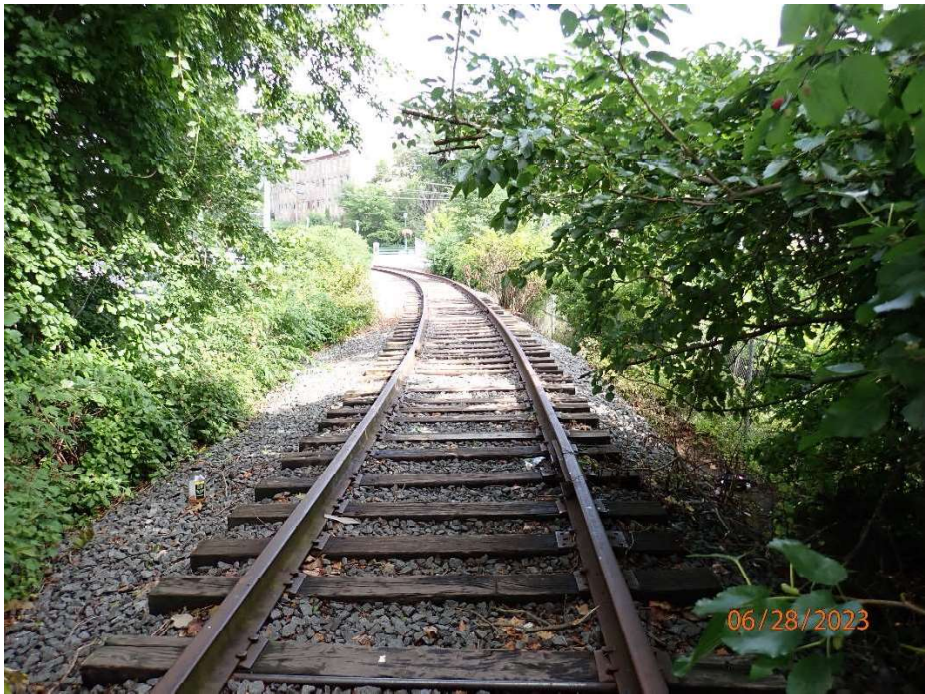
Photo 6

Manayunk approach, looking north.

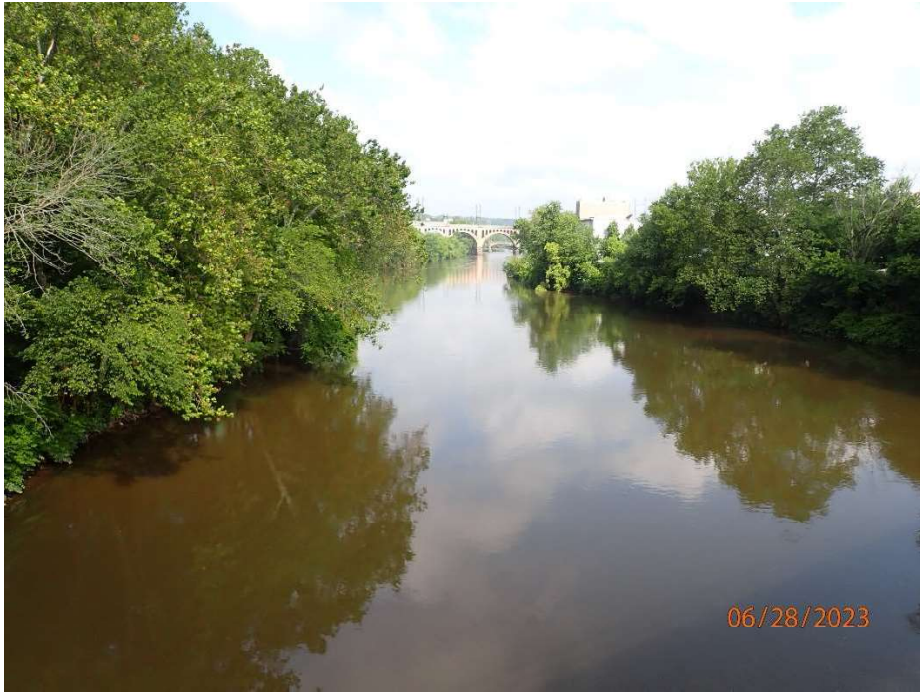
Photo 7

Upstream channel, looking west.

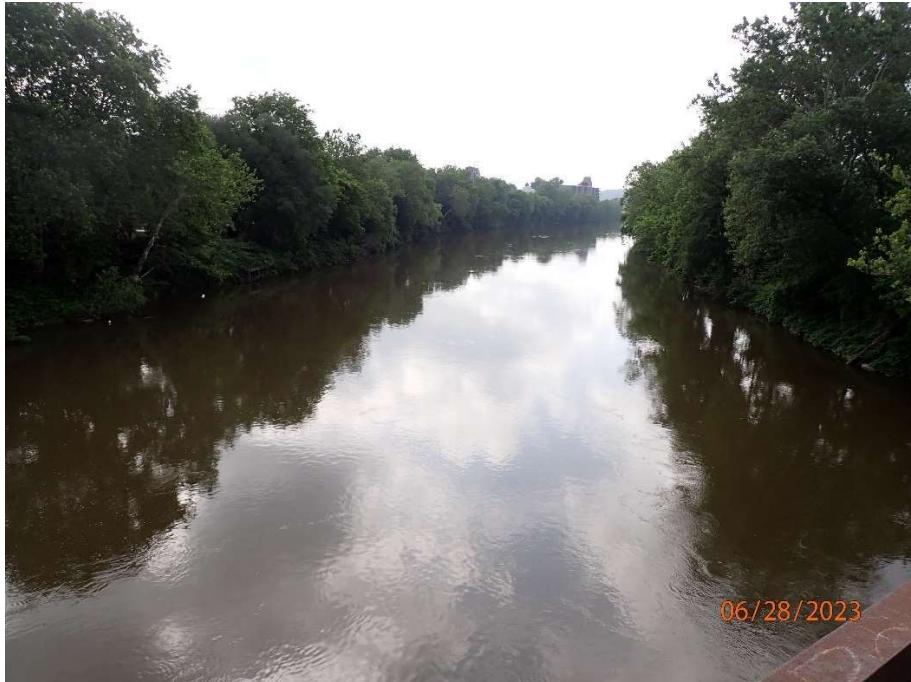
Photo 8

Downstream channel, looking east.

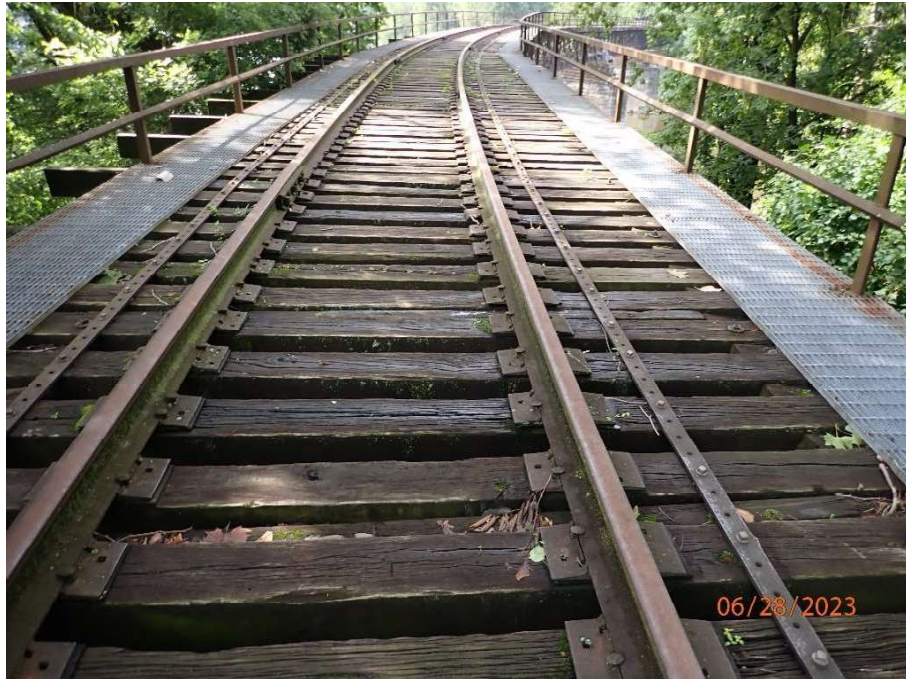
Photo 9

Typical view of the top of deck at Span 8, looking south. Moderate to wide splits and cracks in the ties.

- **Recommendation 1** – The existing timber ties, hand railing, and tracks are recommended to be removed and replaced. The new deck recommended is a new non-composite reinforced concrete deck 14' wide x 8.5" thick with a clear pathway of 12' with new pedestrian trail use barriers or railing. The barrier for rating purposes was preliminarily designed as 12" wide x 42" high vertical concrete barriers.

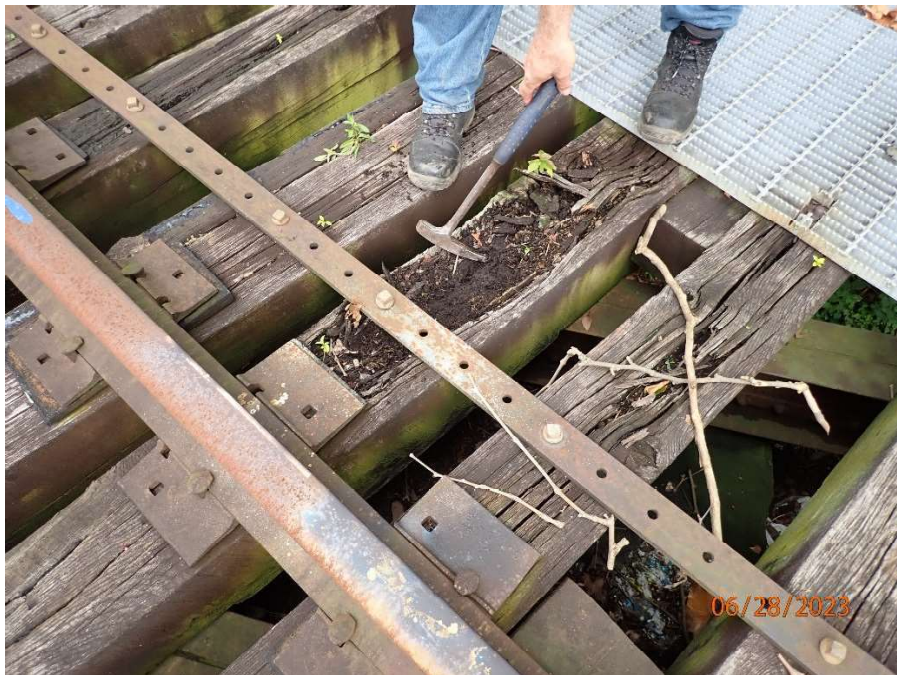
Photo 10

Deck ties, Span 2, looking southwest. Wide splits, severe decay, and section loss in the ties.

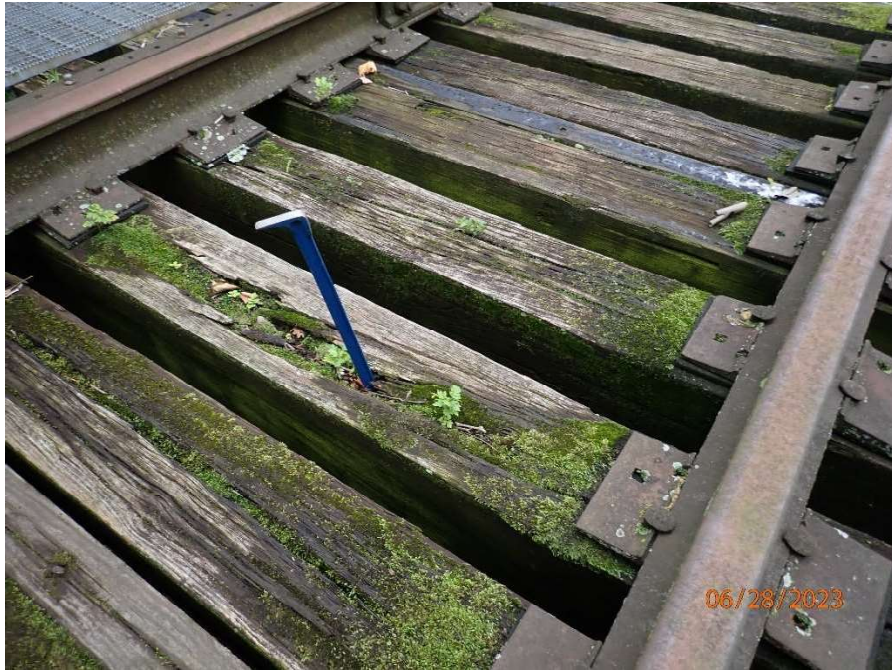
Photo 11

Deck ties, Span 6, looking southeast. Wide splits, moderate to severe decay, and moss growth in the ties.

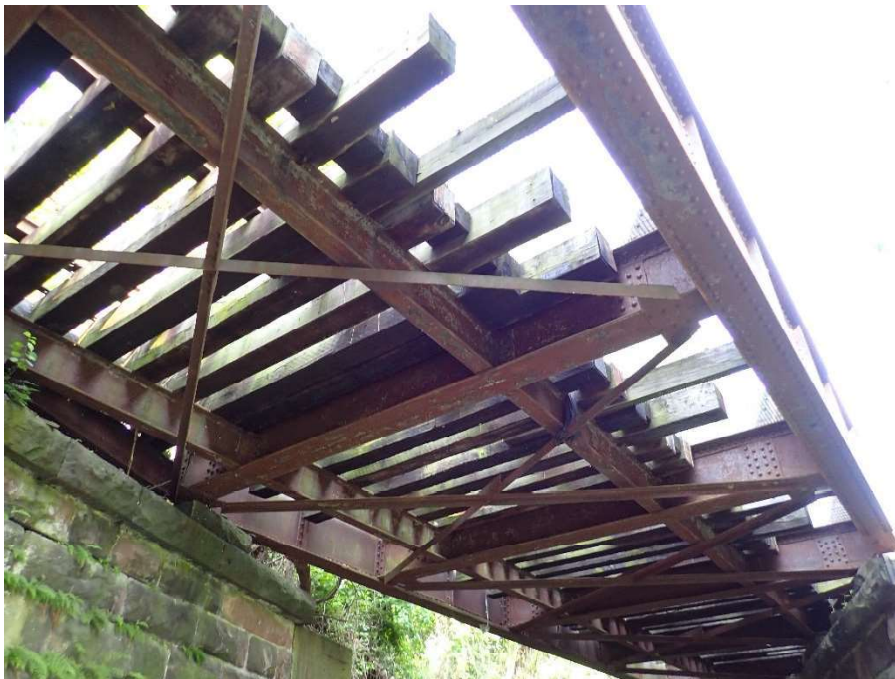
Photo 12

Typical view of the underside of the deck and superstructure in the through-girder spans, Span 1, looking northwest.

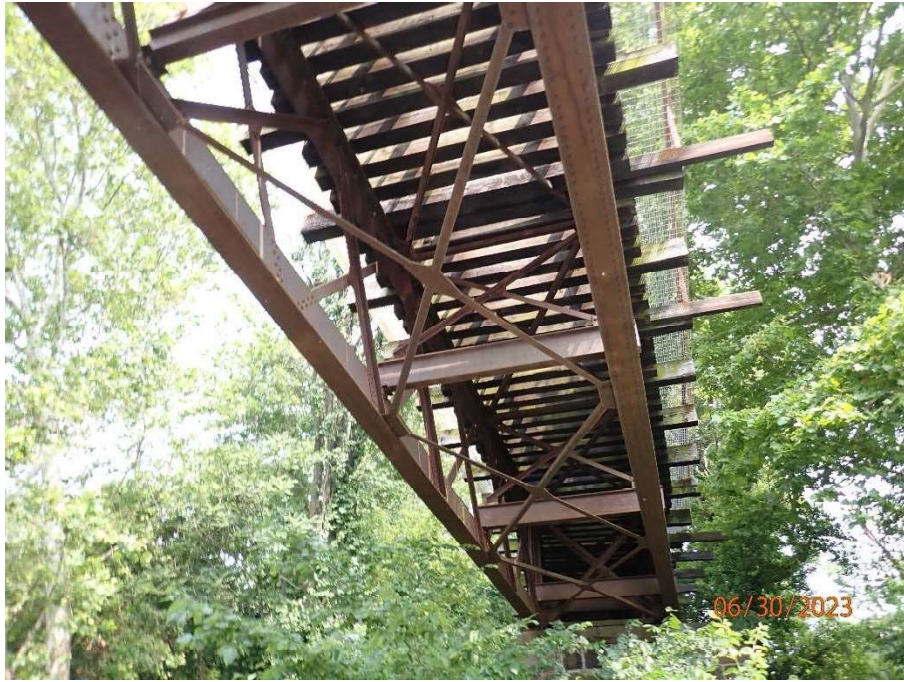
Photo 13

Typical view of the underside of the deck and superstructure in the lattice-girder spans, Span 7, looking north.

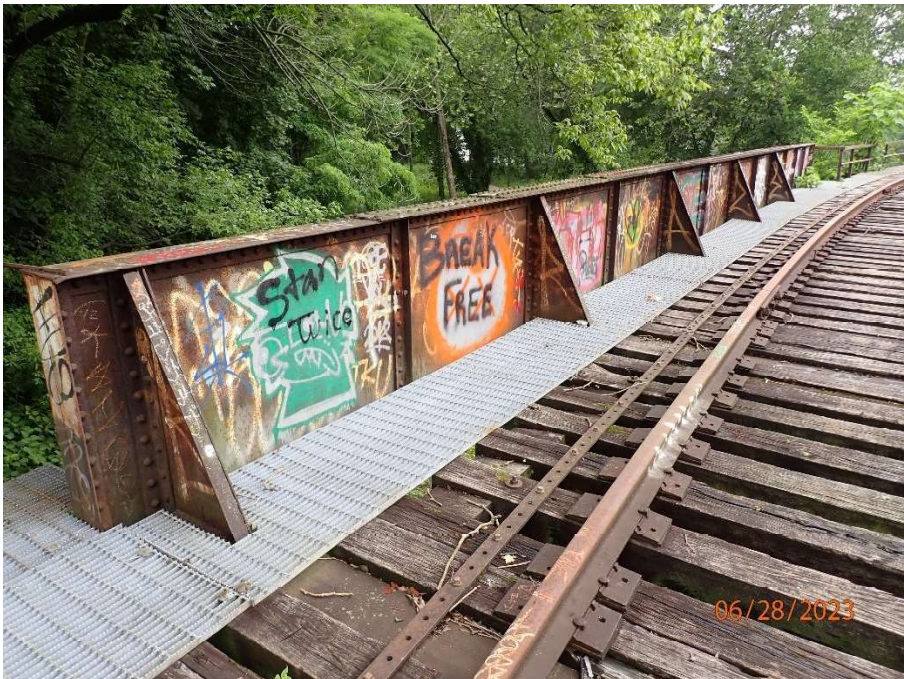
Photo 14

General view of through Girder 1, Span 2, looking northwest. Surface rust and graffiti.

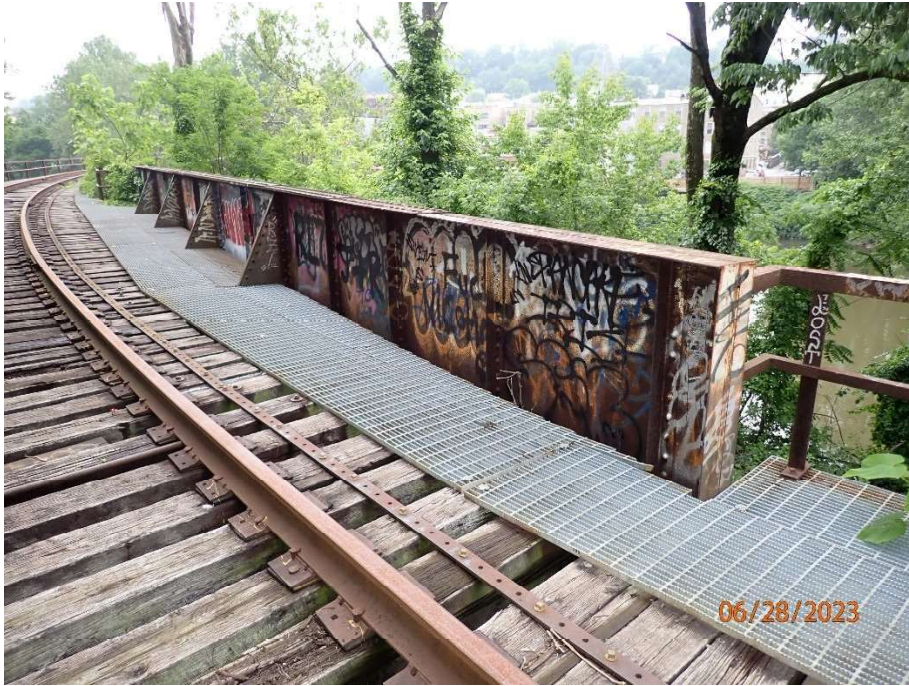
Photo 15

General view of through Girder 2, Span 2, looking northeast. Surface rust and graffiti.

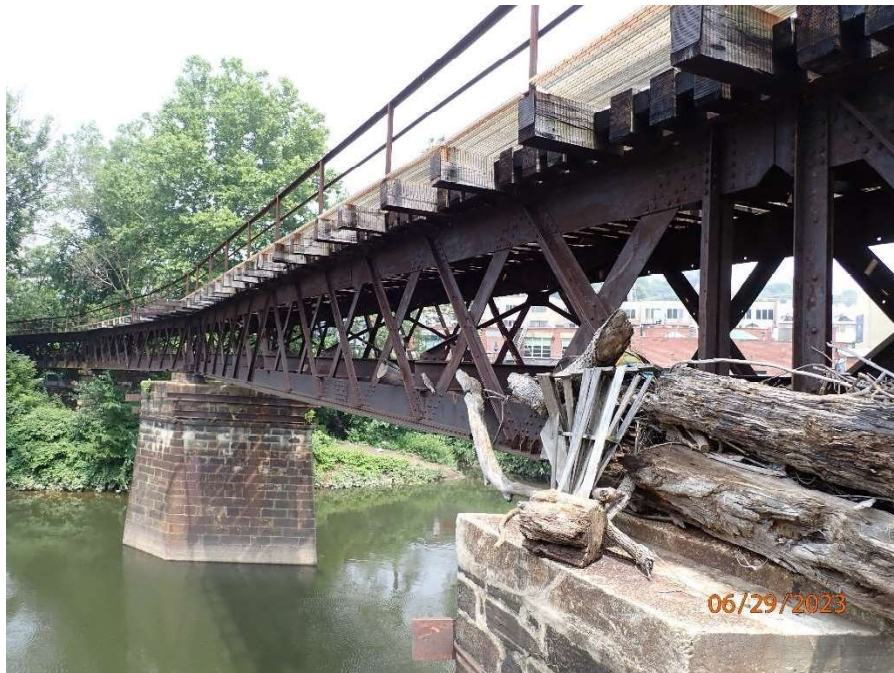
Photo 16

General view of lattice deck Girder 1, Span 6, looking northeast. Note the flood debris on Pier 5 bridge seat.

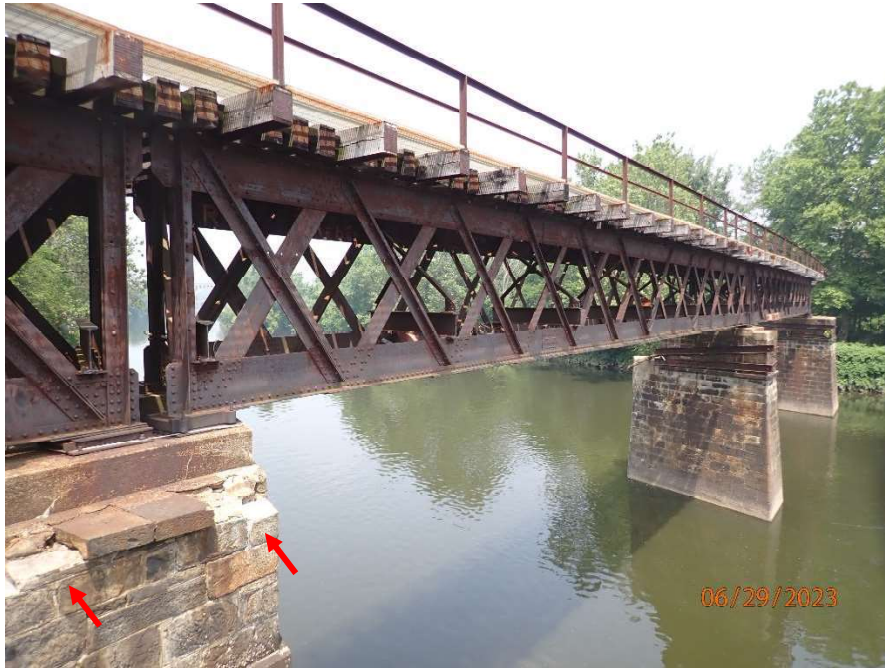
Photo 17

General view of lattice deck Girder 2, Span 5, looking northwest. Surface rust throughout. Note the stone loss at top of the downstream nose of Pier 4 (no undermining to girder bearing). Note Piers 5 and 6 tie rod channel assemblies.

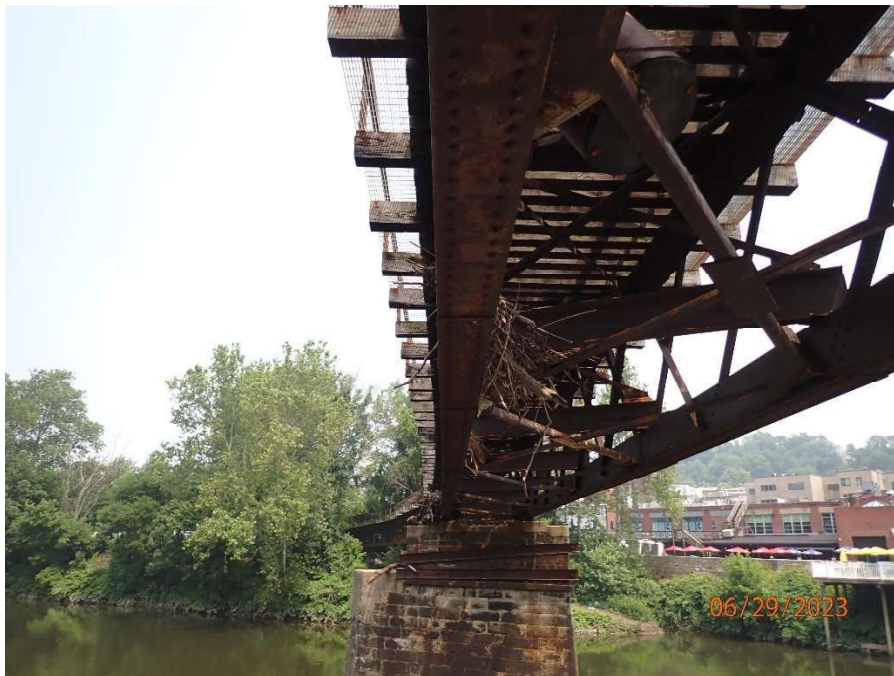
Photo 18

Girder 1, Span 5, looking north. Flood debris between the diagonal angles.

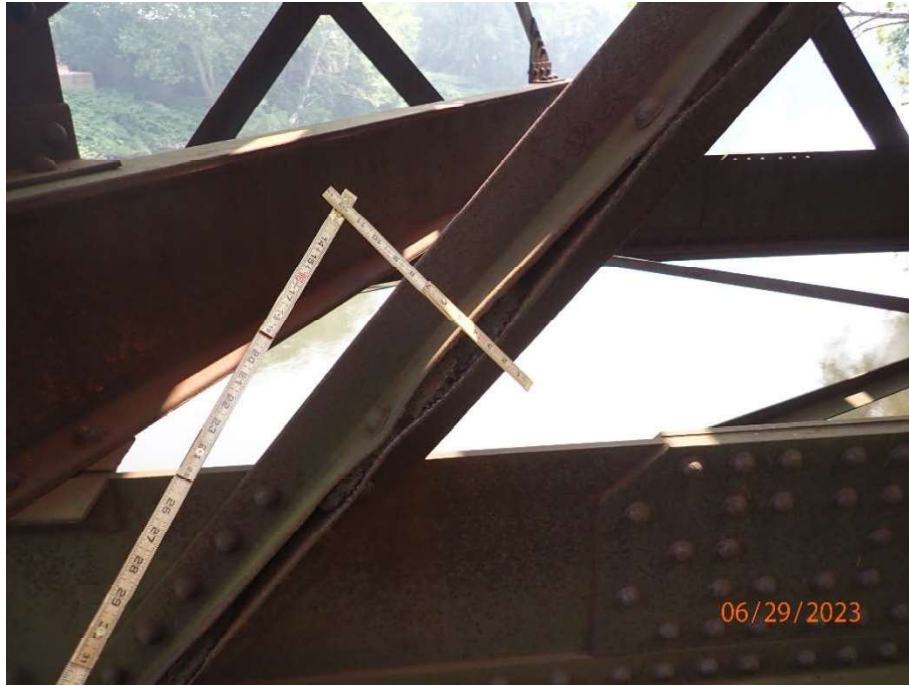
Photo 19

Girder 1, Span 3, looking east. Pack rust (up to 1½”) between the diagonal angles.

- **Recommendation 2** – The existing lattice truss and plate girder superstructure is recommended to remain in place with structural repairs to be performed at critical cracked, bent, and damaged areas where additional crack growth and or additional collisions may impair the bridge's structural capacity. Expansion bearing repairs are recommended to reset or replace critical broken plates. A new coating system is recommended on the entire superstructure to protect the existing members and to arrest further corrosion, pack rust bending/damage, and section loss.

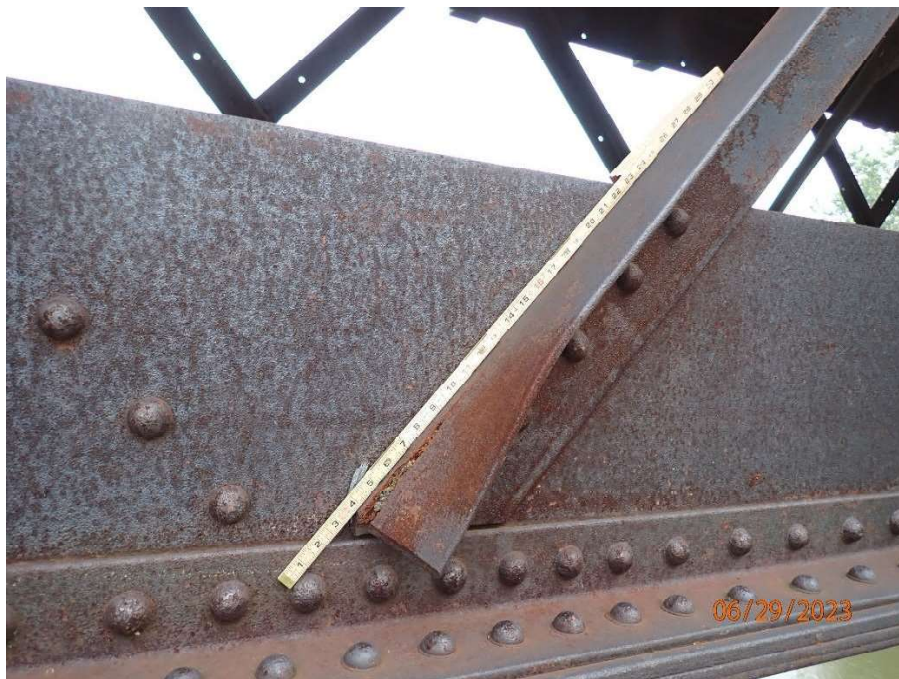
Photo 20

Girder 1, Span 4, looking east. 9” long crack at the base of the horizontal leg of the diagonal angle.

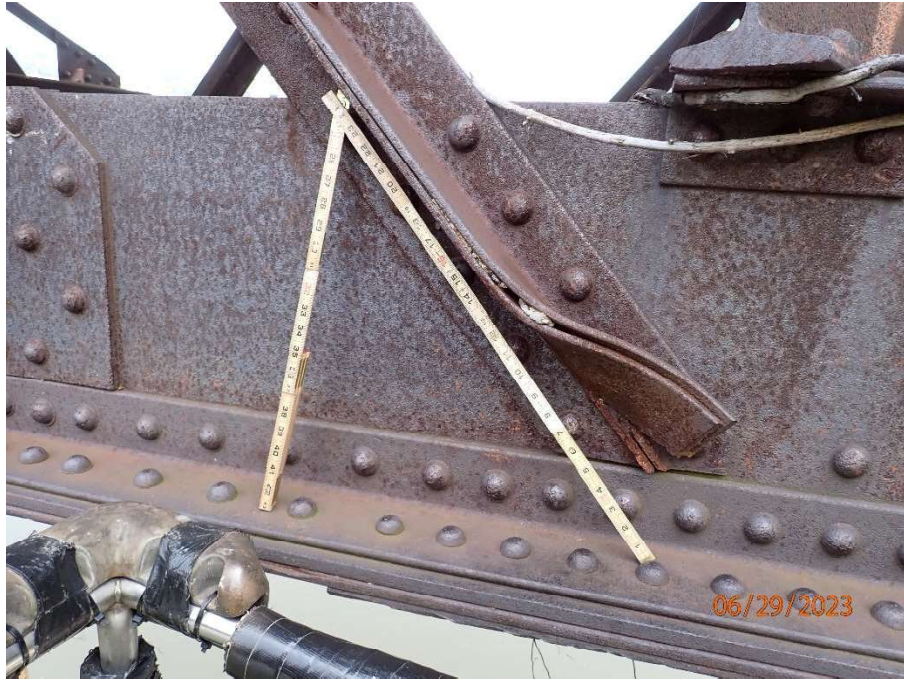
Photo 21

Girder 1, Span 4, looking east. Diagonal angles cracked and bent (7" long) at base.

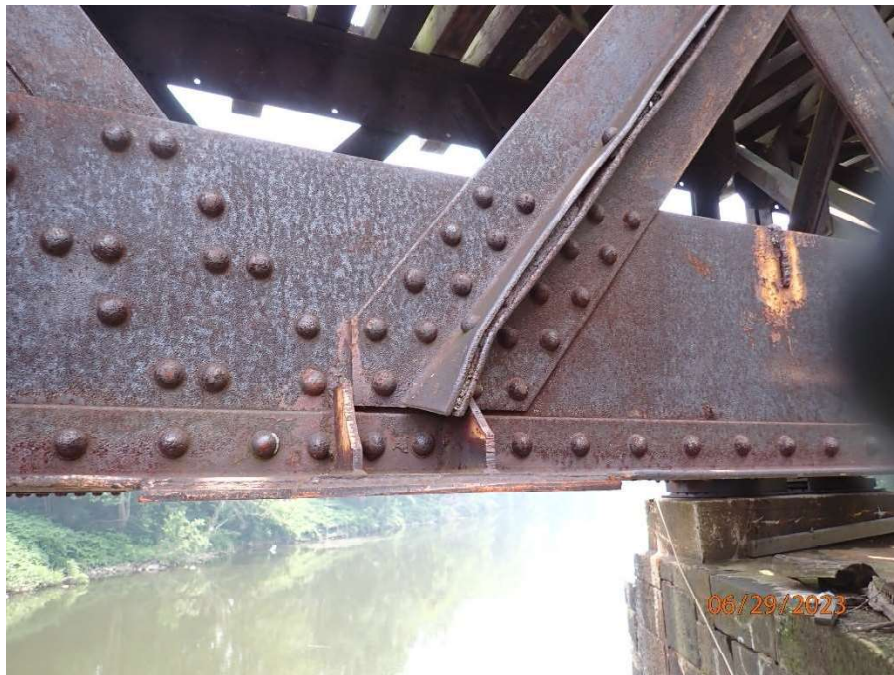
Photo 22

Girder 1, Span 4, looking east. Bent diagonal angles with pack rust along length. Note the welded plate at bottom of the girder (unknown post construction repair or jacking location).

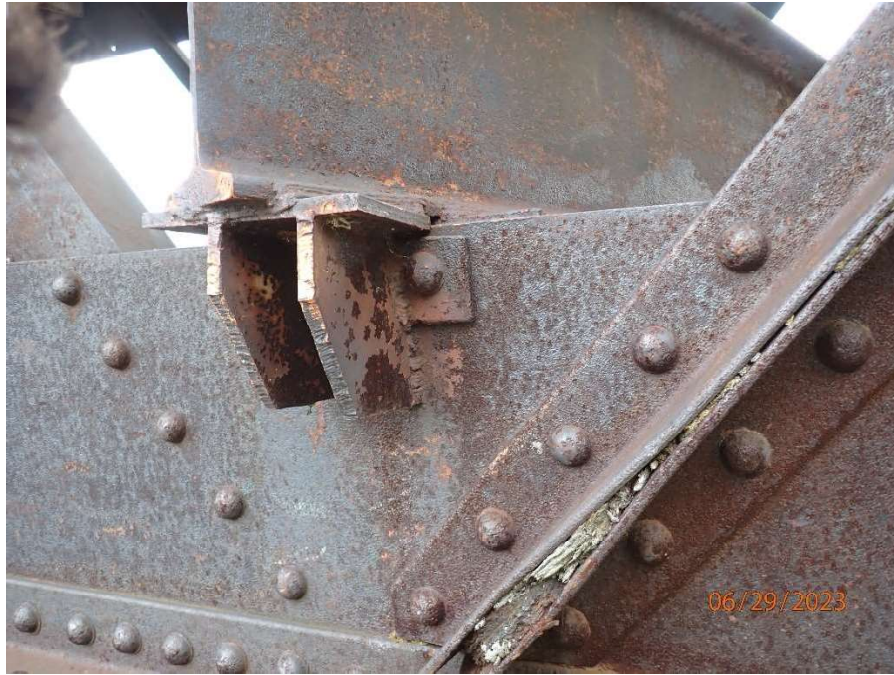
Photo 23

Girder 1, Span 4, looking northeast. Minor pitting throughout. Welded bearing bracket at the connection with the floorbeam (unknown post construction repair). Pack rust between diagonal angles.

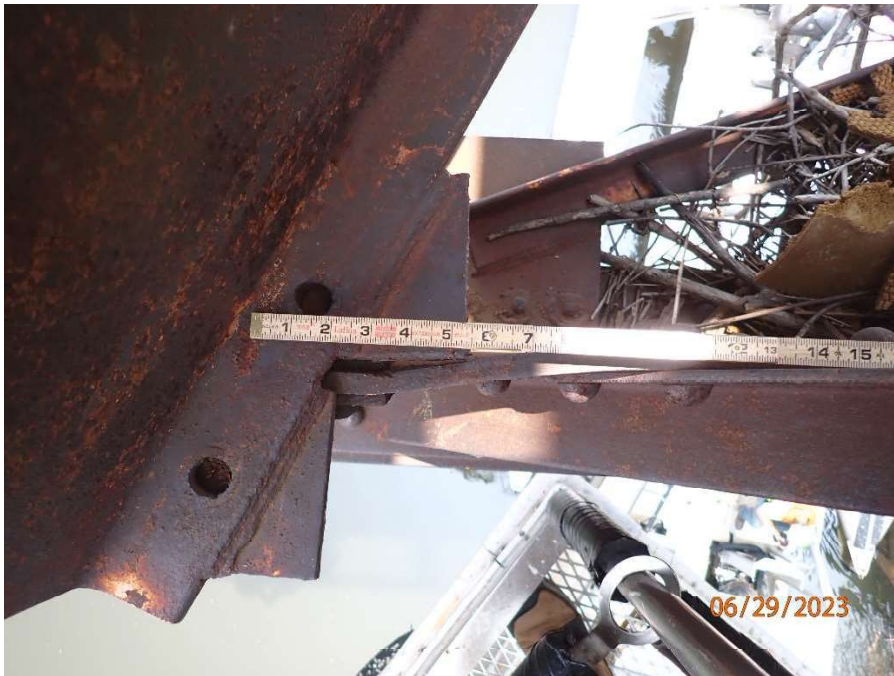
Photo 24

Girder 1, Span 5, looking west. Welded repair at the connection with the cross section. Vertical leg of the angle is bent and impacted by the repair plates.

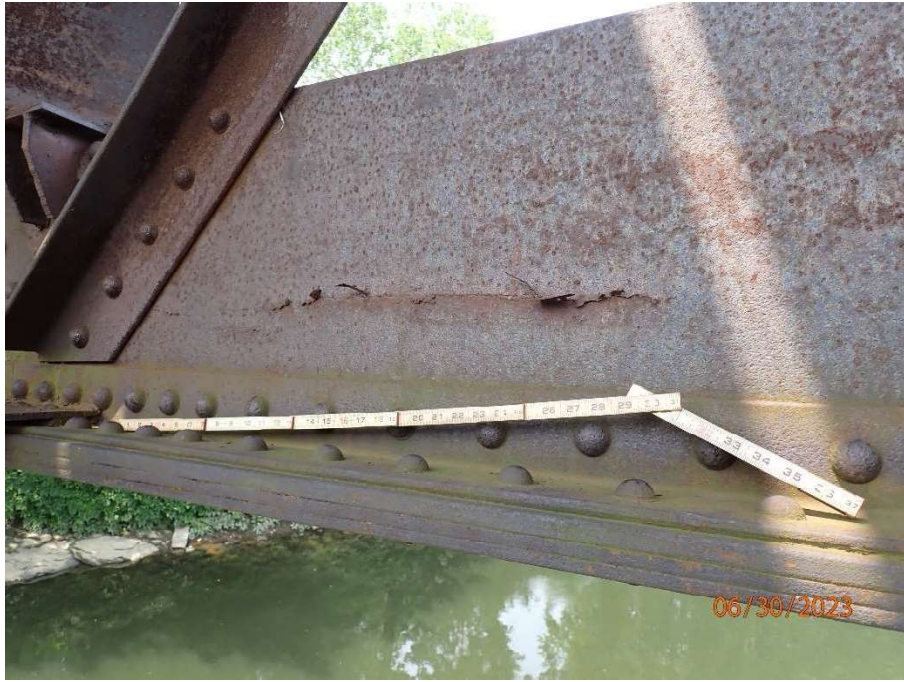
Photo 25

Girder 1, Span 5, looking southwest. 30" long steel defect in the bottom web plate.

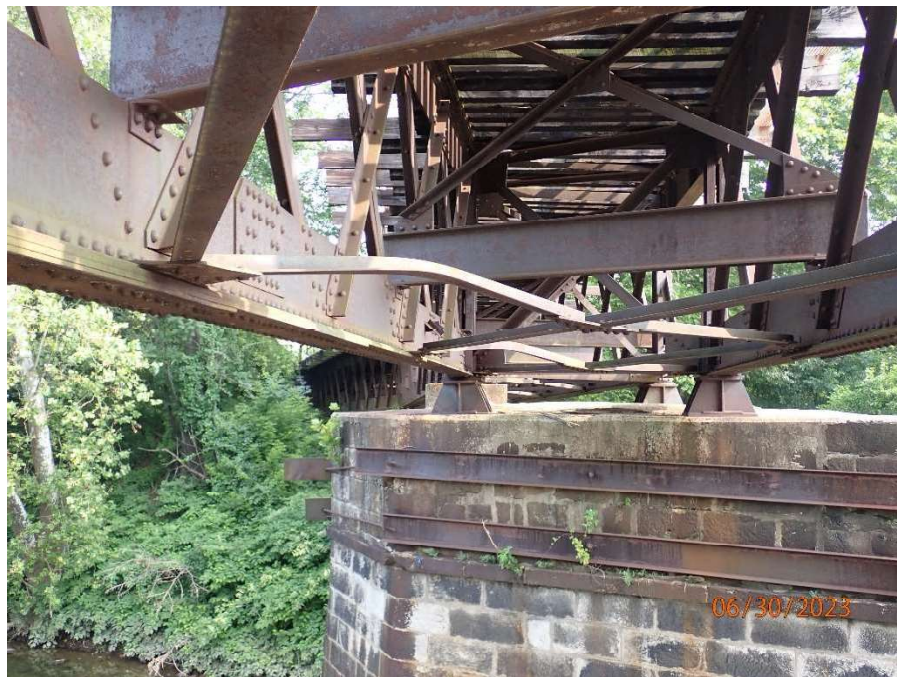
Photo 26

Girder 1, Span 6, looking north. Lower cross bracing is bent due to flood impact damage.

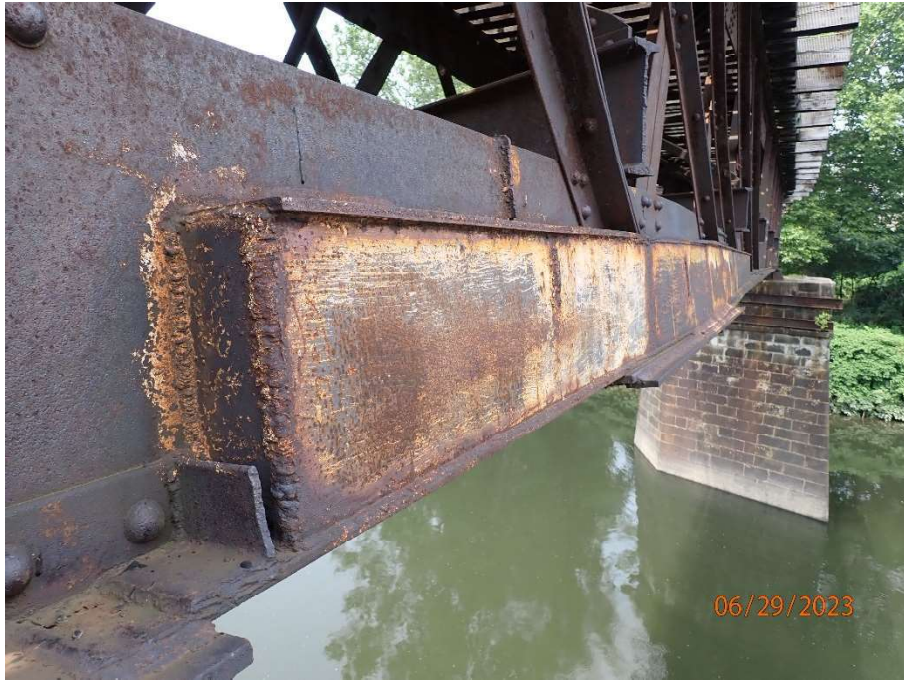
Photo 27

Girder 2, Span 6, looking northwest. Welded repair plates to the web and the bottom flange of girder.

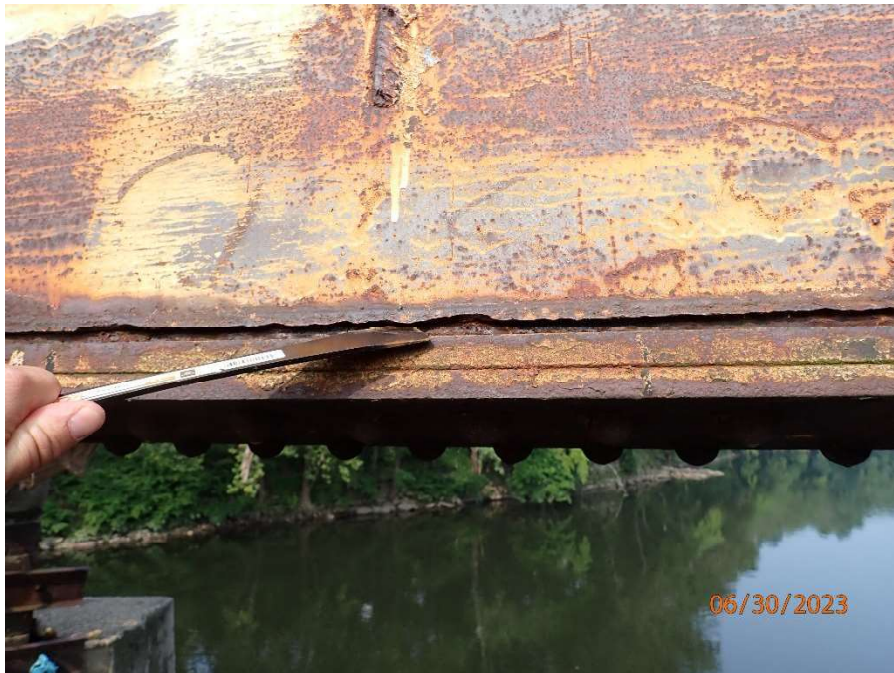
Photo 28

are 2 cracked welds. The first crack is approximately 34” long starting near the third cross bracing from Pier 5. The second crack is approximately 46” long starting near the midpoint of the 4th cross bracing from Pier 5. The girder webs are deflected up to 2” at the floorbeam connections. There is a cracked weld 3.5” long at the first floorbeam from Pier 5 at the connection to Girder 2. There is flood impact damage to the bottom cross bracing. The floorbeam nearest Pier 6 has been removed.

Girder 2, Span 6, looking west. Crack along the welded repair plates at the bottom flange of girder.

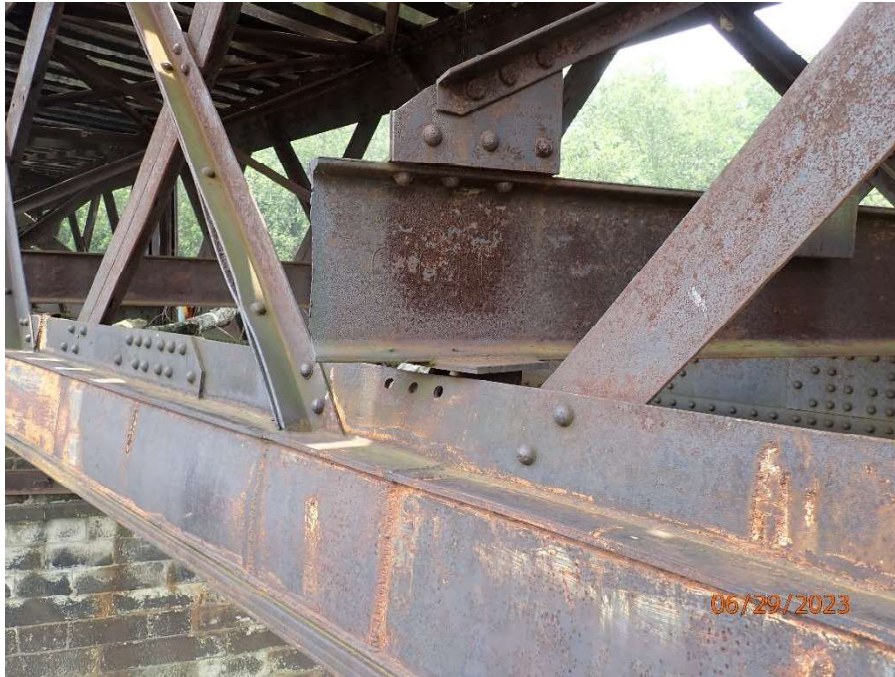
Photo 29

Span 6, floorbeam at connection with Girder 2, looking southwest. Floorbeam end is slightly bent.

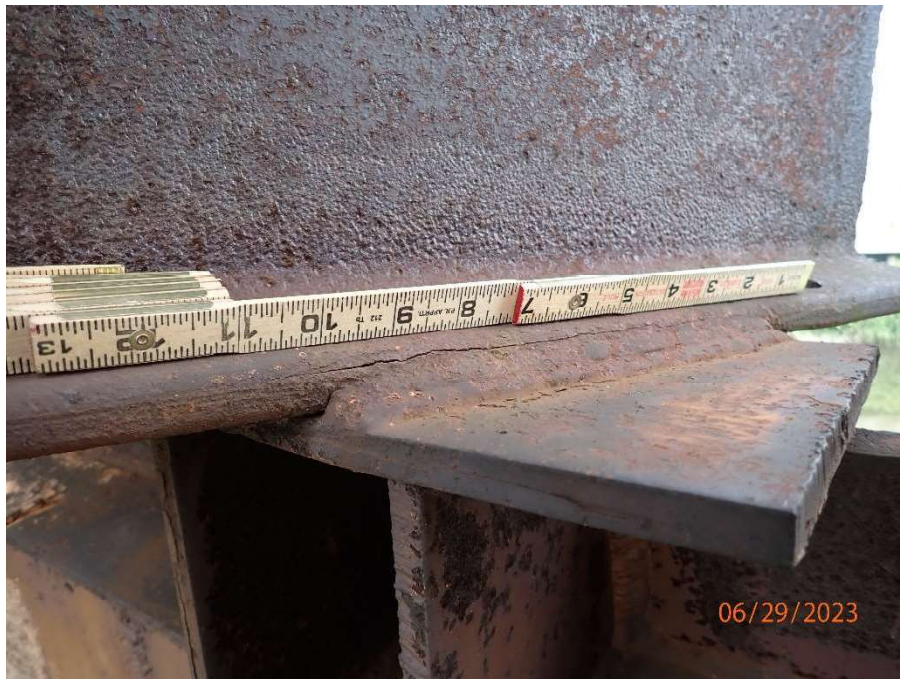
Photo 30

Span 6, floorbeam at connection with Girder 2, looking northeast. Full length weld crack at the connection.

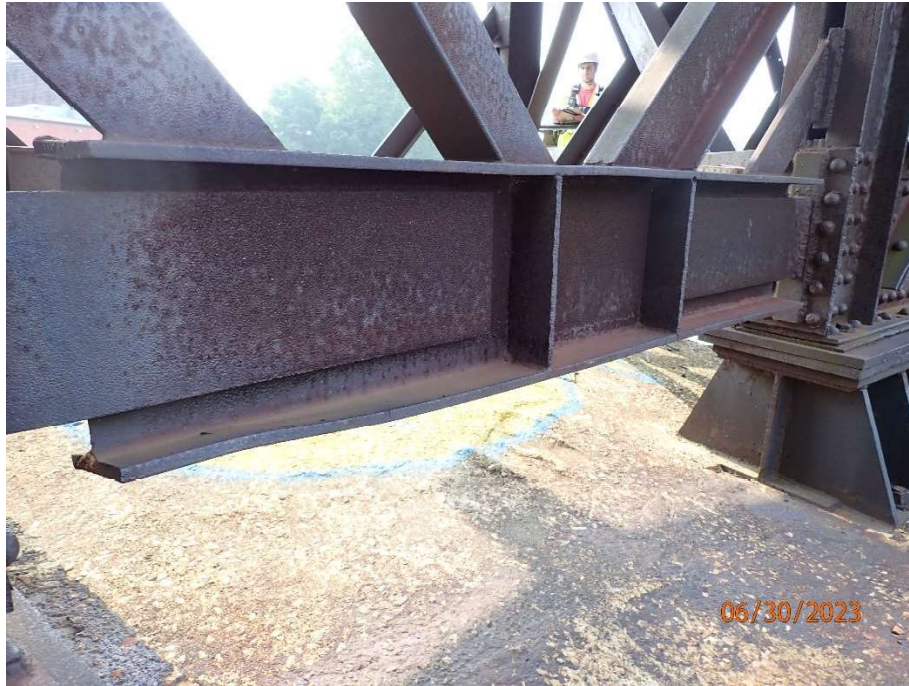
Photo 31

Lower west connection beam to Girder 1 at Pier 5, looking southeast. Bottom flange is bent at north end.

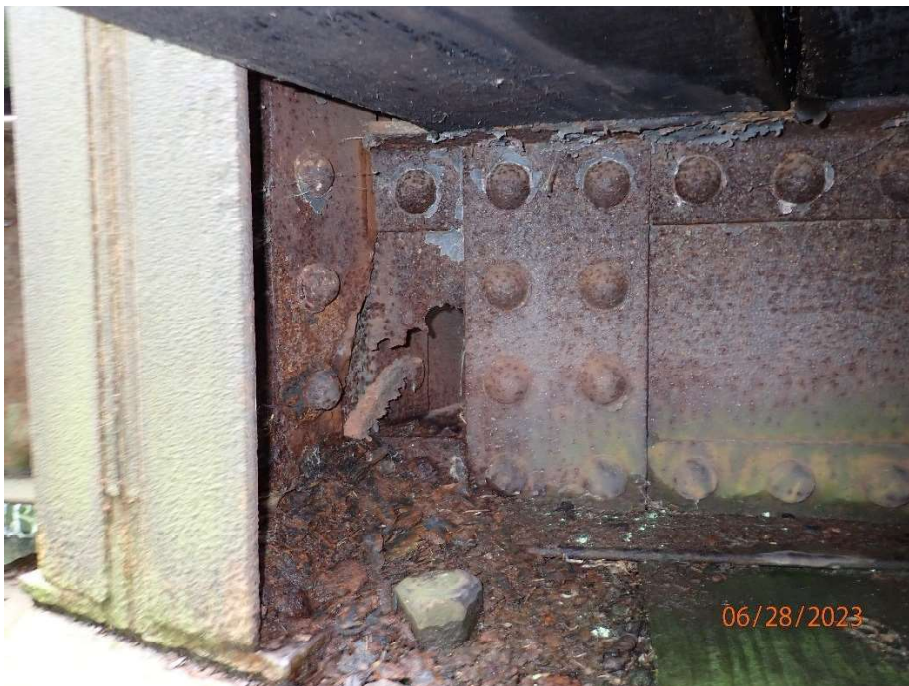
Photo 32

Span 8, floorbeam connection with the north intermediate brace, looking east. Partial width hole in the floorbeam.

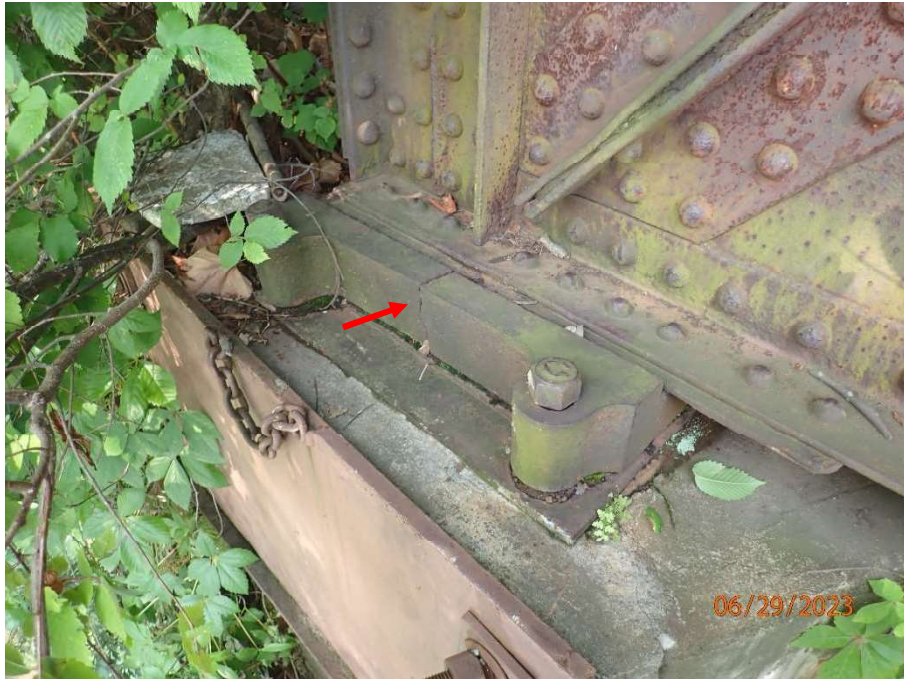
Photo 33

Girder 2 bearing at Pier 2/3, looking south. Side angle is cracked. Note reinforcing tie plate and anchors below on side of concrete pedestal.

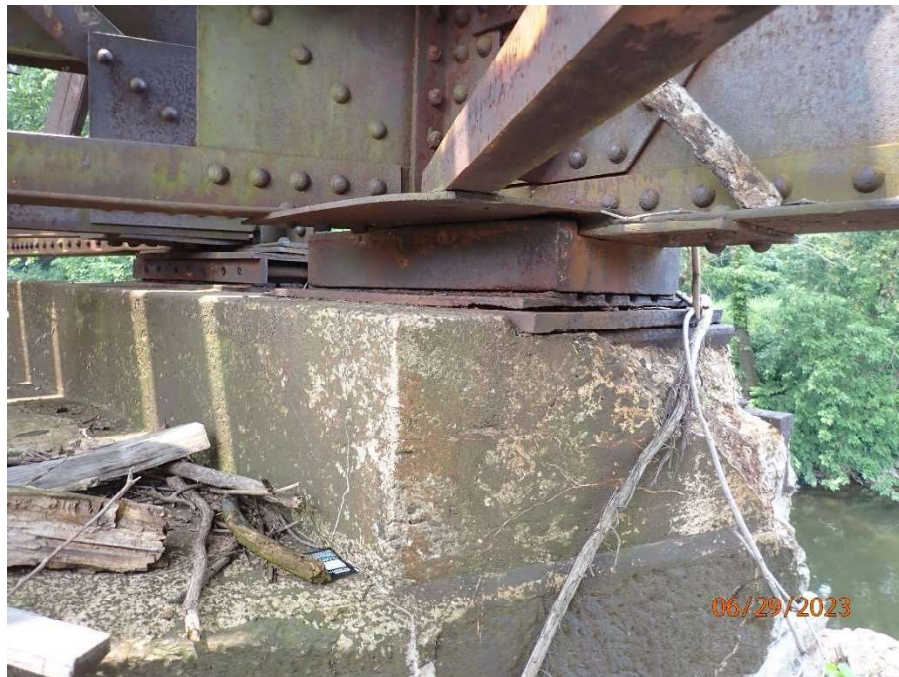
Photo 34

- **Bearings at Pier 4** – The northeast bearing on Pier 4 has approximately 53% of its original bearing area due to undermining from loss of stone in the west face of the pier. The northeast and southeast roller bearings are missing some pin caps. The southeast bearing has a full height vertical crack on the south side.

Girder 1 bearing at Pier 4, Span 5, looking southwest. Pack rust and section loss to the bearing plate. Undermining to bridge seat.

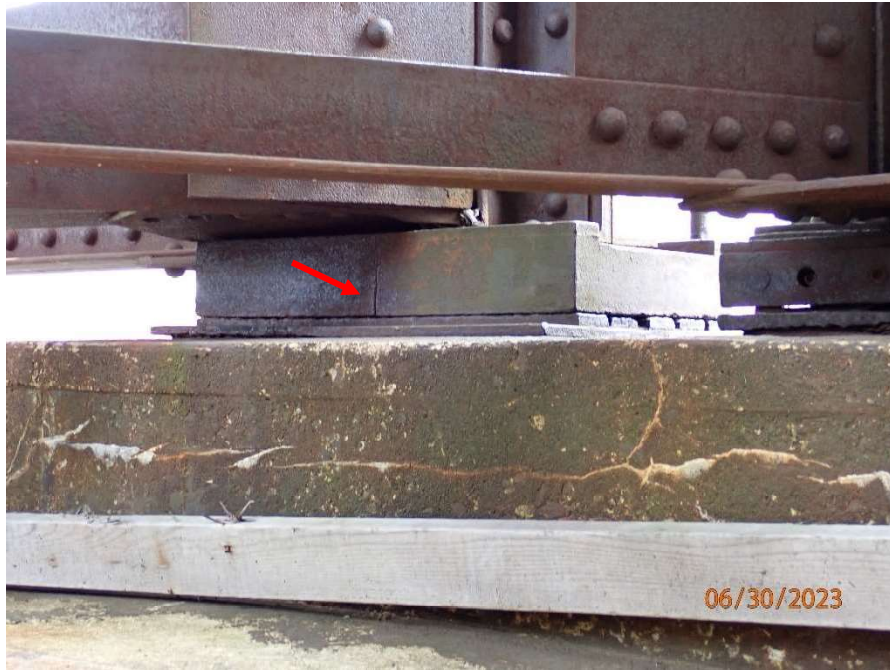
Photo 35

Girder 2 bearing at Pier 4, Span 4, looking northeast. The bearing plate is cracked.
