Submitted by:
TranSystems Corporation
March 15, 2024

Trail Feasibility Study for Repurposing **THE MULE BRIDGE** **OVER SCHUYLKILL RIVER**

City Of Philadelphia, Philadelphia County and
Lower Merion Township, Montgomery County

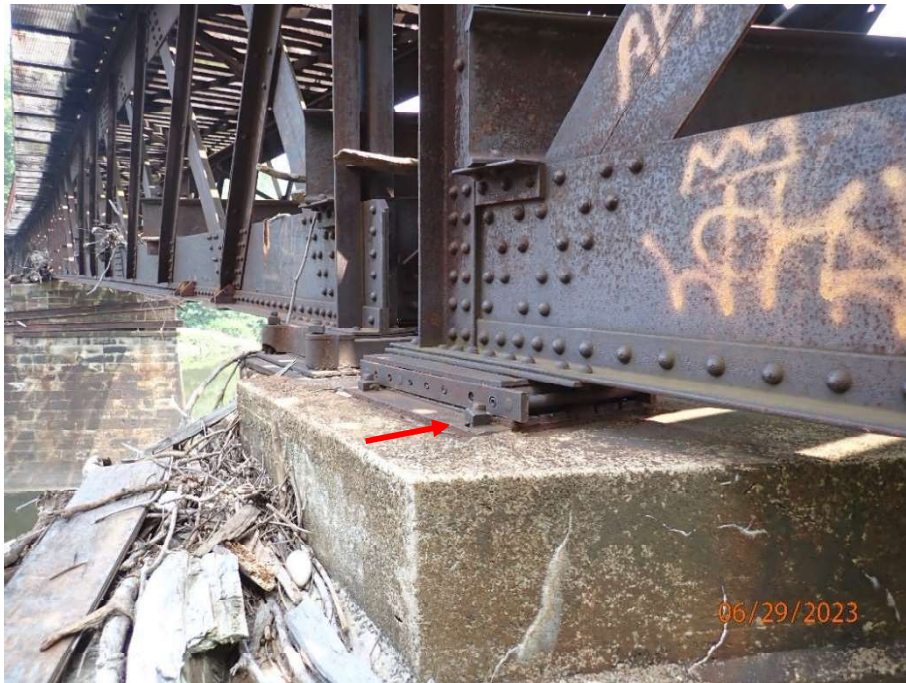
Photo 36

Girder 1 bearing at Pier 4, looking north. Unseated/bent anchor bolt. Note the fine cracks with efflorescence in the pedestal, and the flood debris accumulation.

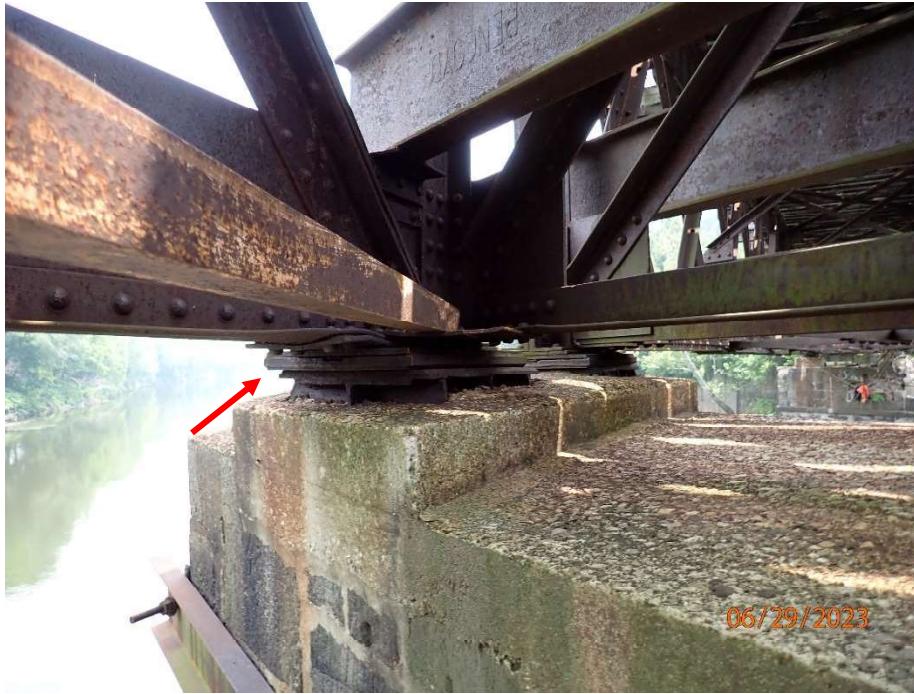
Photo 37

Girder 1 bearing at Pier 5, looking southeast. Bent top bearing plate.

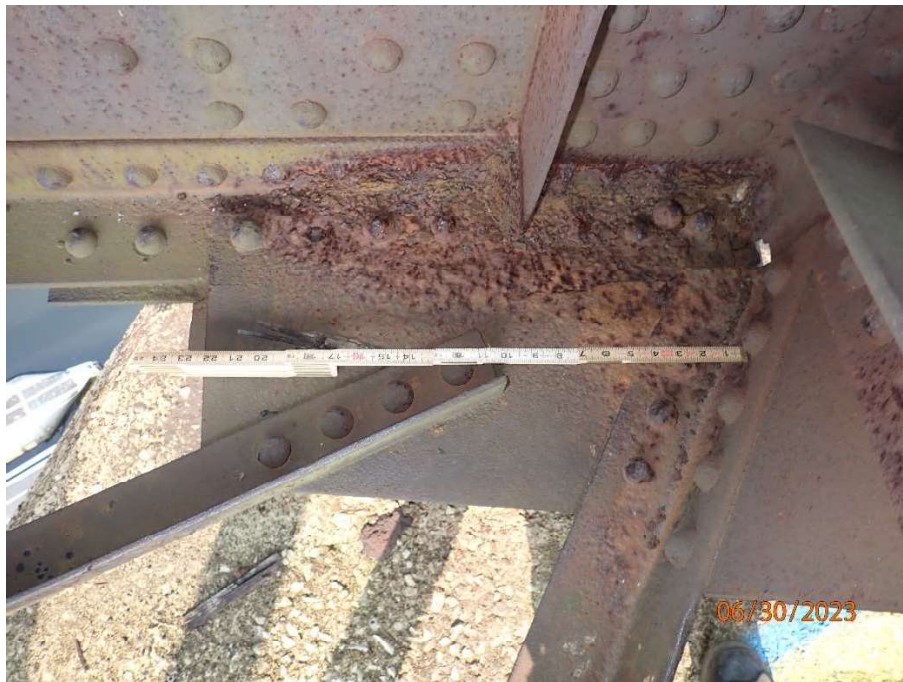
Photo 38

Span 5, Girder 1 bearing at Pier 6, looking west. Cracked connection to top bearing plate. Severe pitting to angles with up to 100% section loss to the rivet heads.

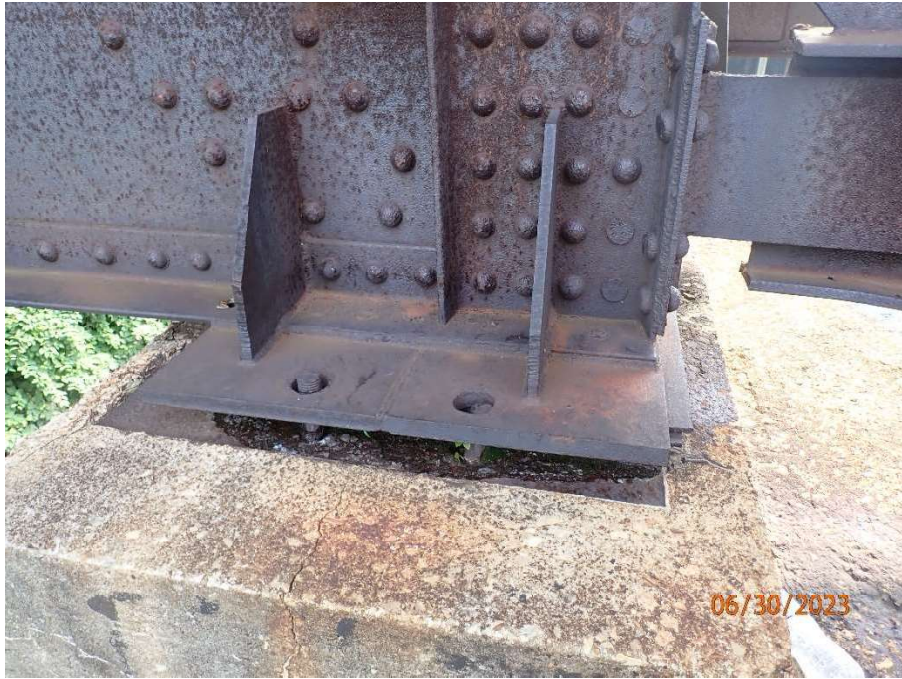
Photo 39

Span 6, Girder 1 bearing at Pier 5, looking right. Anchor bolts are sheared off with missing nuts.

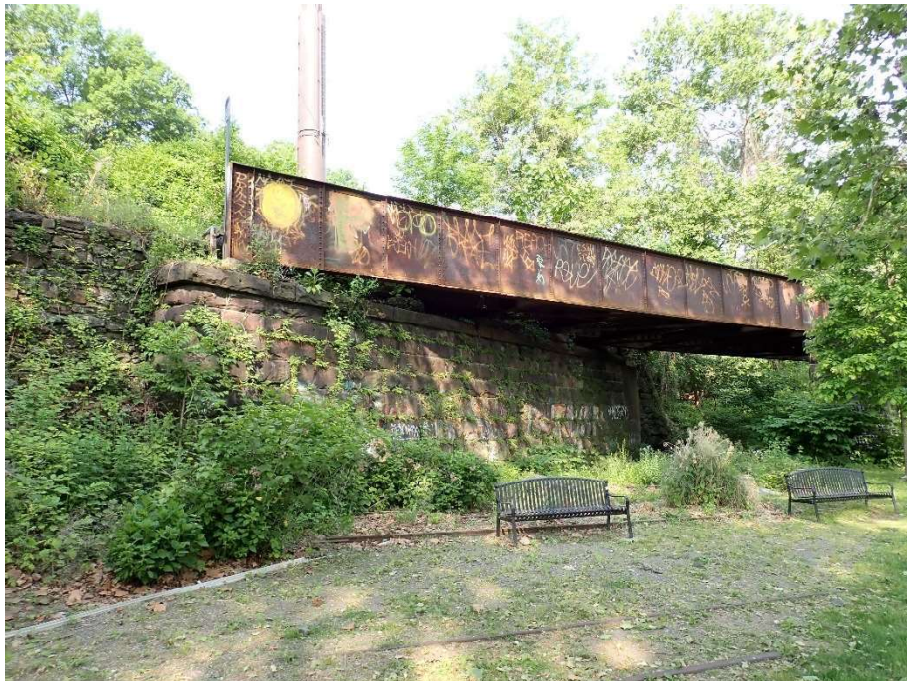
Photo 40

General view of the Lower Merion Abutment, looking west. Moss growing throughout the stem wall. Heavy vegetation growth and graffiti.

- **Recommendation 3** – The stone masonry substructure is recommended to remain in place with masonry repointing and repairs at all abutments, wingwalls, and piers; resetting displaced wingwall stones; reconstructing Pier 4 masonry void at upstream nose and far face at the waterline; repairing loose stones behind the Pier 4 void as feasible; and reconstructing Pier 2/3, Pier 4, Pier 5, and Pier 6 upper masonry and bearing caps. Undermine repairs between stone masonry and bedrock foundation gaps at Piers 5 and 6 are recommended along with installing rock protection around all piers in river and pier faces adjacent to the riverbanks.

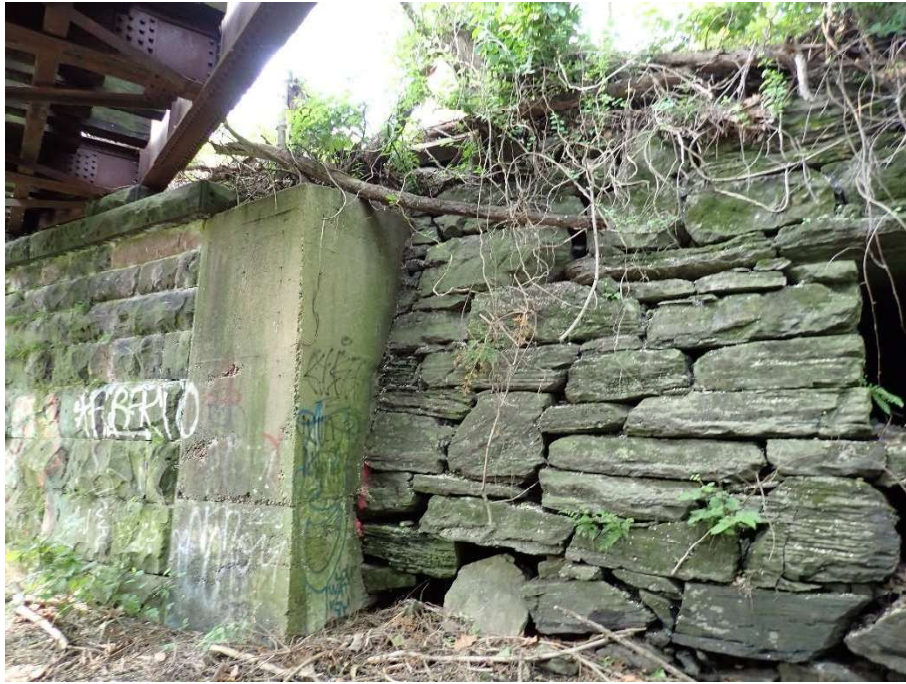
Photo 41

Southwest Wingwall, Lower Merion Abutment looking south. Large voids at the base of the wall with vegetation growth at the top.

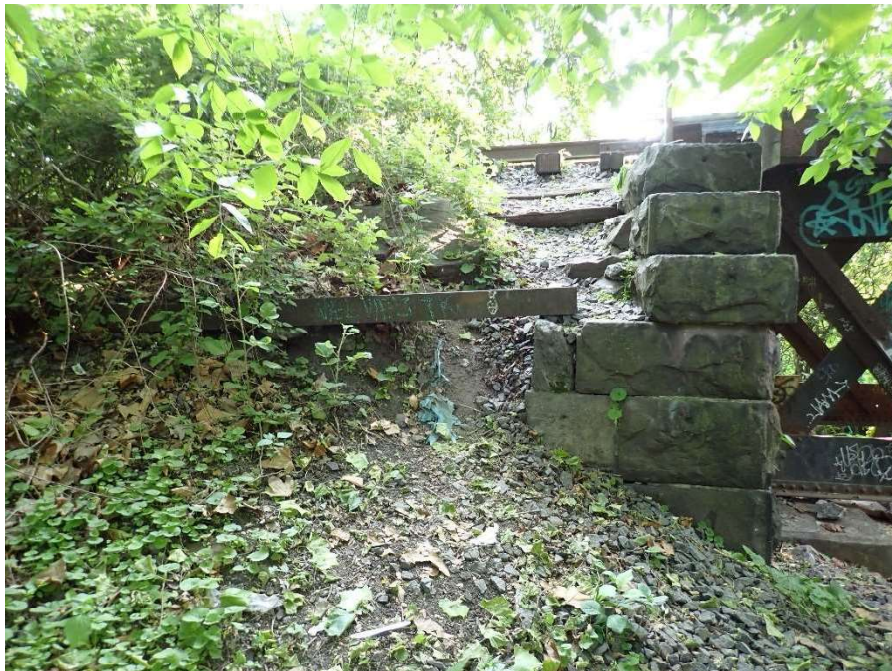
Photo 42

Northwest Wingwall, Manayunk Abutment looking east. Several missing stones with erosion and vegetation growth. Note the rotated and displaced stones at the west corner of the abutment stem wall.

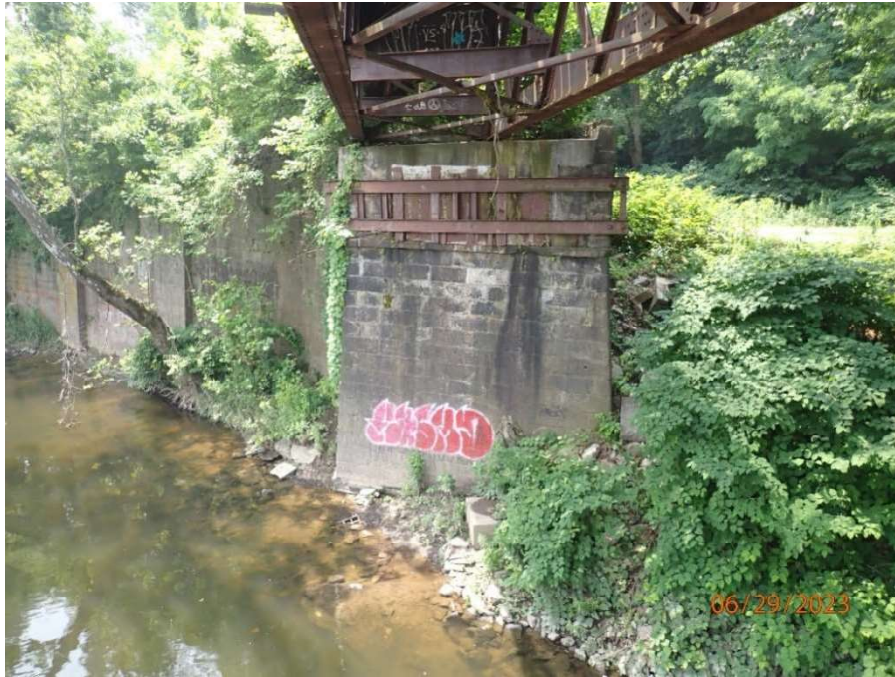
Photo 43

General view of Pier 2/3 east face, looking south. Note the tie rod channel assembly repair using additional vertical members around the pier cap. Moderate efflorescence throughout stem.

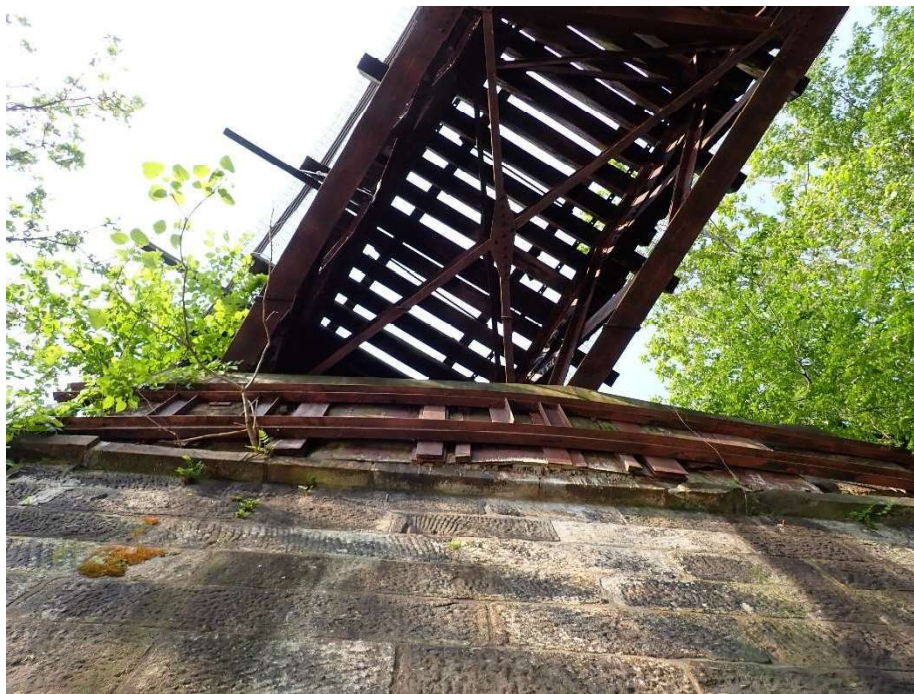
Photo 44

Pier 2/3 north face, looking south and up. The top of the pier masonry bulged out causing the tie rod channel assembly members to bend out.

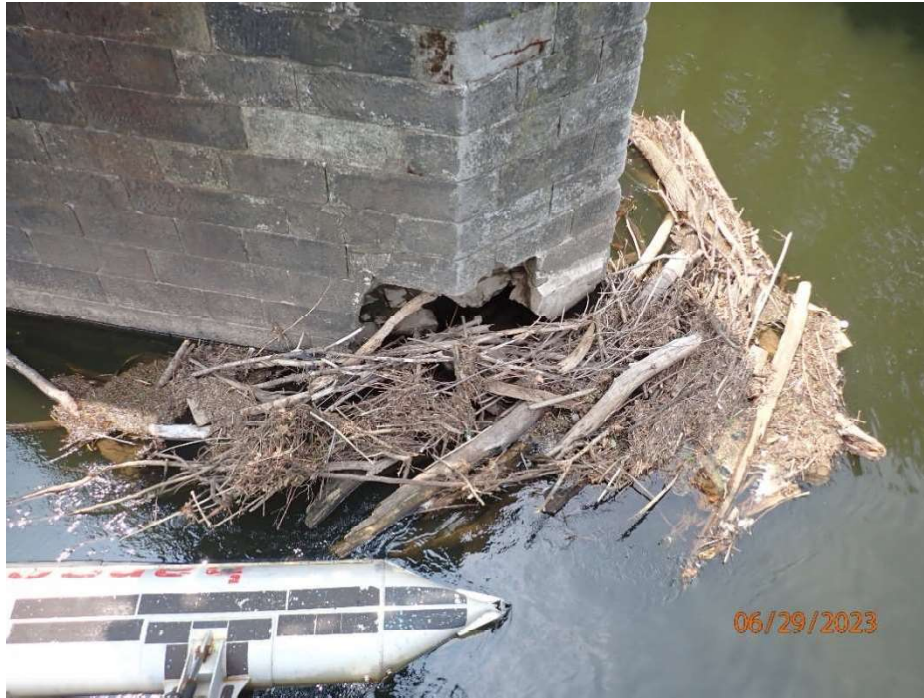
Photo 45

- **Pier 4:** Pier sits in the river near the Lower Merion bank. Severe storm damage has removed a large area of stone near the water level on the upstream end. Debris wraps around the upstream end of the pier trapped in this location. The void in the stones measures about 4' high (above water line) x 12'-6" long x 5' deep. Another void in stones appears on the top upstream north corner of the pier approximately 3' long x 2' wide x 1' deep. There are an additional 2 stones missing from the top of the pier on the downstream side. Storm debris rests on the top of the pier on the upstream end. A 10' long section on the south face near the top exhibits up to 100% mortar loss.

An area of missing stones was observed at the upstream end of the far face (Photos 4 to 6). The void measured 12'-6" long x 7'-11" high (4'-0" above the waterline and 3'-11" below the waterline) x up to 5'-0" laterally max. The stones in the back of this void were observed to be loose. Below the waterline, the stone masonry pier stem and footing exhibited up to 70% mortar loss with up to 1'-0" lateral penetrations into several of the joints. The footing was exposed around the entire perimeter of the pier and the maximum height of exposure measured 7'-9" at the downstream end. A small void between the footing and the bedrock was detected in this area. The void measured 1'-0" long x 3" high x 3" laterally. The footing stones above these voids are tight and sound. The streambed in the vicinity of the element consists of sand and gravel over bedrock. Probing the streambed resulted in penetrations of up to 5". Soundings indicate minor scour at the element. The channel flow was parallel with the pier.

Pier 4 upstream nose, looking back. Large area of stone loss causing undermining of the pier. Flood debris accumulation.

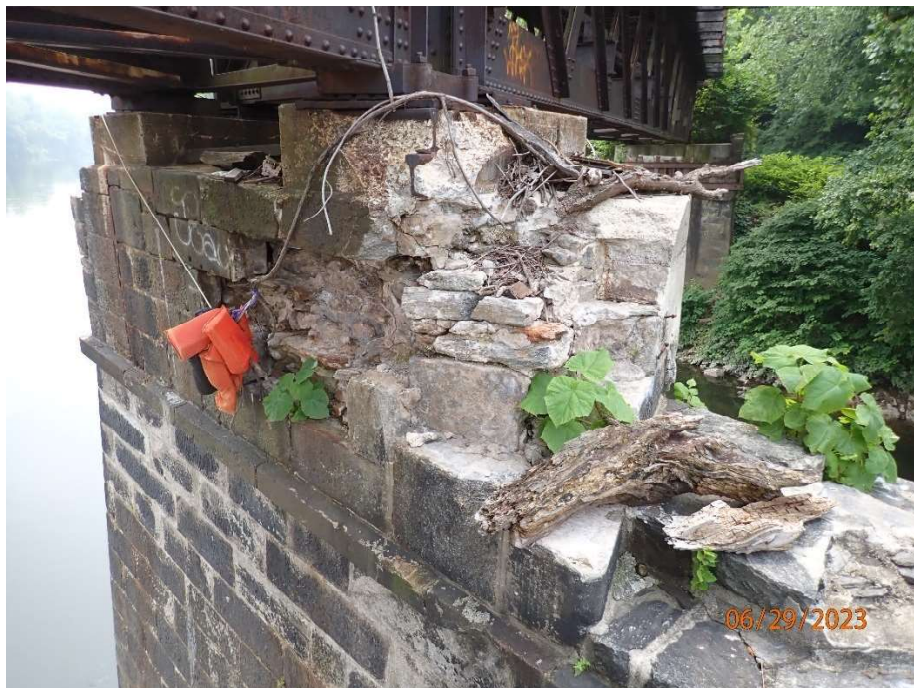
Photo 46

Pier 4 cap, looking southeast. Large masonry loss in the perimeter cut stone exposing rubble fill and undermining the girder bearing. Flood debris accumulation/vegetation growth.

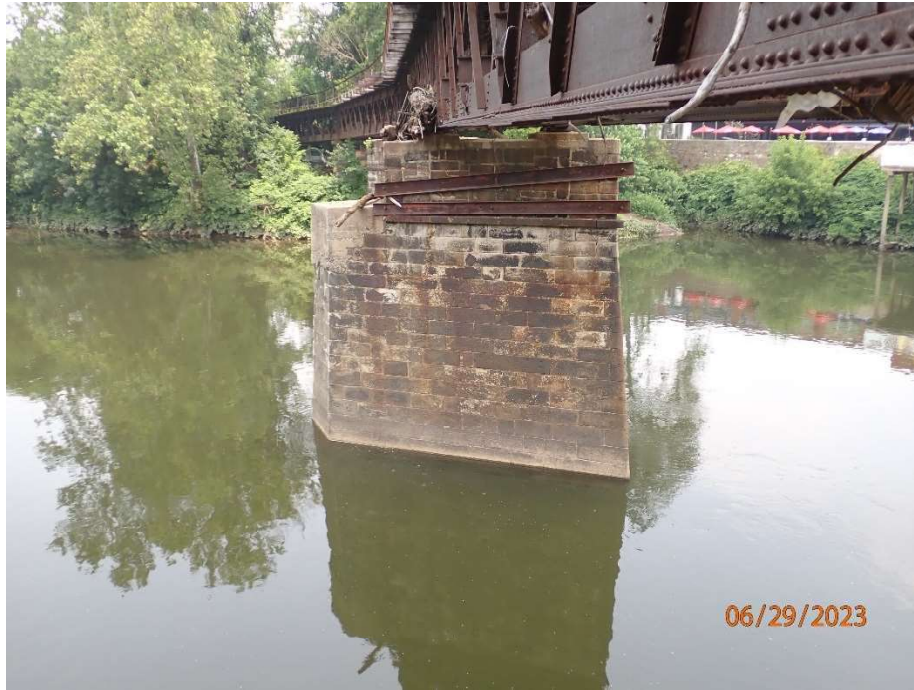
Photo 47

- **Pier 5:** Pier sits near the middle of the river. Tie rod channel assembly sections on the north and south side of the pier reinforces the upper pier masonry. The nuts on the tie rods are loose or missing in several locations and the channels are not tight around the pier. There is heavy storm debris on the upstream end of the pier cap including 2 large tree branches that extend on to the superstructure in Span 6.

Pier 5 cap, south face, looking north. Minor to moderate efflorescence throughout. Flood debris at the upstream side of the bridge seat. Tie rod channel assembly typically loose.

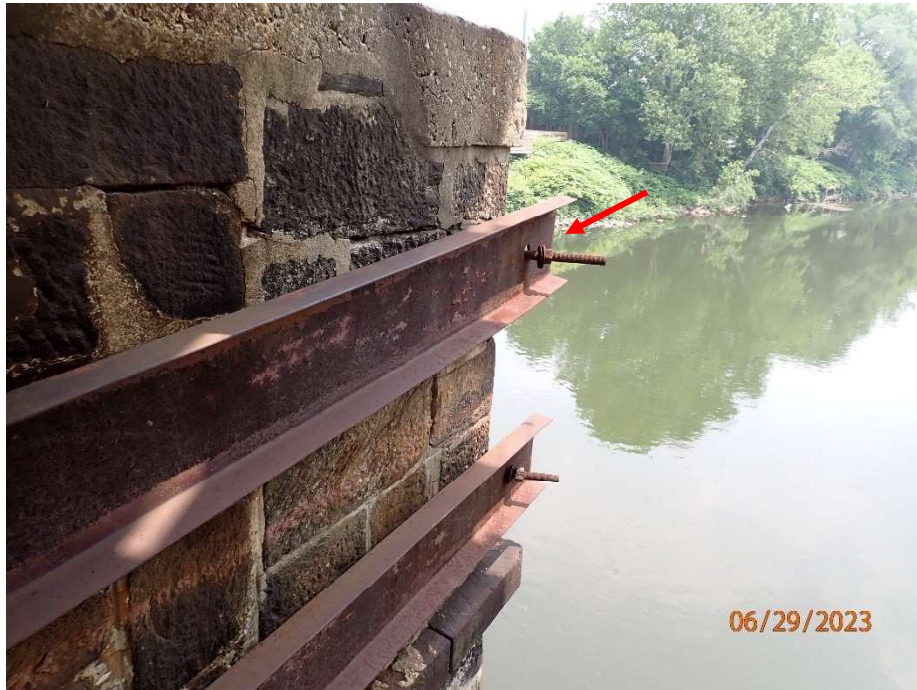
Photo 48

Pier 5 cap, south face, looking east. Tie rod channel assembly with nuts not fully tightened.

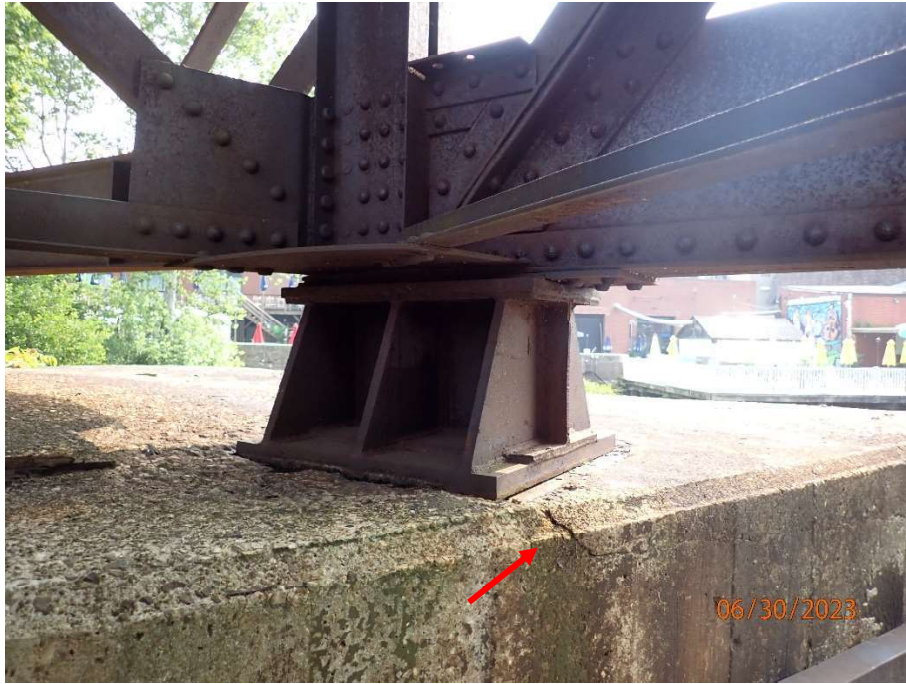
Photo 49

Bridge seat under Girder G2 bearing at Pier 6, looking northeast. Wide crack in the bridge seat under the bearing.
