**ADDRESS: 1021 CHESTNUT ST**

Proposal: Remove structure, construct structure, reconstruct façade

# PPA GARAGE HISTORIC PRESENTATION

**ADDRESS:** 1021-1029 Chestnut Street

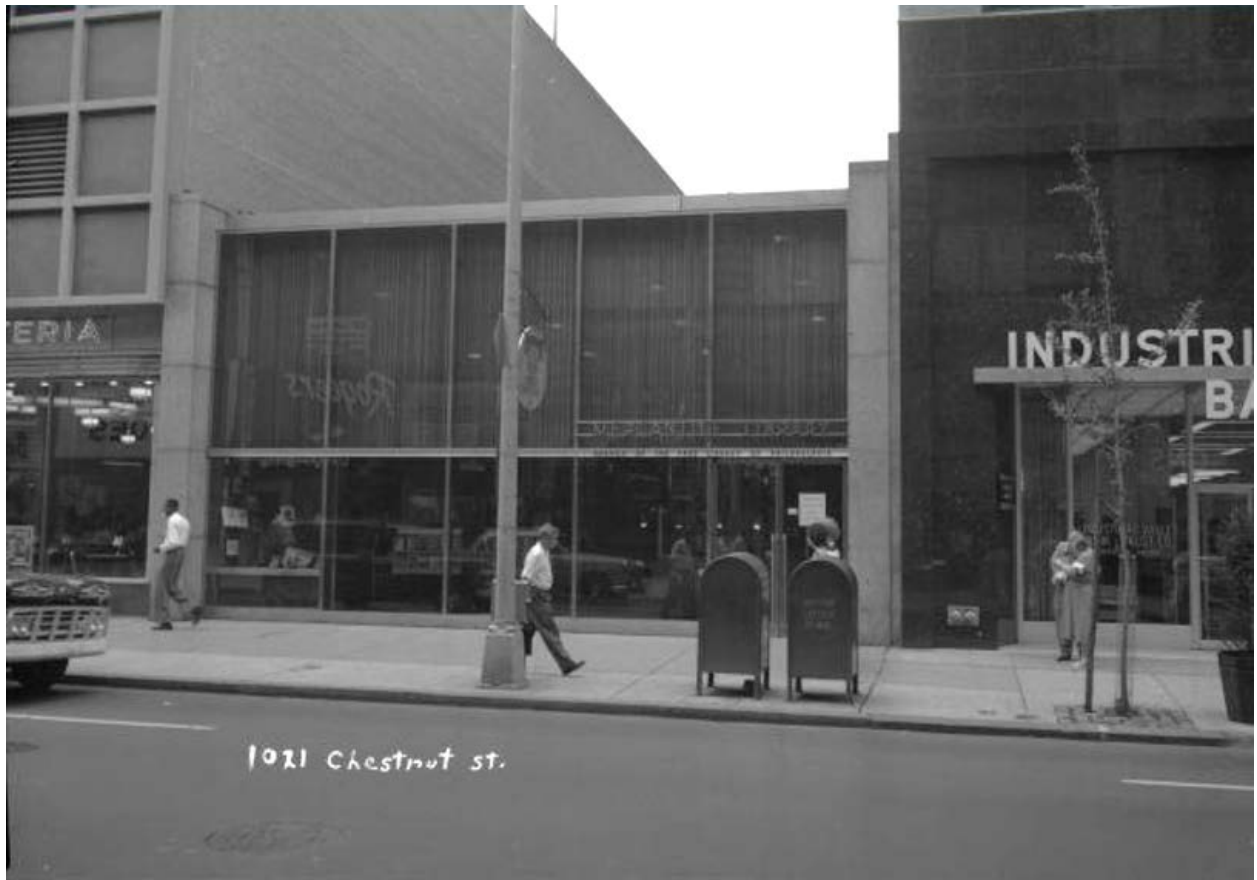
and rear wall are not visible (Figure 1). The staff suggests that the front façade of the library building is the historic resource, and, with its faithful reconstruction, this project will not constitute a demolition.

Figure 1. Photograph of the front façade of the library, the only photograph included in the 1990 nomination.

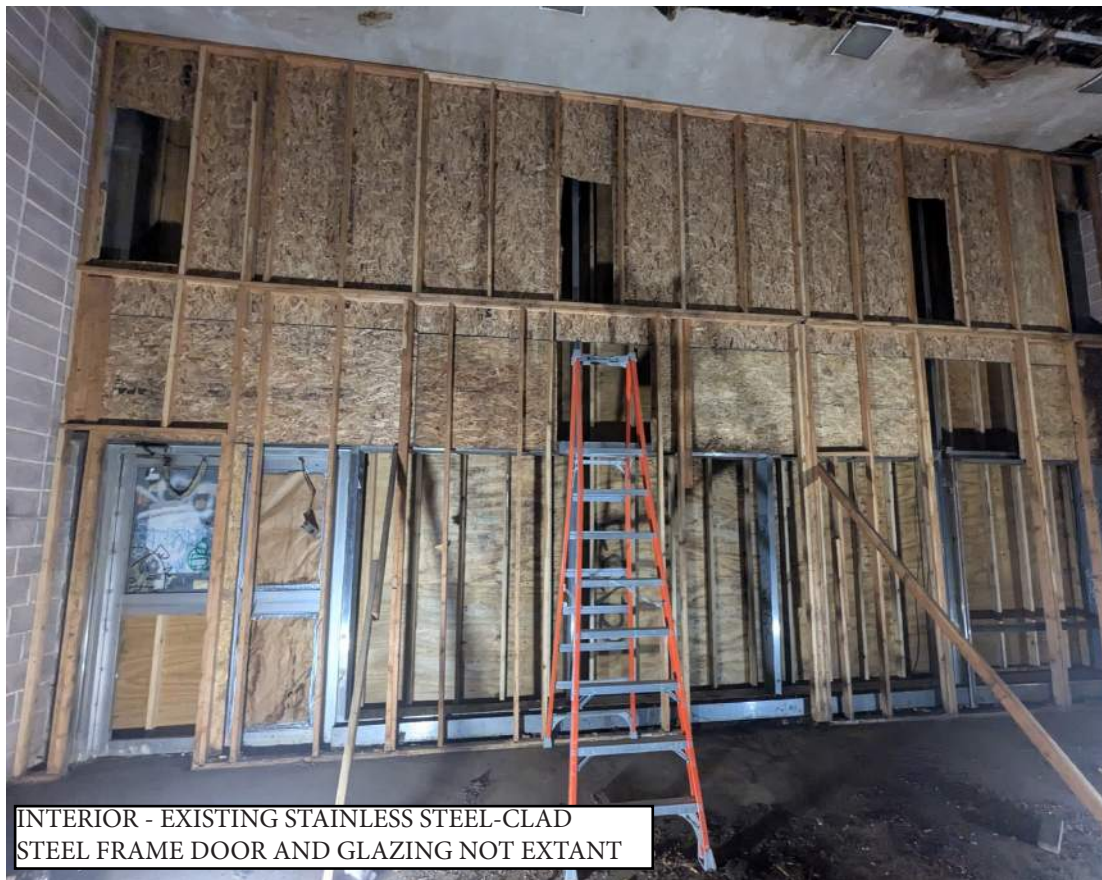
INTERIOR - EXISTING STAINLESS STEEL-CLAD STEEL FRAME DOOR AND GLAZING NOT EXTANT

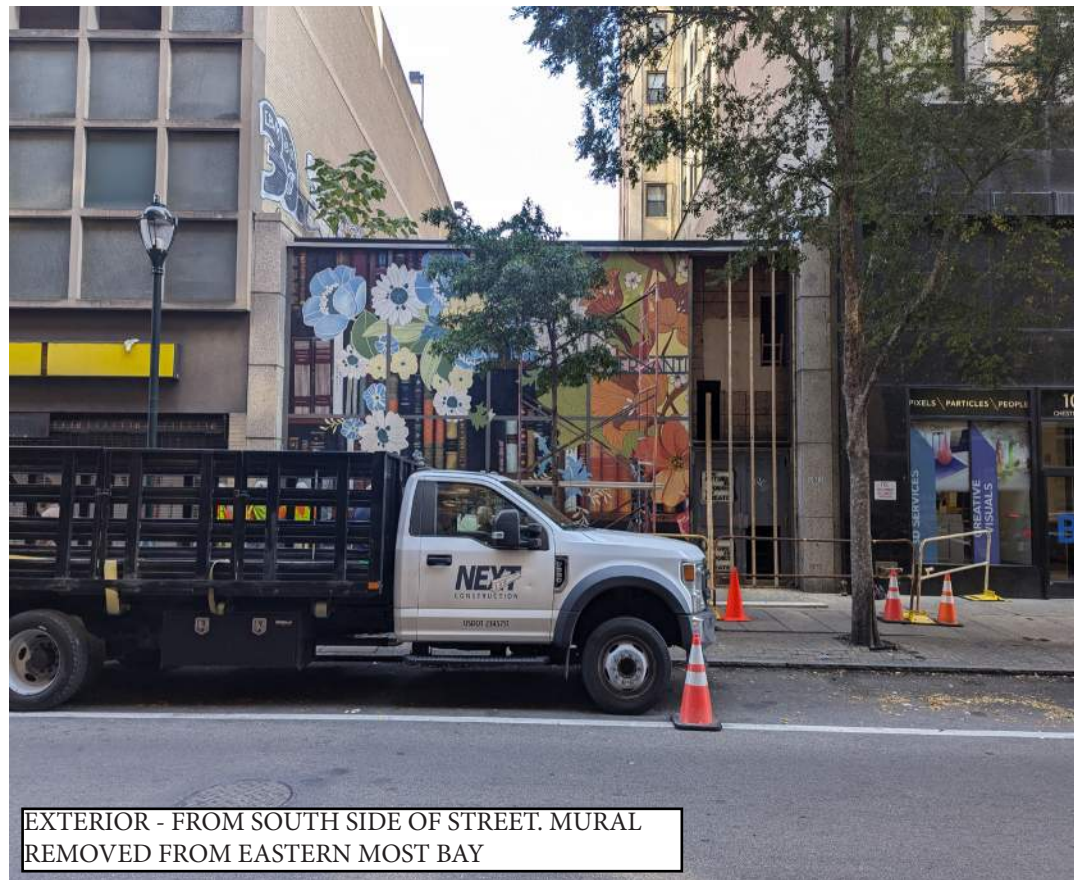
EXTERIOR - FROM SOUTH SIDE OF STREET. MURAL REMOVED FROM EASTERN MOST BAY

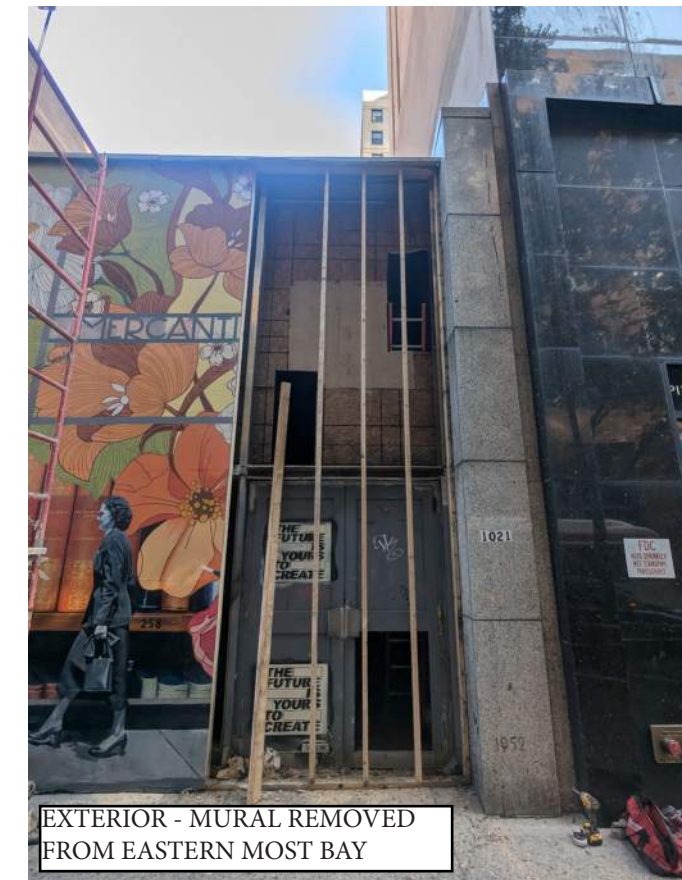
EXTERIOR - MURAL REMOVED FROM EASTERN MOST BAY

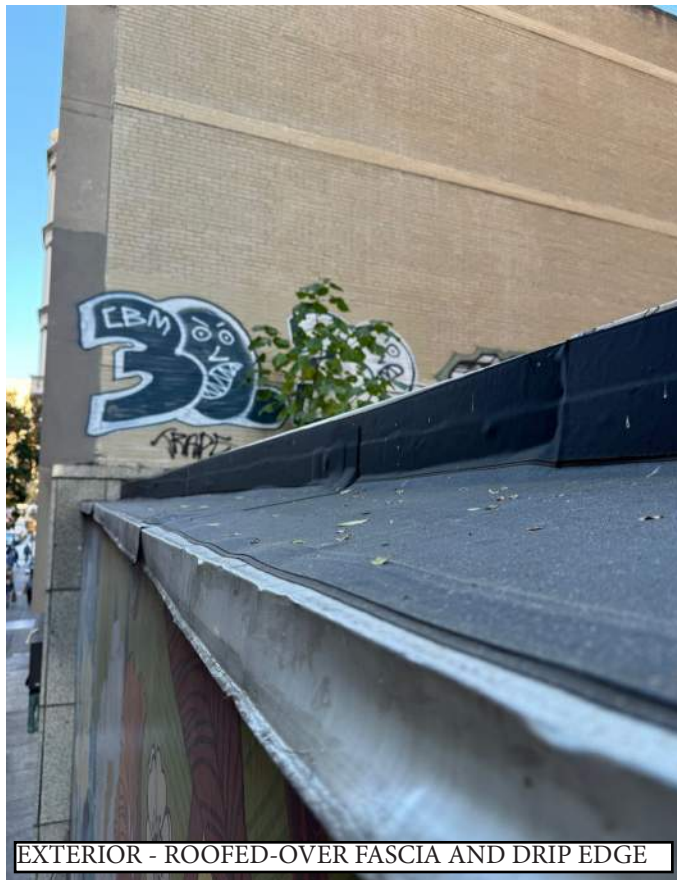
EXTERIOR - ROOFED-OVER FASCIA AND DRIP EDGE

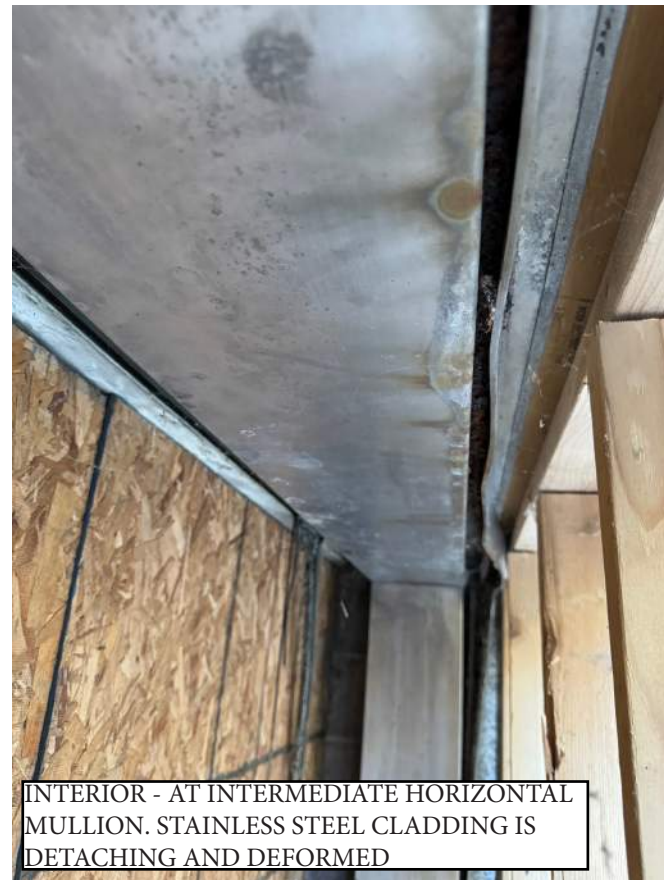
INTERIOR - AT INTERMEDIATE HORIZONTAL MULLION. STAINLESS STEEL CLADDING IS DETACHING AND DEFORMED

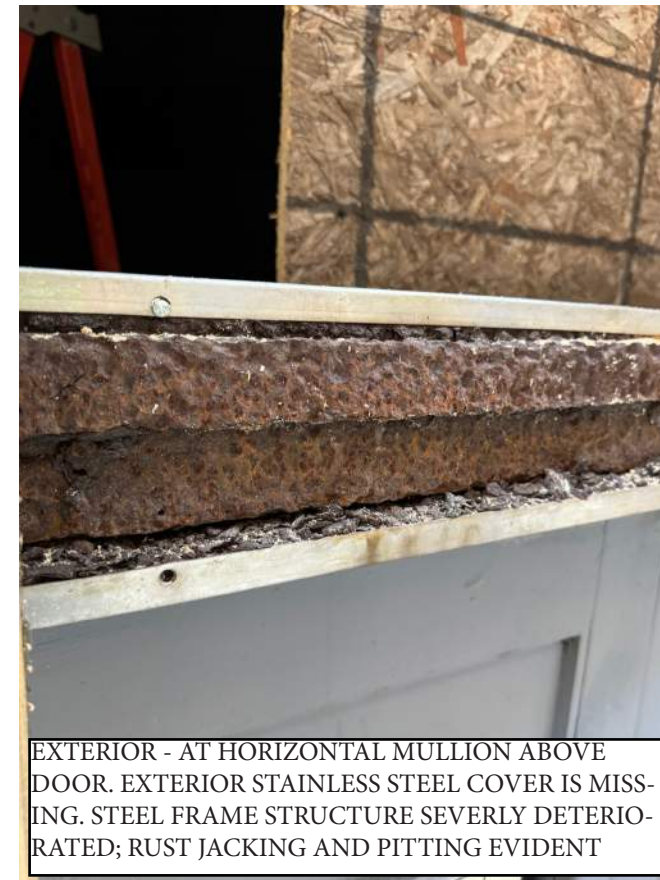
EXTERIOR - AT HORIZONTAL MULLION ABOVE DOOR. EXTERIOR STAINLESS STEEL COVER IS MISSING. STEEL FRAME STRUCTURE SEVERELY DETERIORATED; RUST JACKING AND PITTING EVIDENT

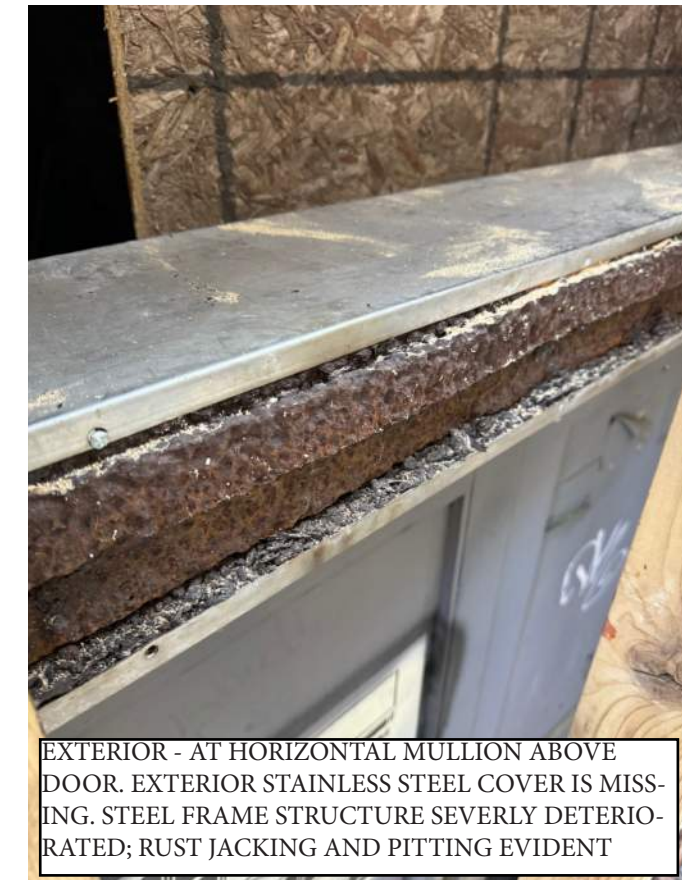
EXTERIOR - AT HORIZONTAL MULLION ABOVE DOOR. EXTERIOR STAINLESS STEEL COVER IS MISSING. STEEL FRAME STRUCTURE SEVERELY DETERIORATED; RUST JACKING AND PITTING EVIDENT

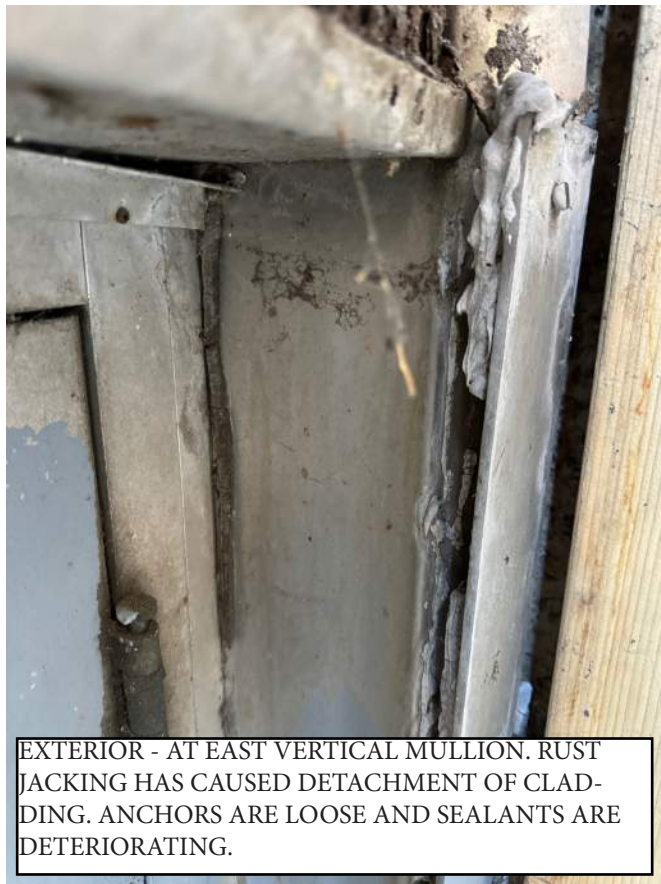
EXTERIOR - AT EAST VERTICAL MULLION. RUST JACKING HAS CAUSED DETACHMENT OF CLADDING. ANCHORS ARE LOOSE AND SEALANTS ARE DETERIORATING.

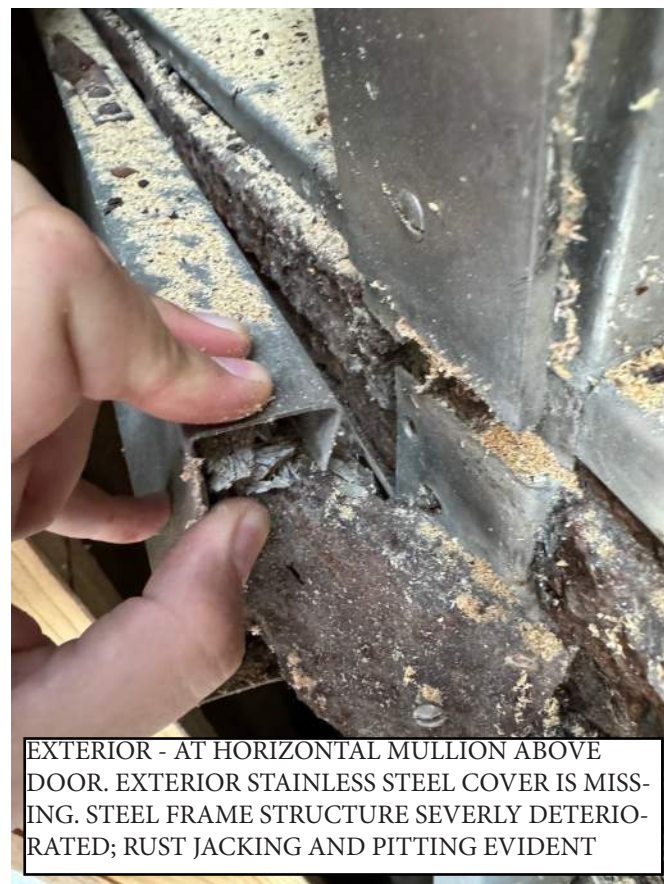
EXTERIOR - AT HORIZONTAL MULLION ABOVE DOOR. EXTERIOR STAINLESS STEEL COVER IS MISSING. STEEL FRAME STRUCTURE SEVERLY DETERIORATED; RUST JACKING AND PITTING EVIDENT

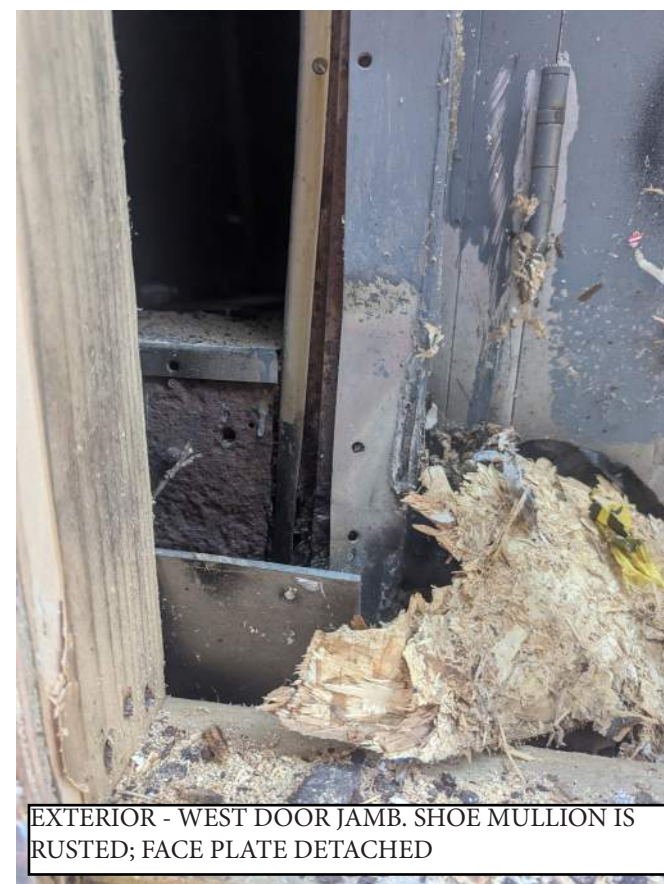
EXTERIOR - WEST DOOR JAMB. SHOE MULLION IS RUSTED; FACE PLATE DETACHED

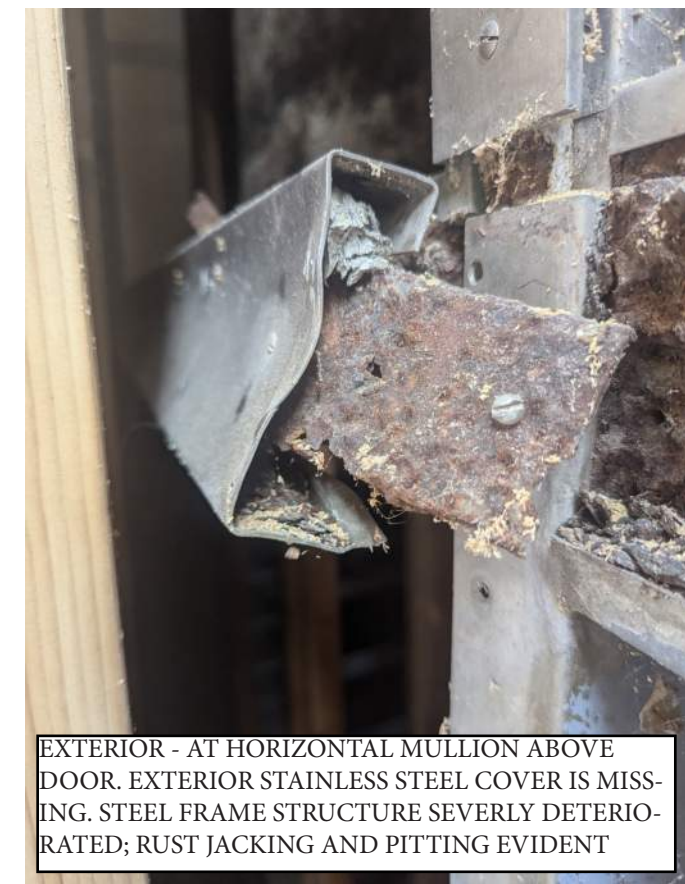
EXTERIOR - AT HORIZONTAL MULLION ABOVE DOOR. EXTERIOR STAINLESS STEEL COVER IS MISSING. STEEL FRAME STRUCTURE SEVERLY DETERIORATED; RUST JACKING AND PITTING EVIDENT

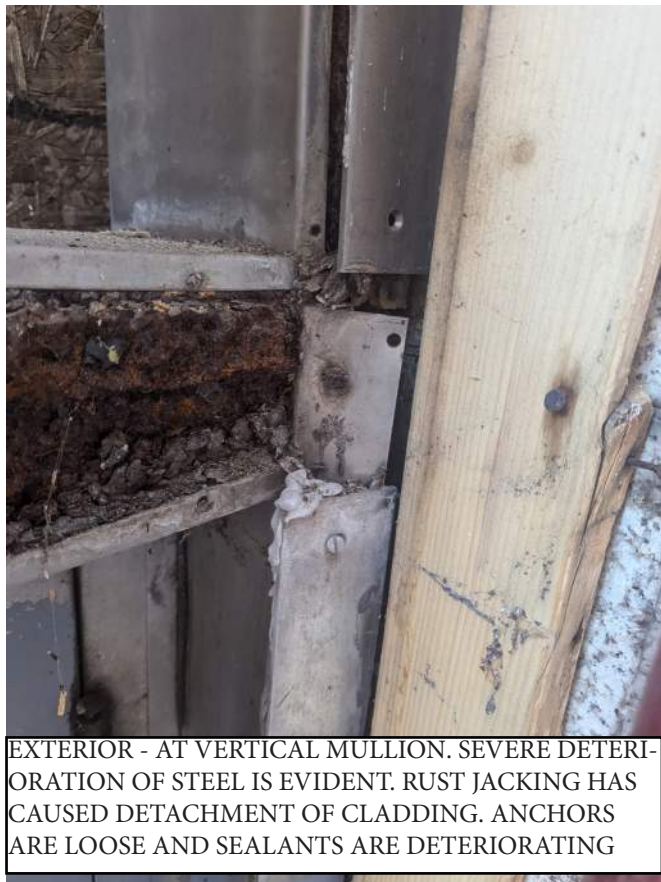
EXTERIOR - AT VERTICAL MULLION. SEVERE DETERIORATION OF STEEL IS EVIDENT. RUST JACKING HAS CAUSED DETACHMENT OF CLADDING. ANCHORS ARE LOOSE AND SEALANTS ARE DETERIORATING

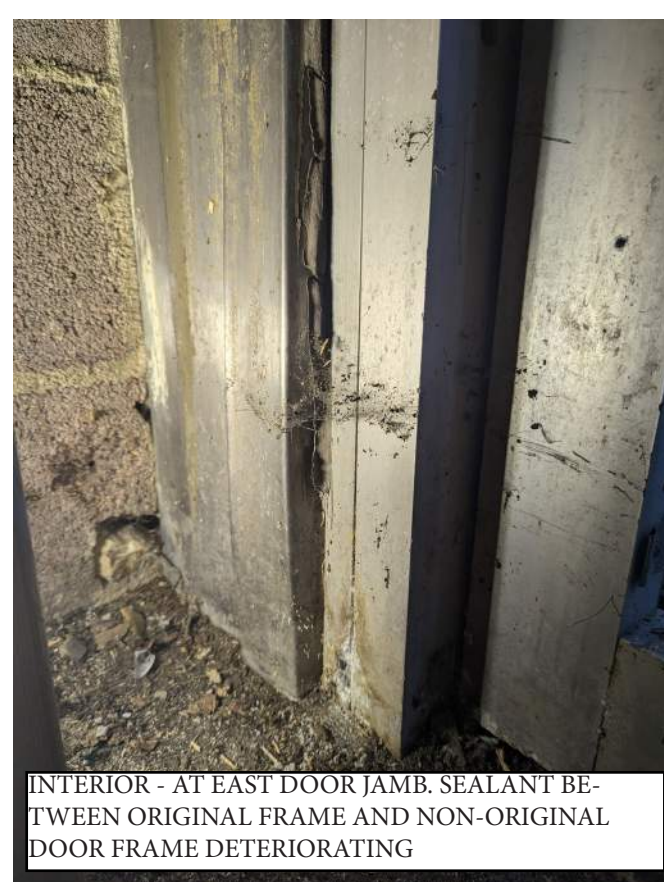
INTERIOR - AT EAST DOOR JAMB. SEALANT BETWEEN ORIGINAL FRAME AND NON-ORIGINAL DOOR FRAME DETERIORATING

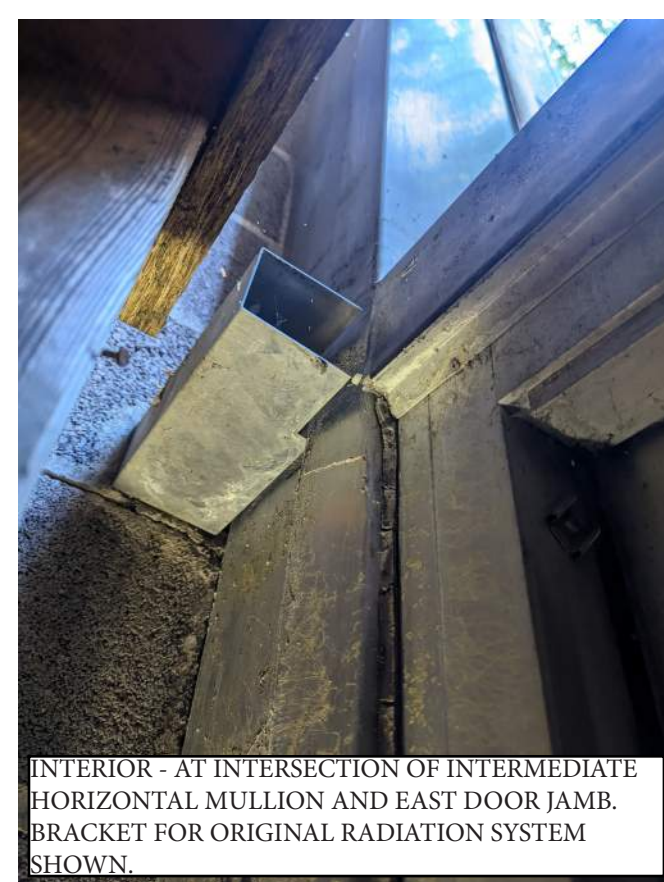
INTERIOR - AT INTERSECTION OF INTERMEDIATE HORIZONTAL MULLION AND EAST DOOR JAMB. BRACKET FOR ORIGINAL RADIATION SYSTEM SHOWN.

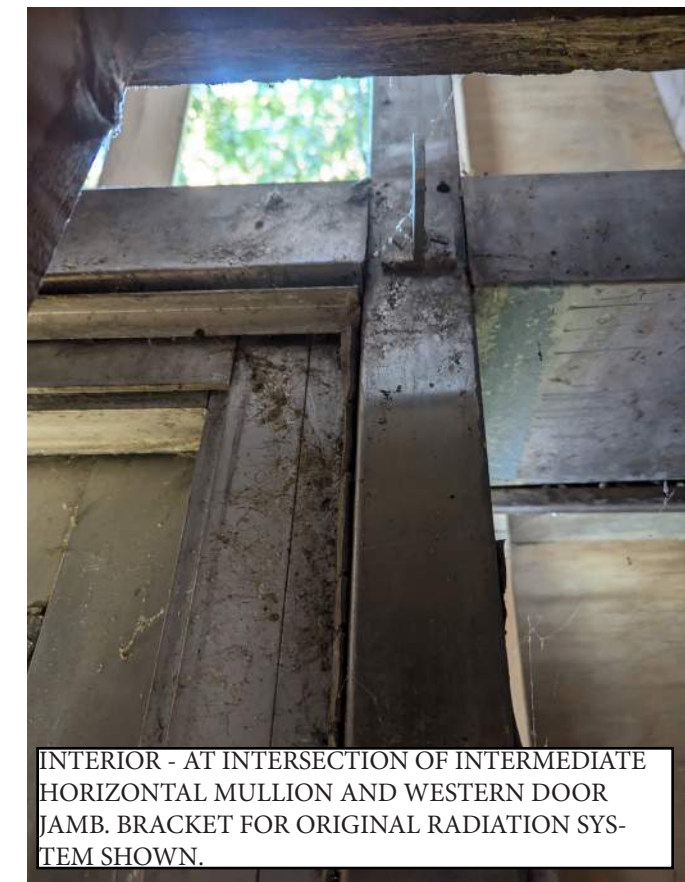
INTERIOR - AT INTERSECTION OF INTERMEDIATE HORIZONTAL MULLION AND WESTERN DOOR JAMB. BRACKET FOR ORIGINAL RADIATION SYSTEM SHOWN.

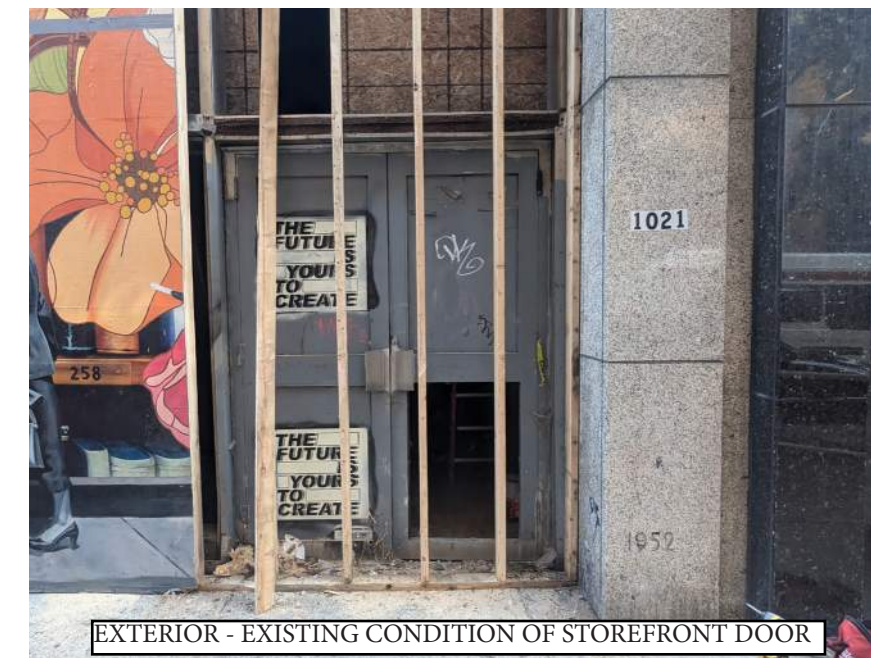
EXTERIOR - EXISTING CONDITION OF STOREFRONT DOOR

ORIGINAL DOOR IS NOT EXTANT. SEE CURRENT CONDITION PHOTO AT RIGHT.
