**ADDRESS: 1830 RITTENHOUSE SQ, UNIT 6A**

Proposal: Replace Windows

Review Requested: Final Approval

History: 1913; Frederick Webber, architect

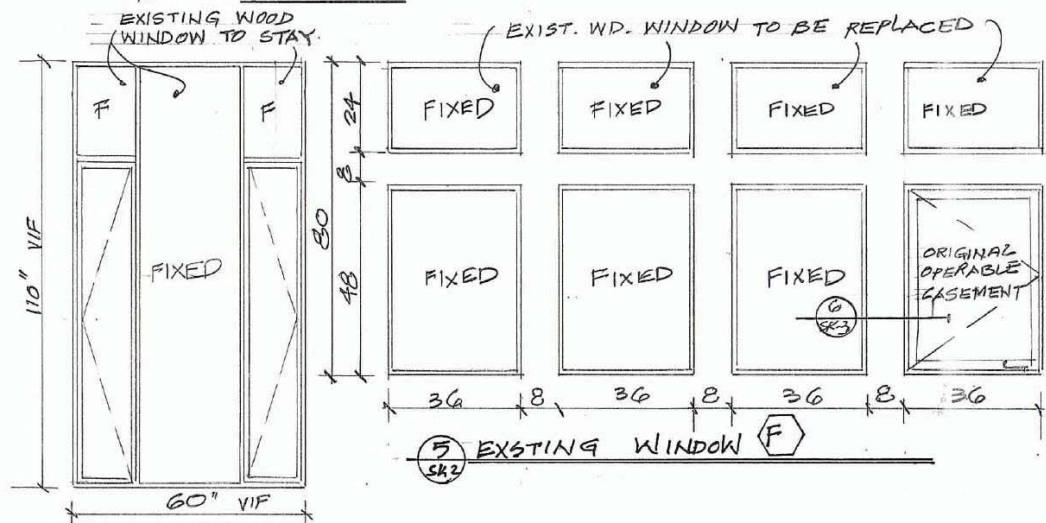
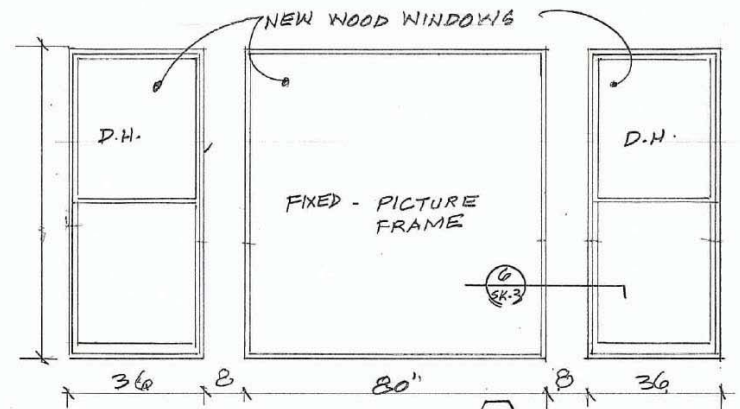
4 WINDOW E  
 3/8" = 1'-0"

5 EXISTING WINDOW F

6 NEW PROPOSED WINDOW F  
 (1) REQ'D

- Mr. Kane responded that, although they propose to replace side and rear windows at a later date, only the front window marked “F” on the drawings is in question today. He noted that they have shown alternates that either remove or retain the transom windows on F.

- Mr. Rosen explained that they would be willing to retain the two side windows and even retain the transom at “F,” but that they would like to remove the wide central mullion.

- The removal of the original architectural window features in either alternate proposal does not meet Standards 2 and 6.

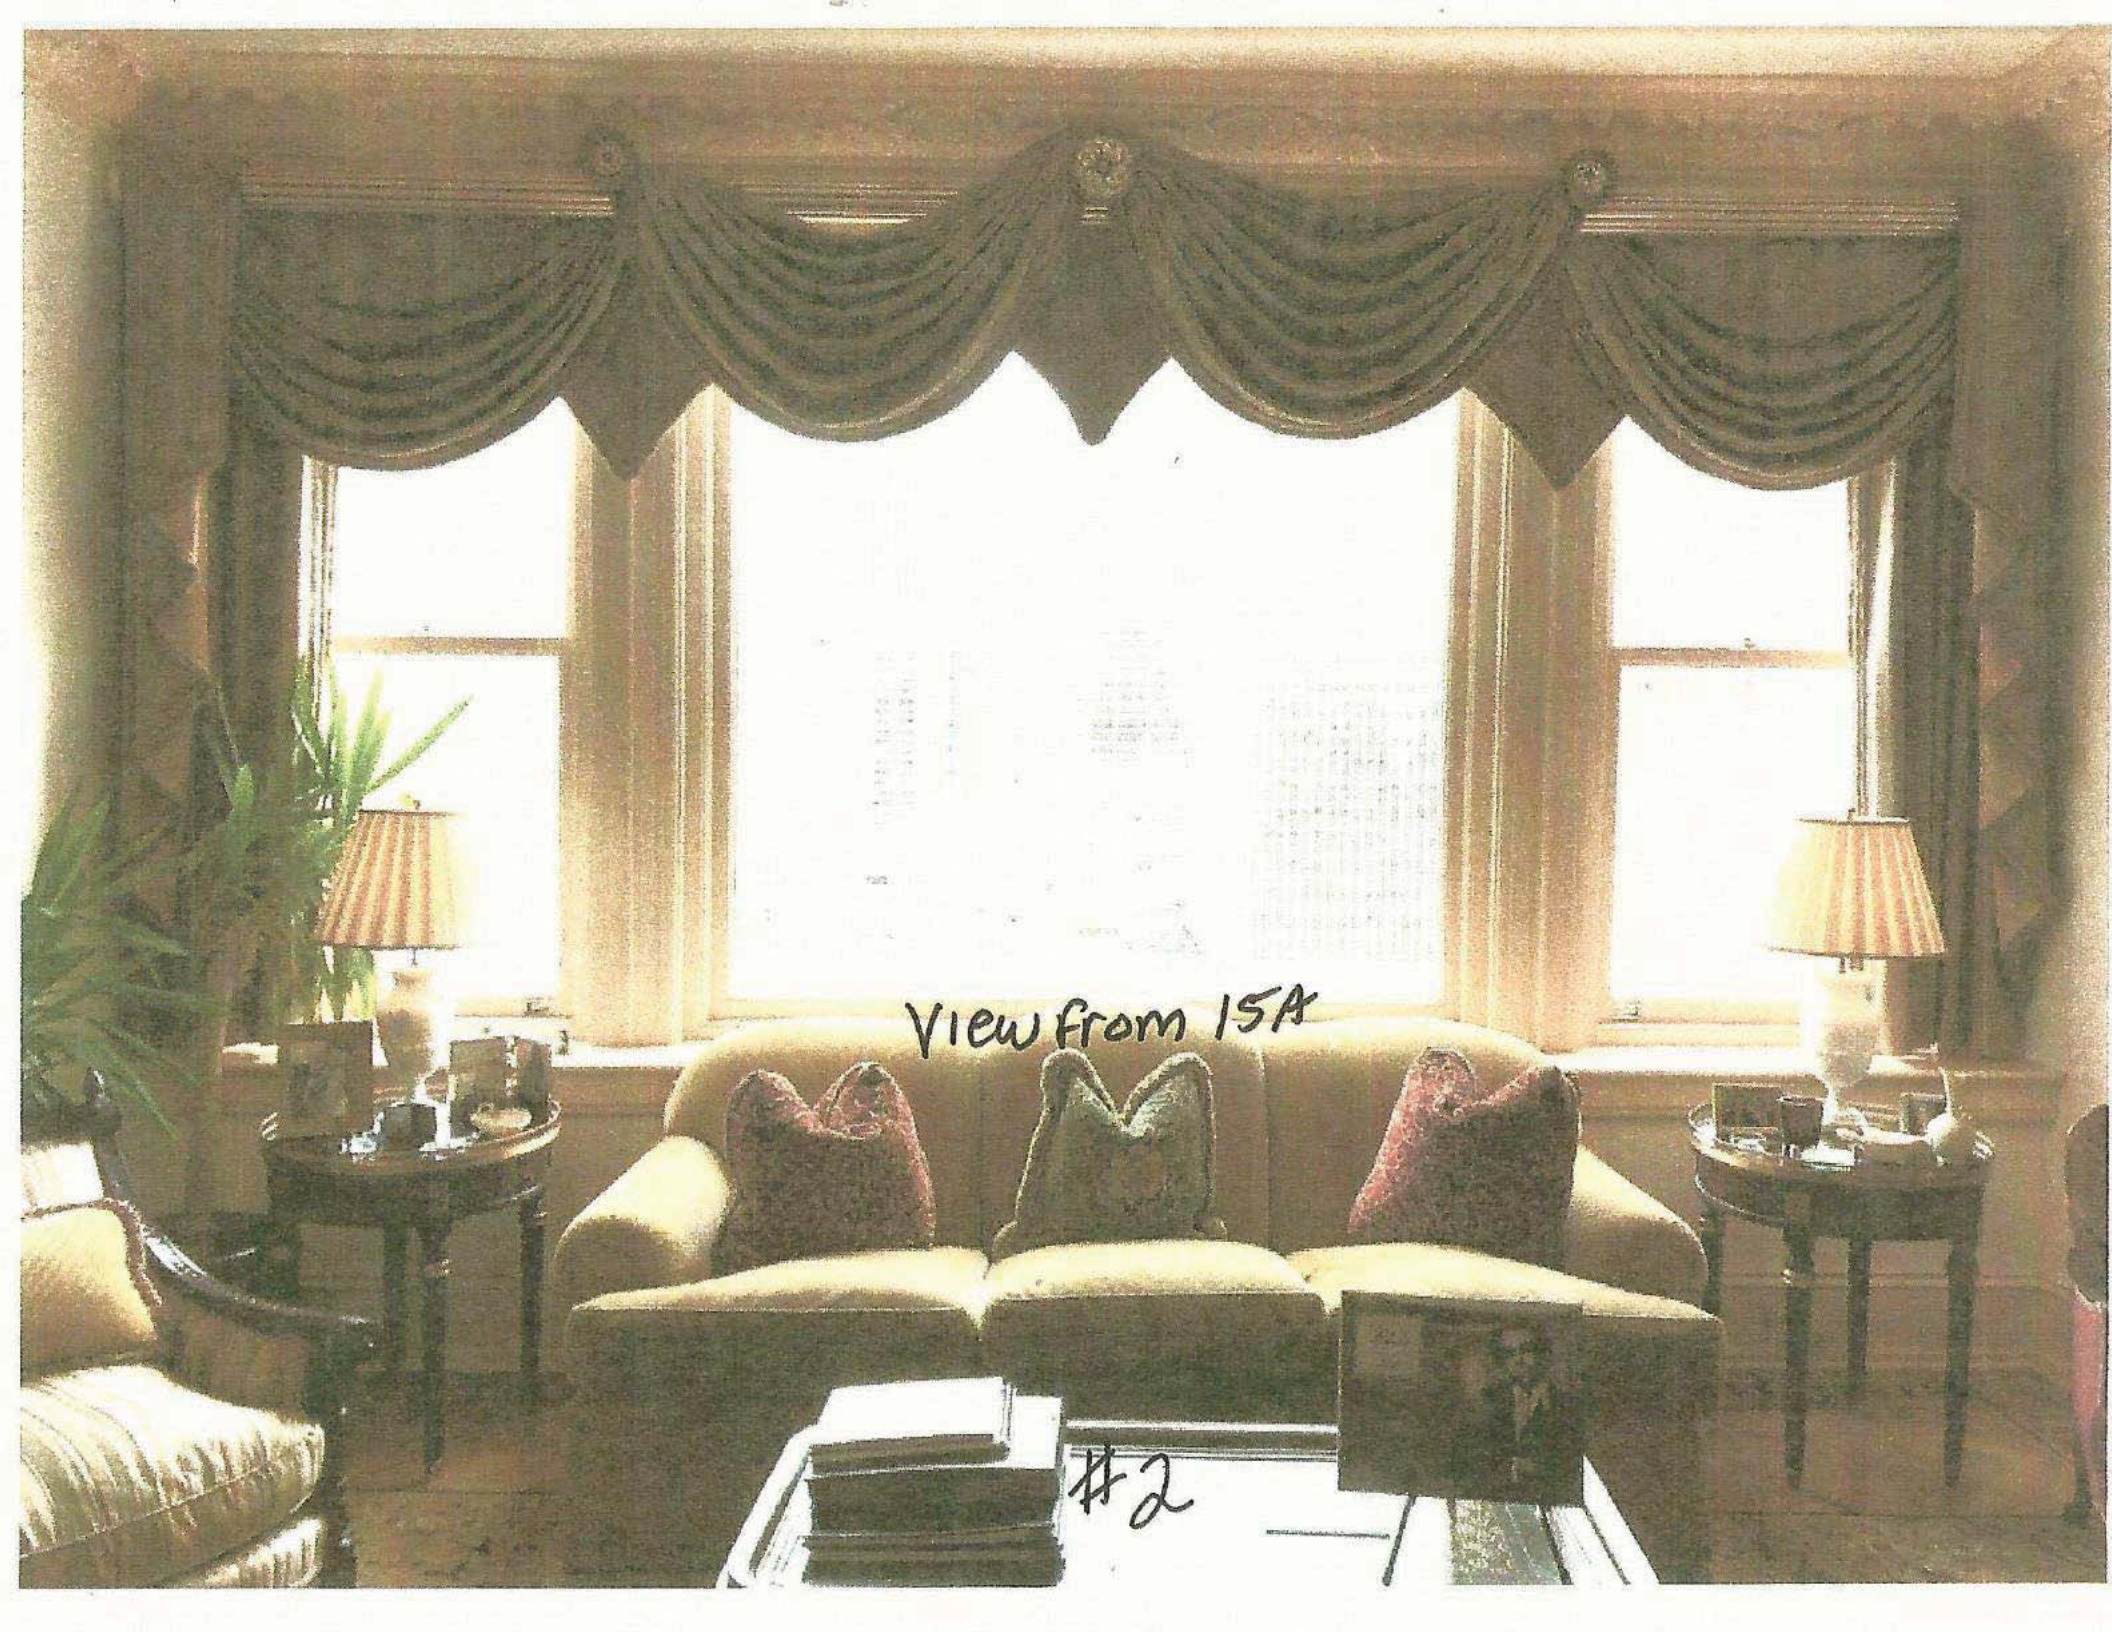
windows  
to be replaced

View from 15A

Similar Windows

Replace the existing (4) casement windows in 6-A with a new (2) double hung and (1) fixed center window unit

Paul and Wendy Rosen would like to remove the (4) Casement Windows on the North Elevation  
And Install A Center Picture Window and (2) Flanking 1/1 Double Hung Windows.  
(See Pictures #1 and #2)

Please note on Picture #3 there are (5) Picture Windows in that North Elevation.  
4<sup>th</sup> , 9<sup>th</sup>, 10<sup>th</sup>, 11<sup>th</sup> and 15<sup>th</sup> Floor.

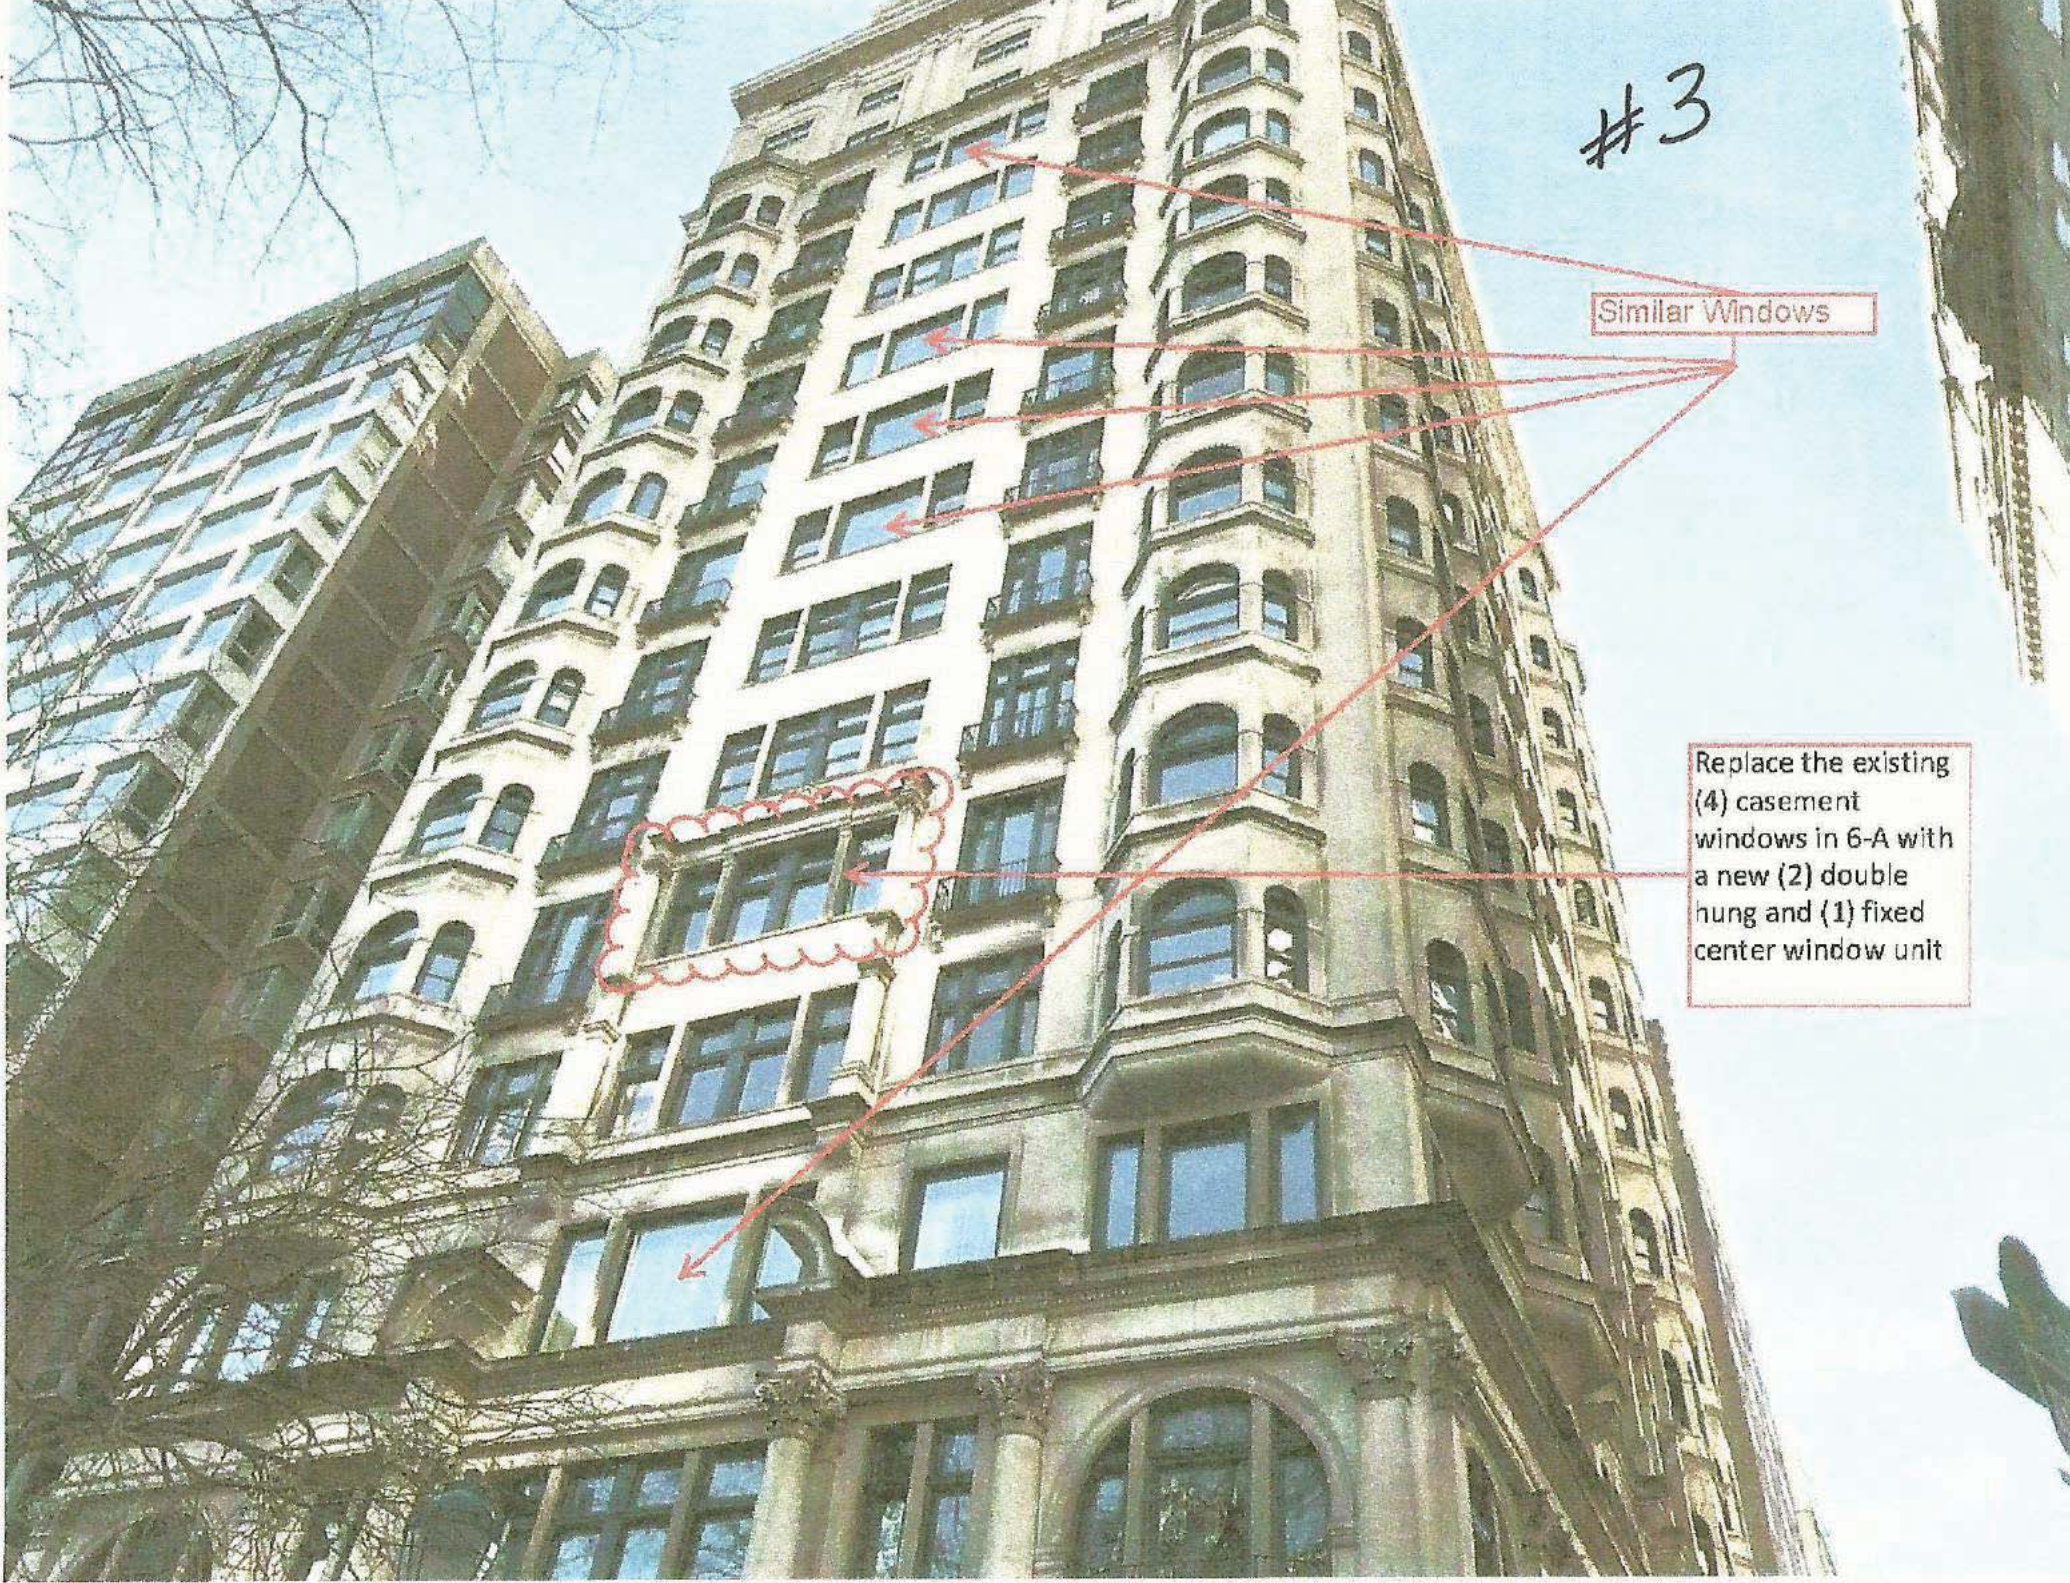
Metal

Bay ONE  
West Elevation

(10) Metal Flanking 1/1 Double Hung Windows at Bays Type "A" on Plan SK-1. Elevation 1- SK-2  
(6) on 19<sup>th</sup> Street West Elevation and (4) on North Elevation Rittenhouse Street. Pictures 4,5,6,7 and 8  
With Wood Historically Correct 1/1 Sash Kits.

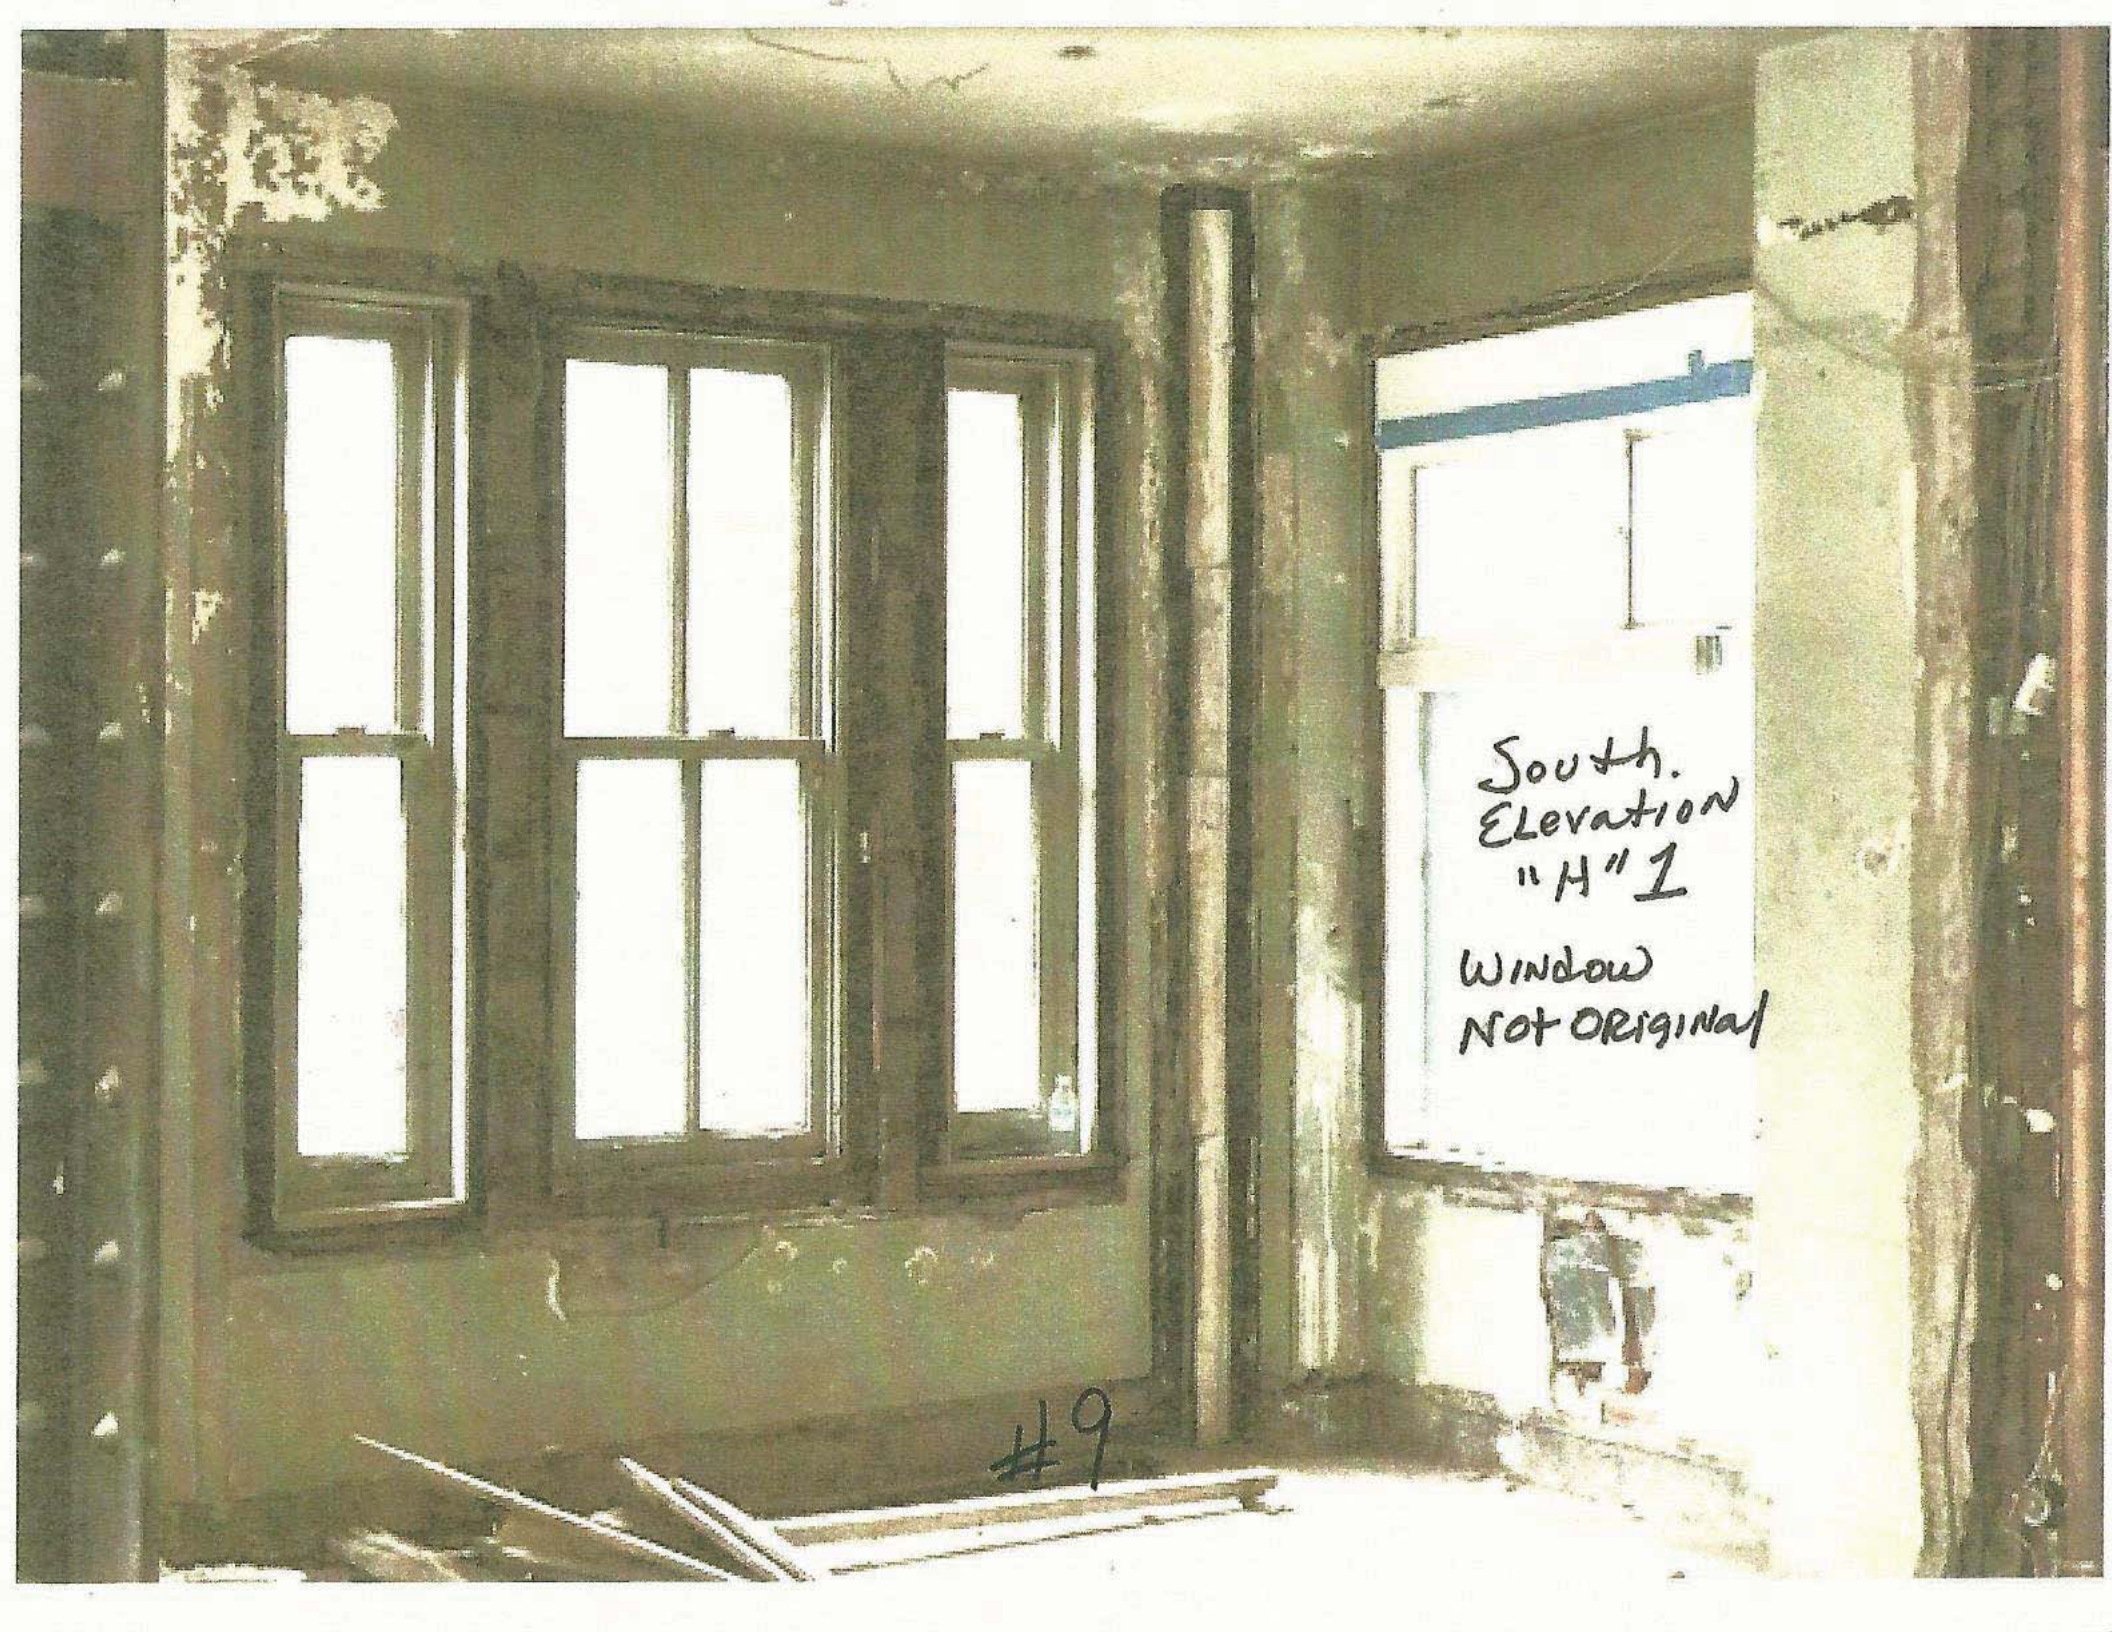
South.  
Elevation  
"H" 1

Window  
NOT ORIGINAL

They are also replacing a Bay Window on the South Elevation "H" on Plan SK-1. Picture #9 and #10  
with A Historically Correct Bay Window. Pictures # 11 and #12 Detail 4 on SK-3

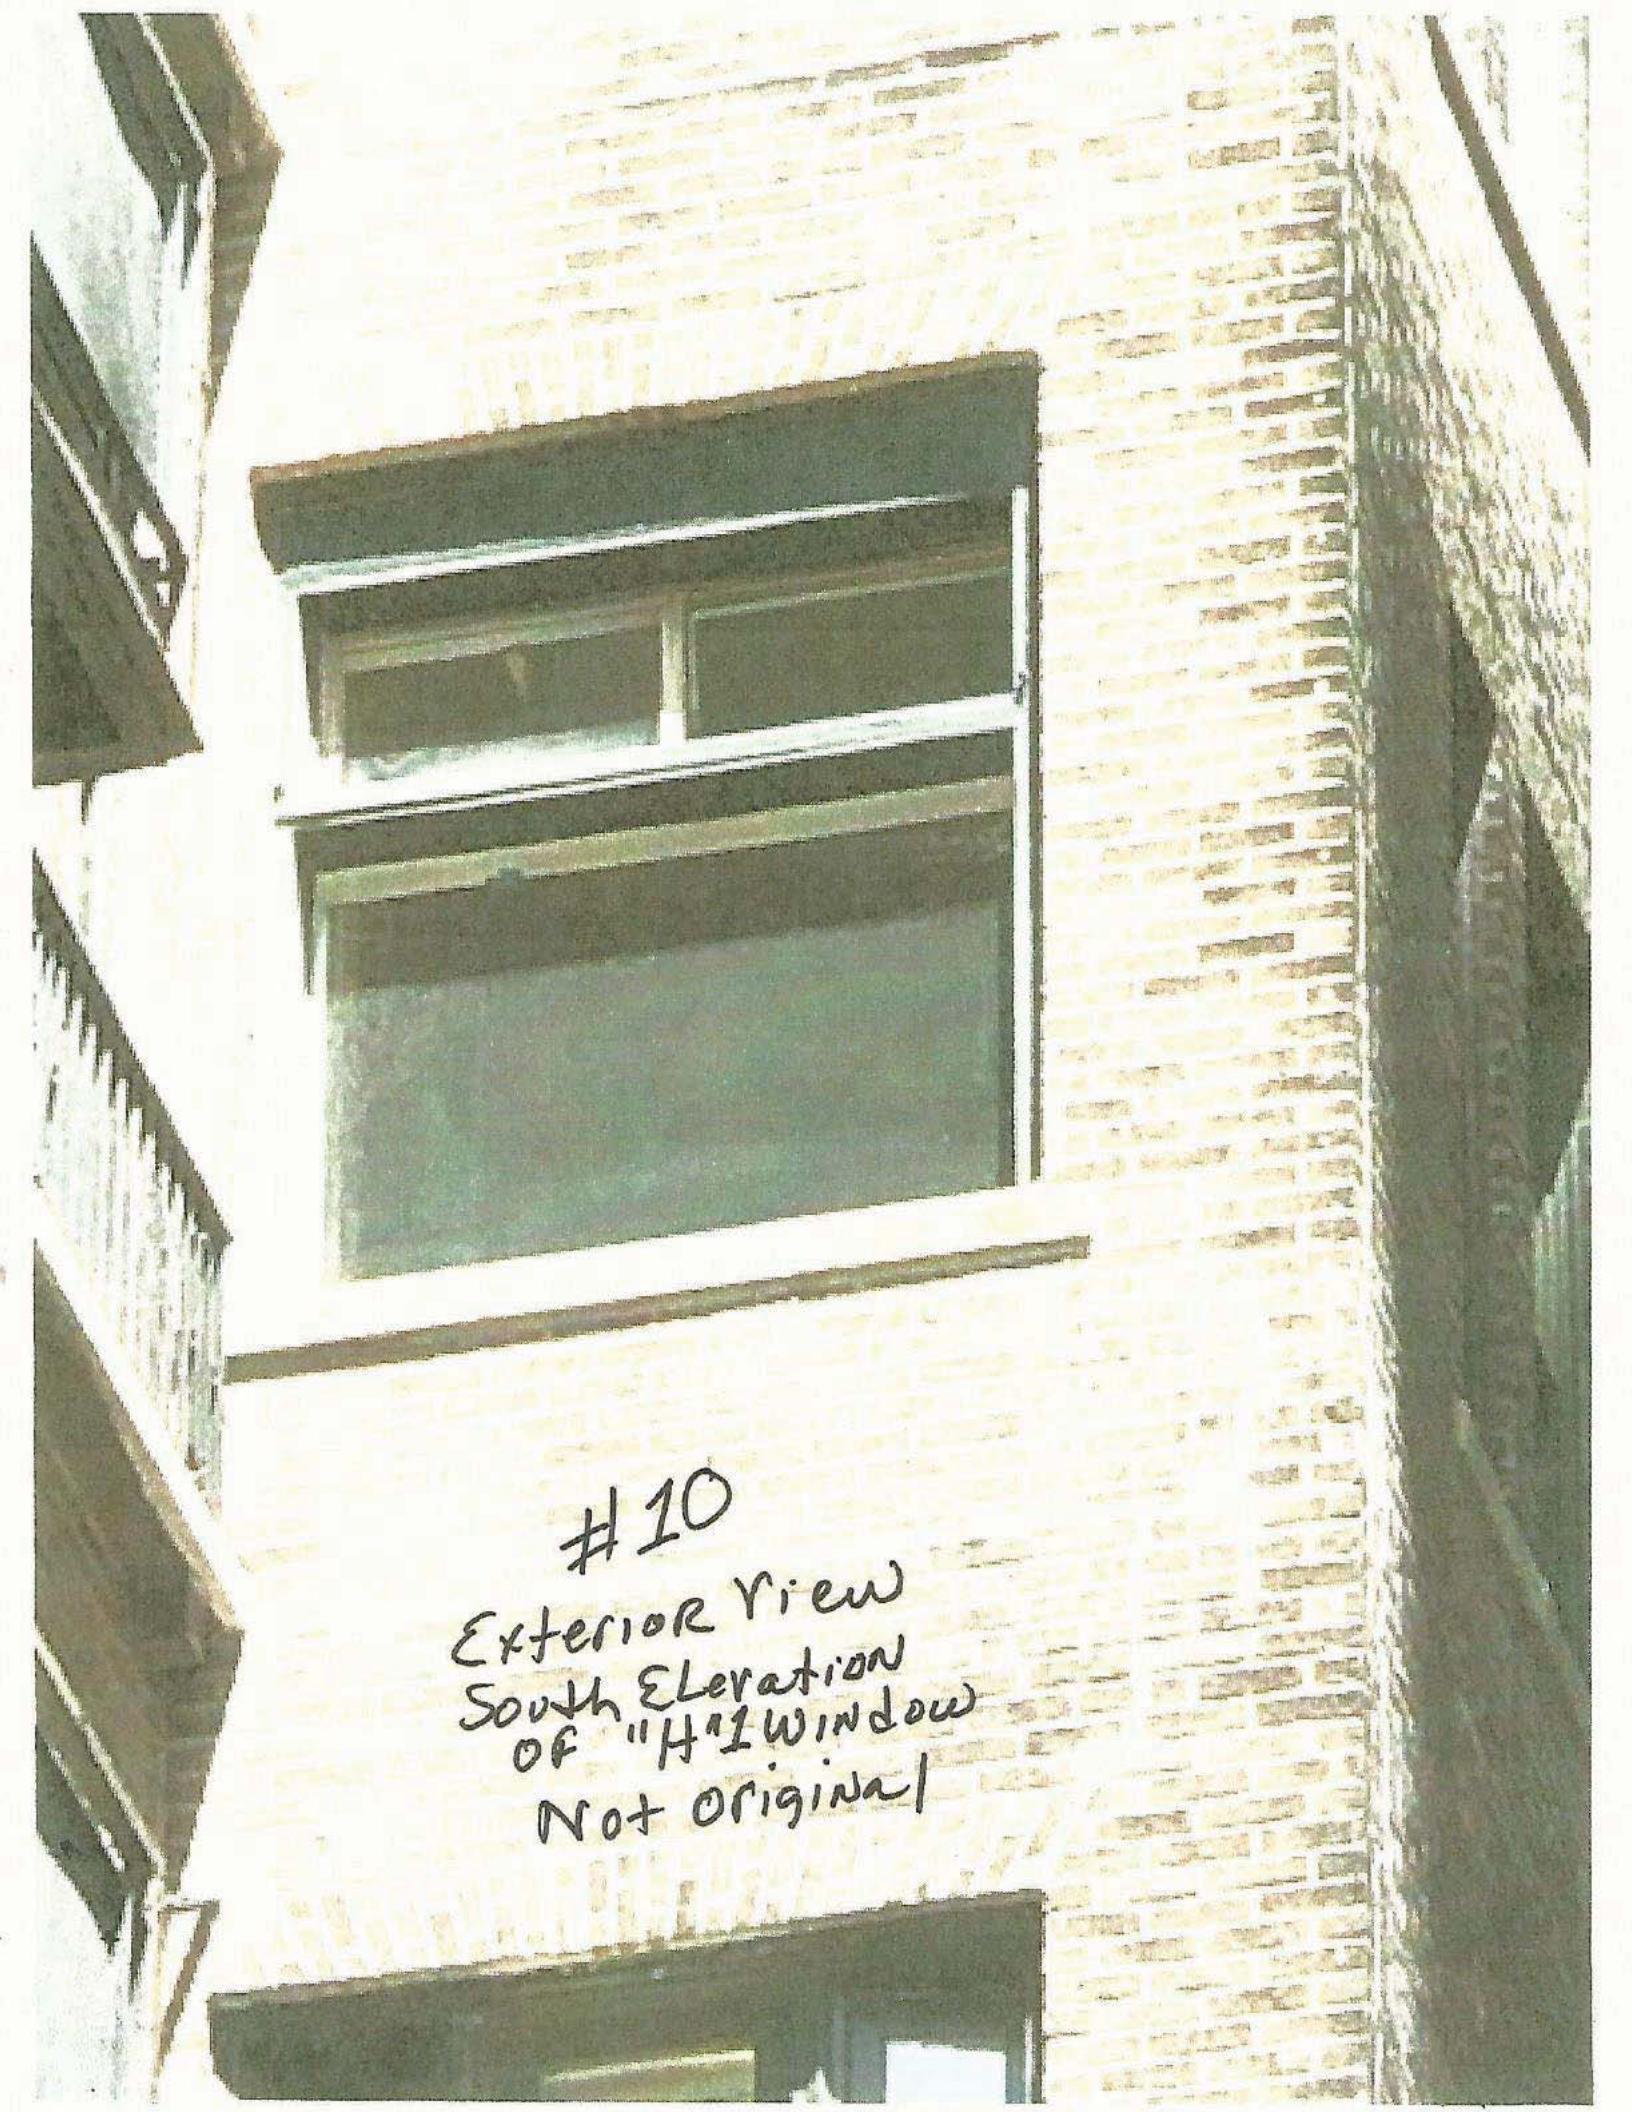
#10  
Exterior View  
South Elevation  
of "H" Window  
Not Original

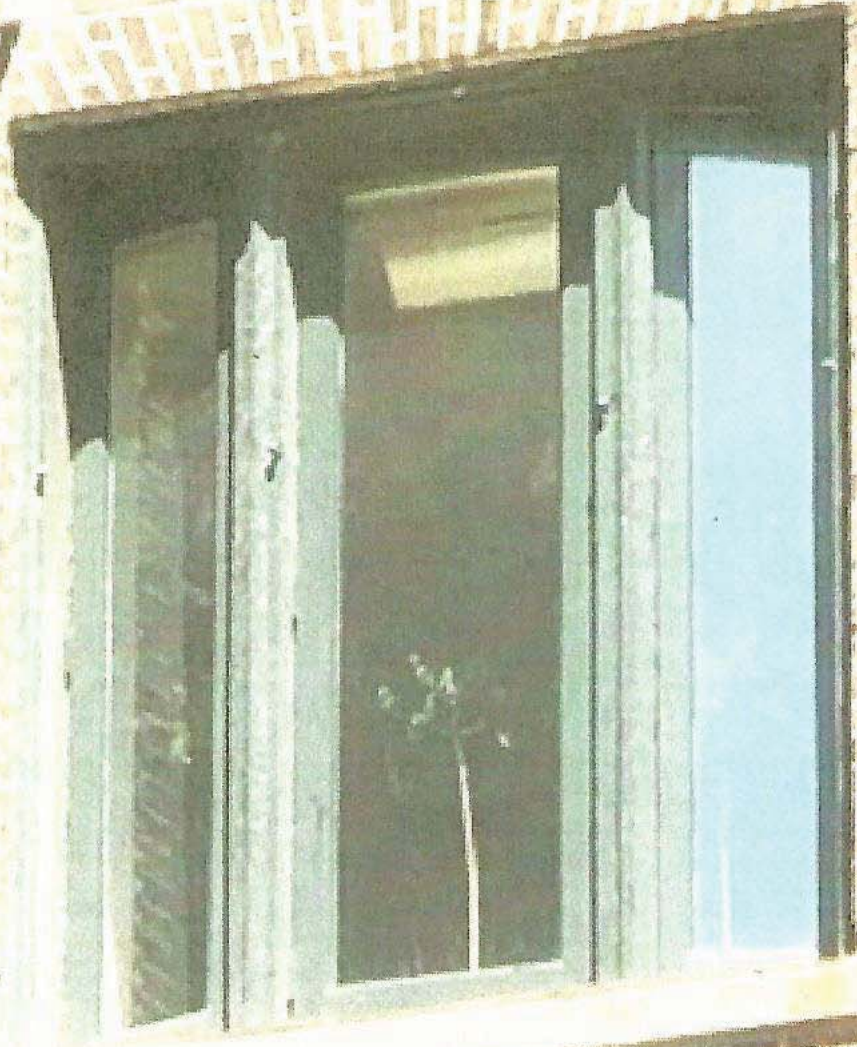
#11

Exterior View  
South Elevation  
OF "H" 2  
ORIGINAL WINDOW

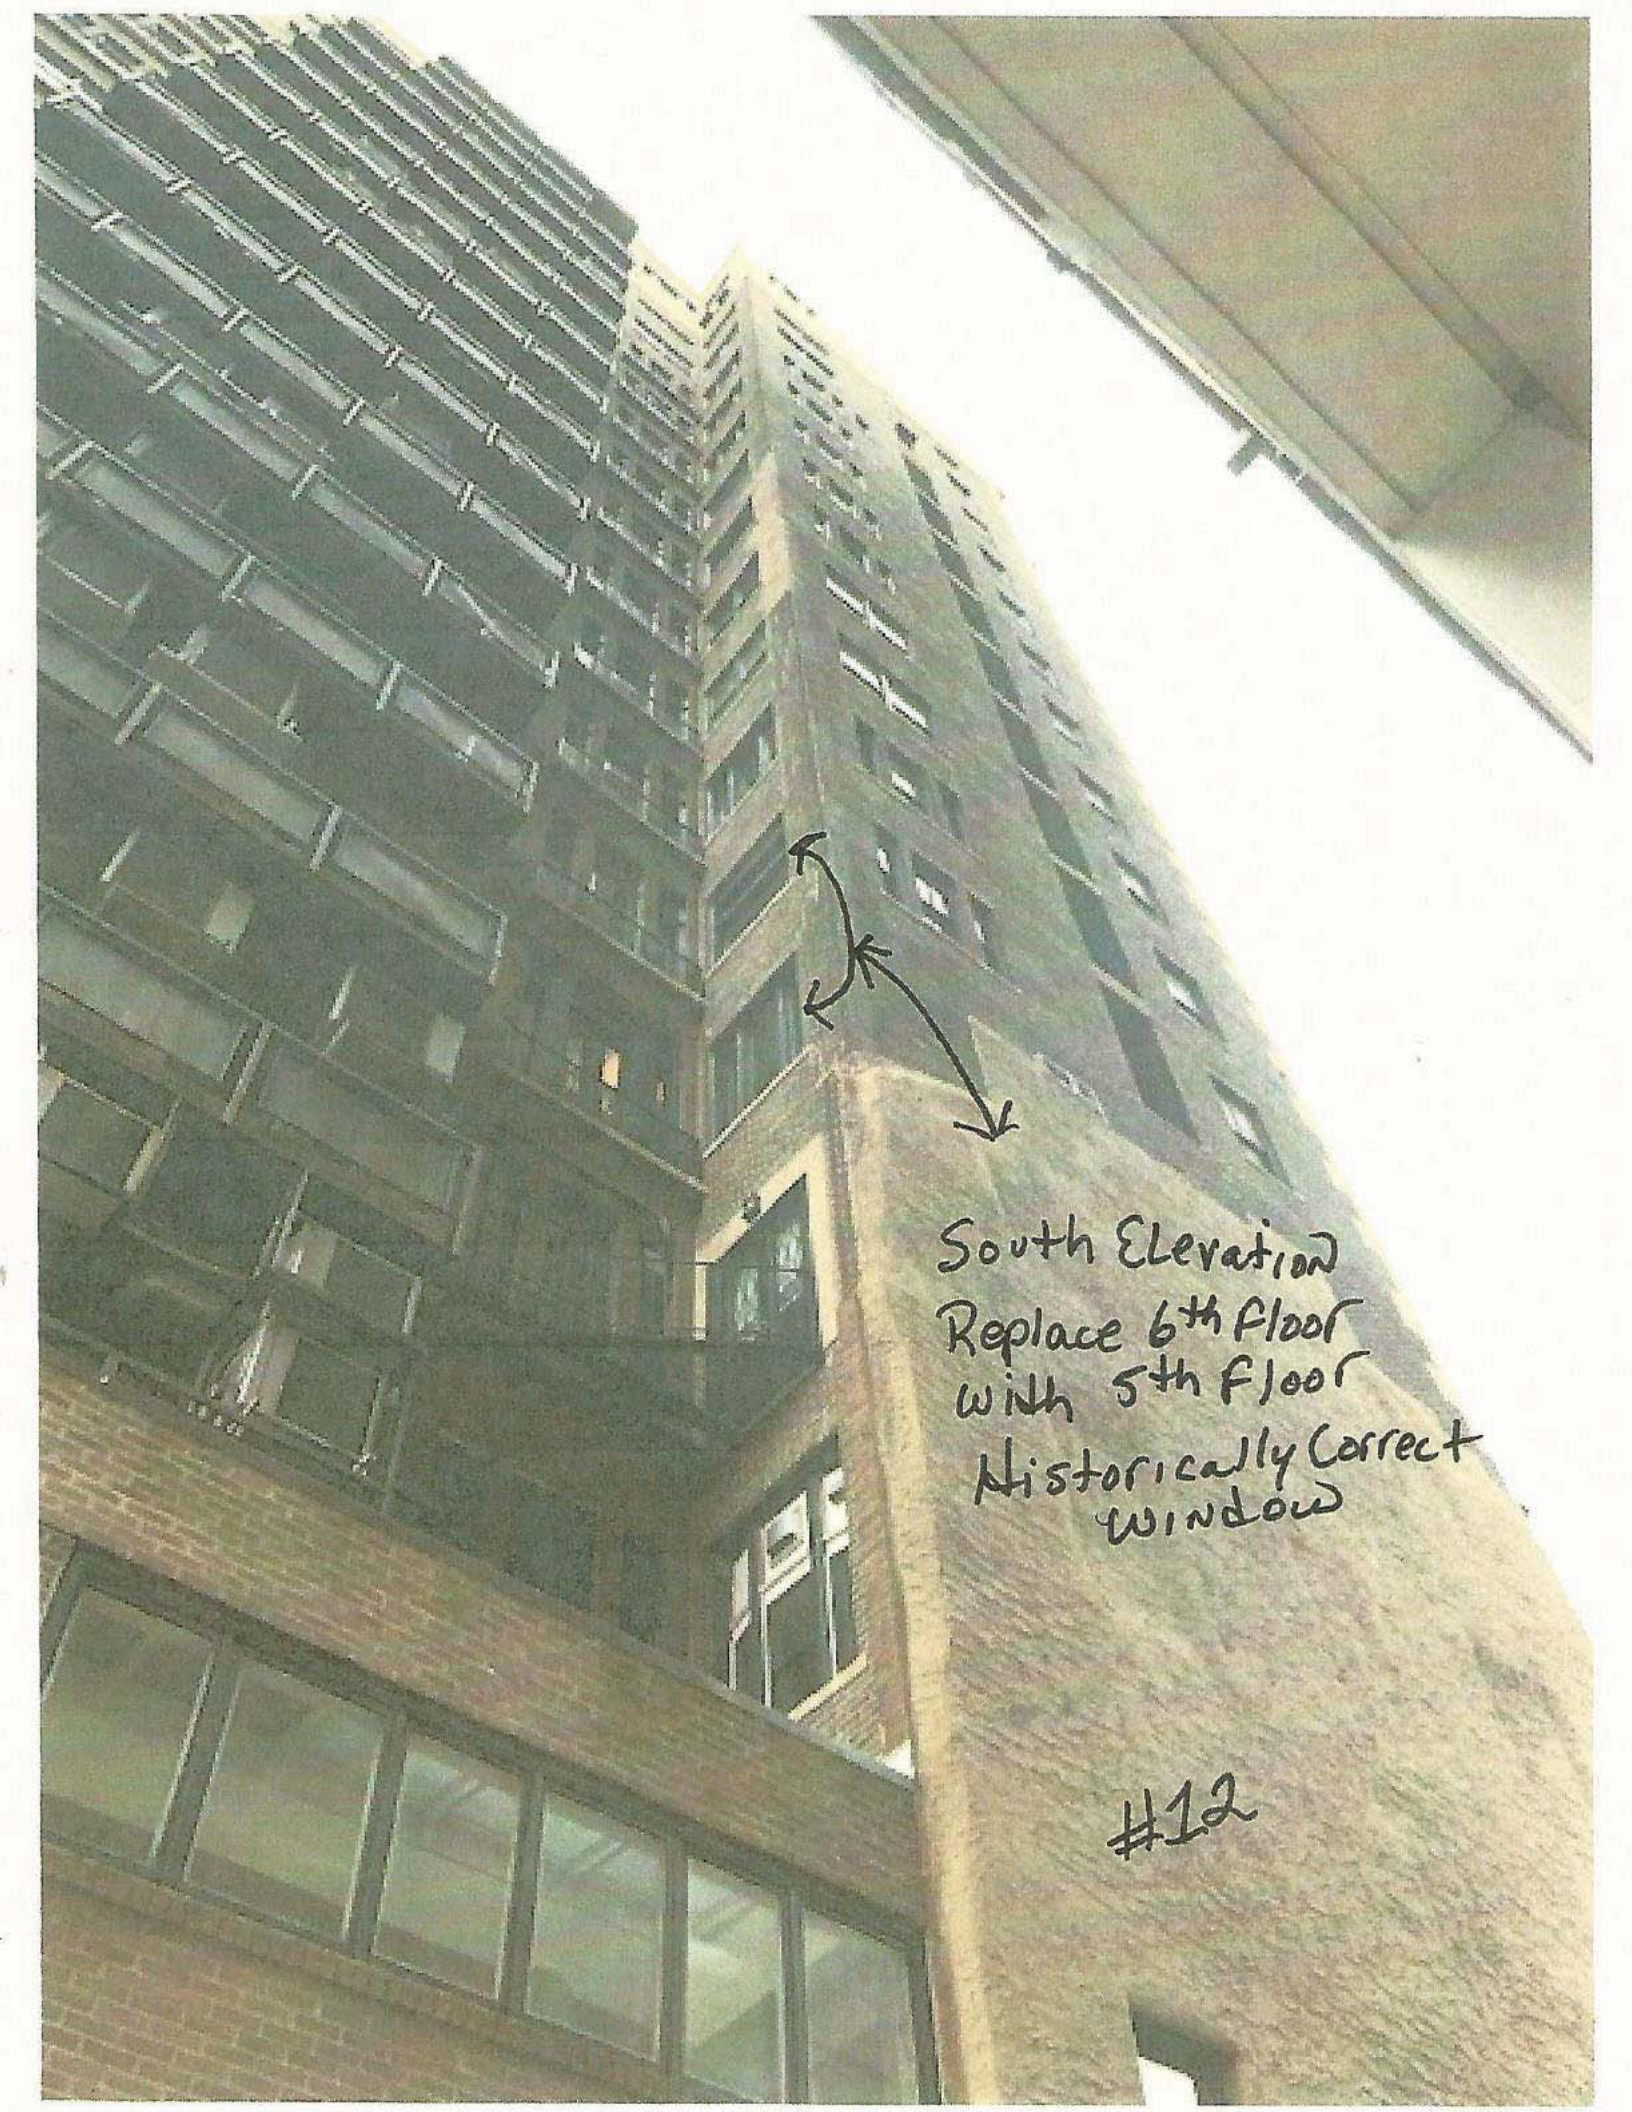
#12

South Elevation  
Replace 6<sup>th</sup> floor  
with 5<sup>th</sup> floor  
Historically Correct  
window
