ADDRESS: 1435-41 WALNUT ST

Proposal: Cut window sills; install new windows

THE DREXEL BUILDING • EXTERIOR ALTERATIONS

THE DREXEL BUILDING, 15TH AND WALNUT, PROPOSED GROUND FLOOR WINDOW ALTERATIONS

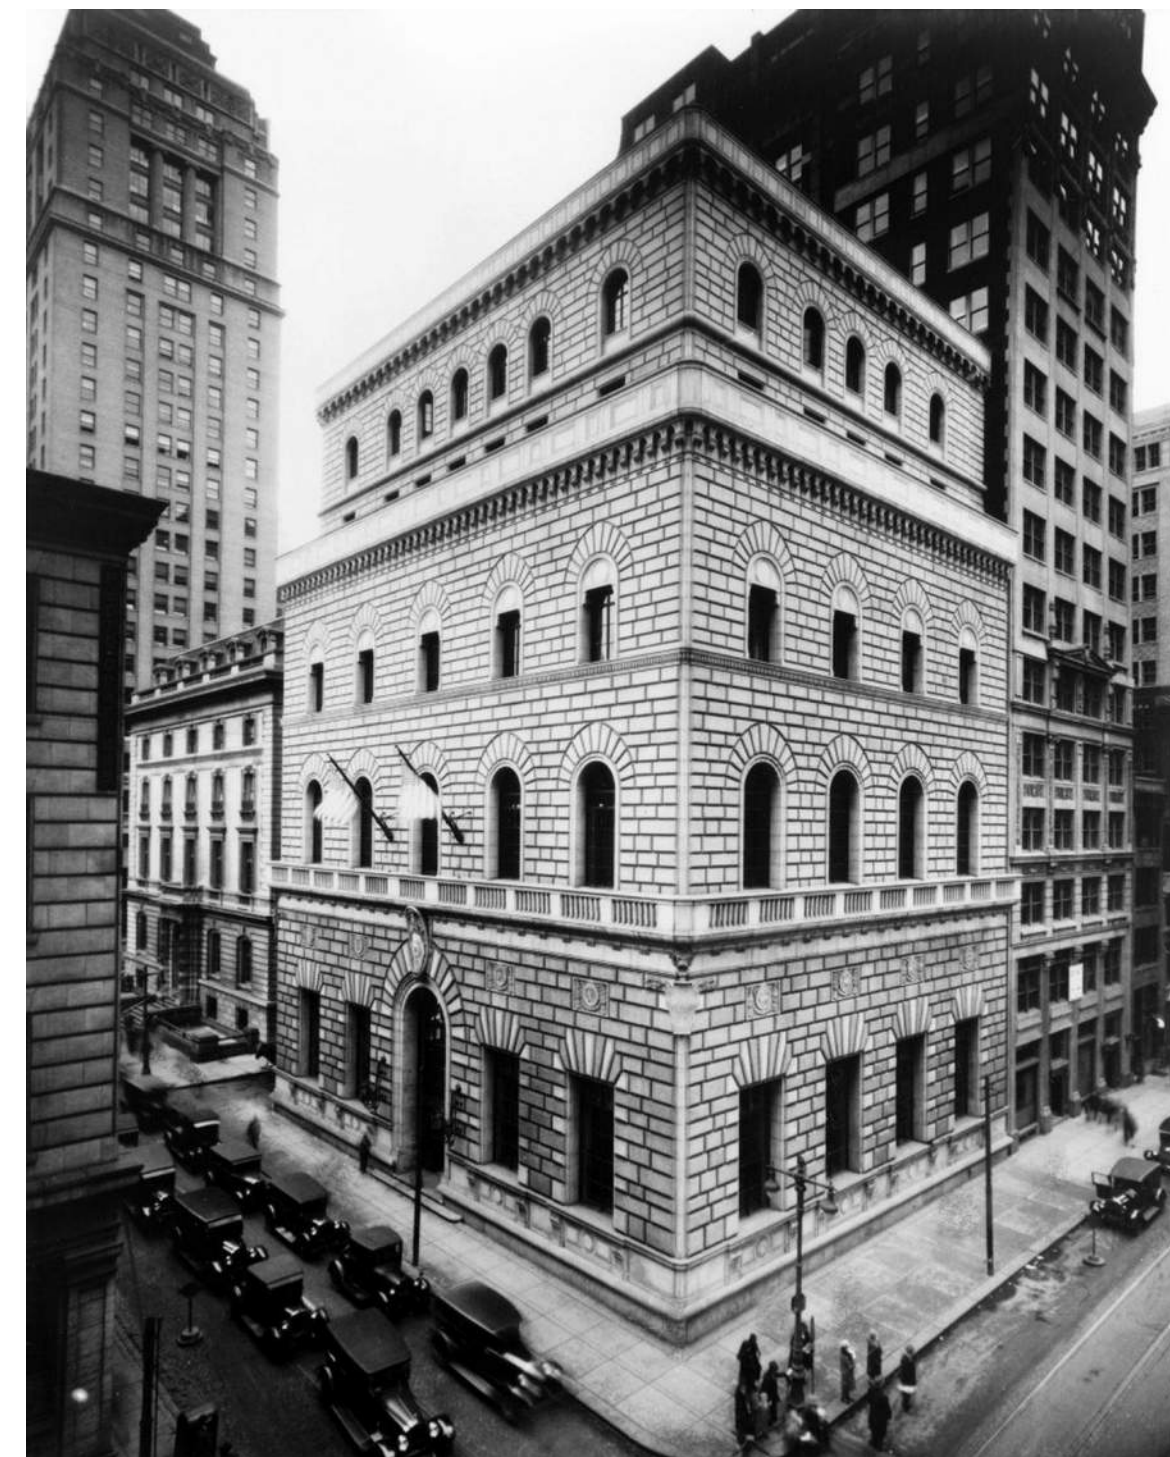
THE DREXEL BUILDING, 15TH AND WALNUT, CIRCA 1925-28

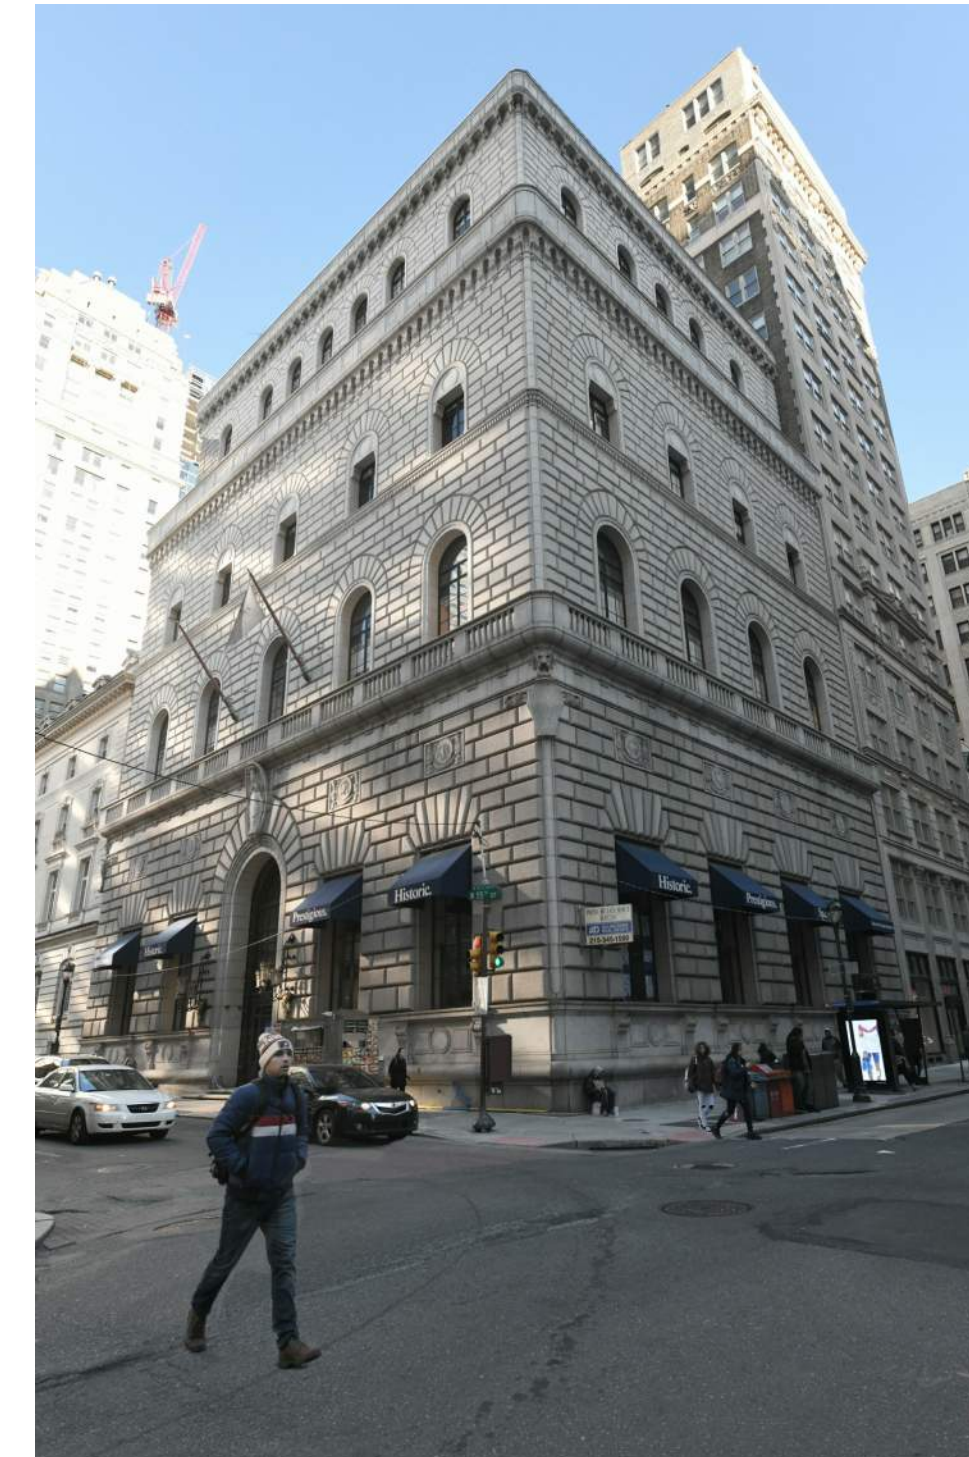
THE DREXEL BUILDING, 15TH AND WALNUT, 2018

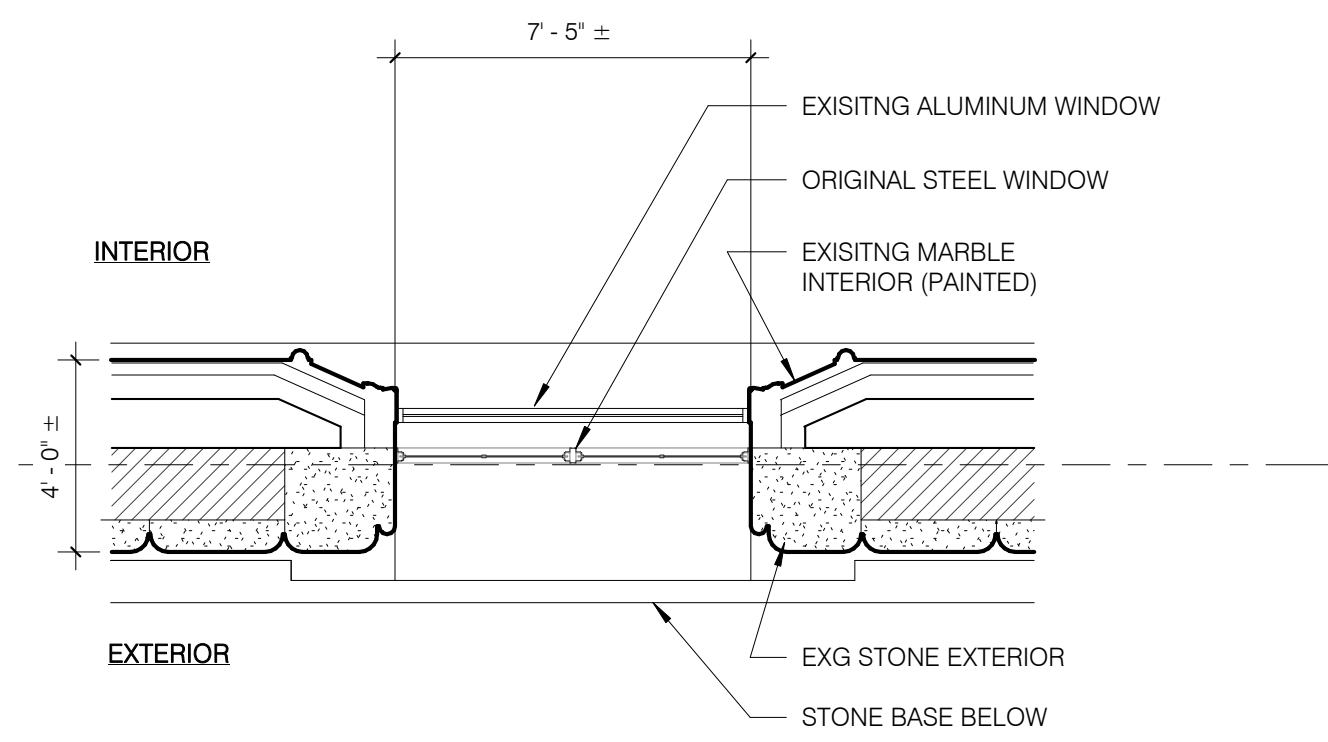
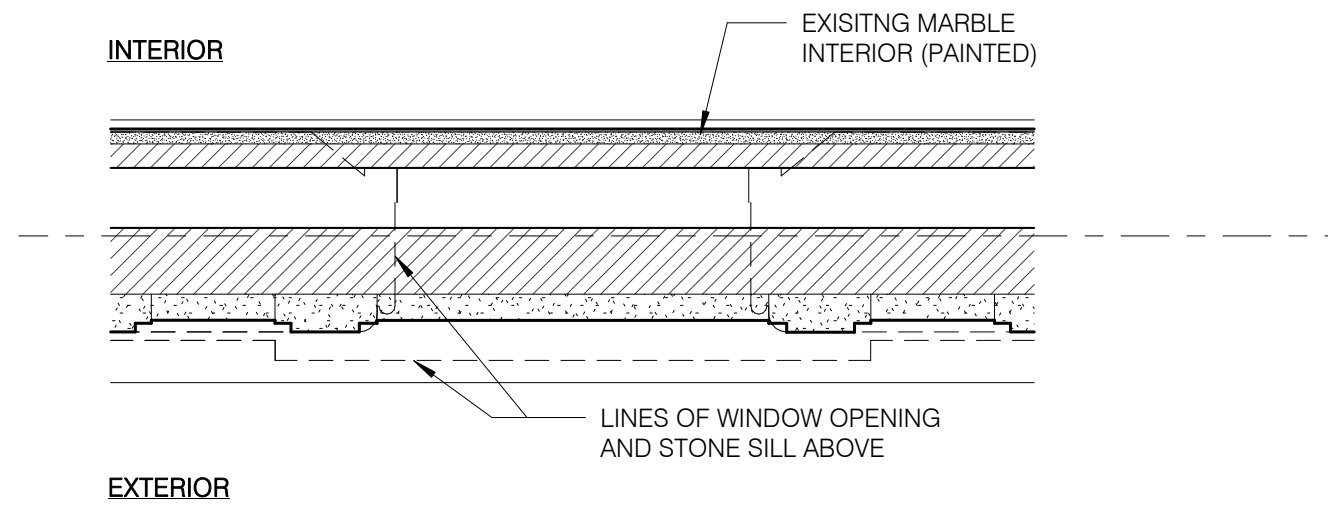
4 TYPICAL WINDOW ENLARGED VIEWS - EXG
1/4" = 1'-0"

PLAN VIEW ABOVE SILL

PLAN VIEW BELOW SILL

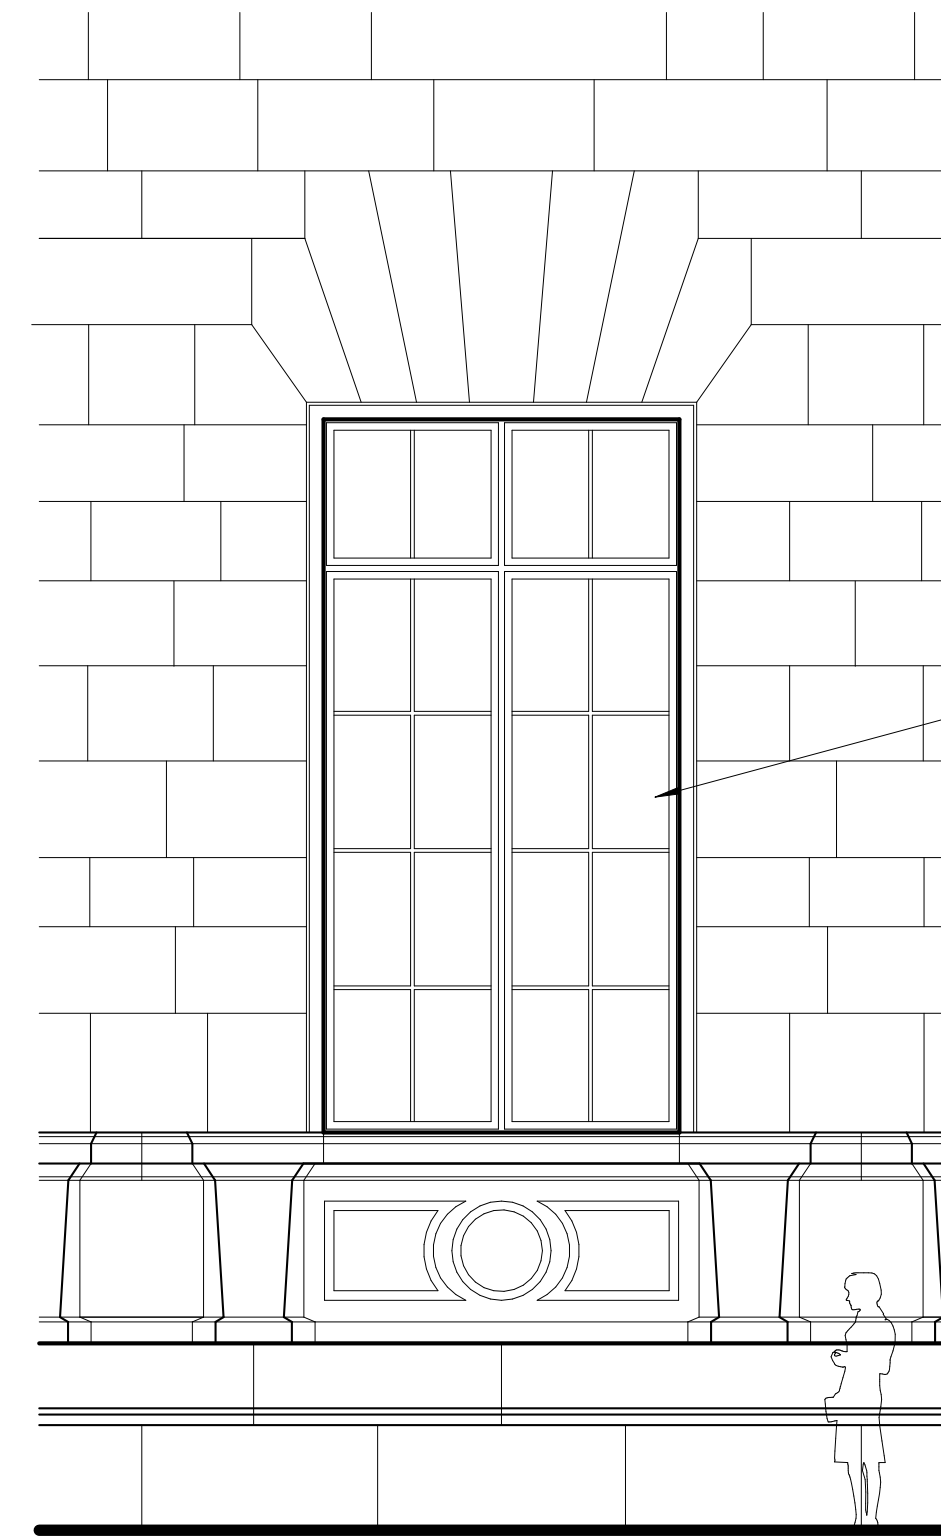
PARTIAL EXTERIOR ELEVATION

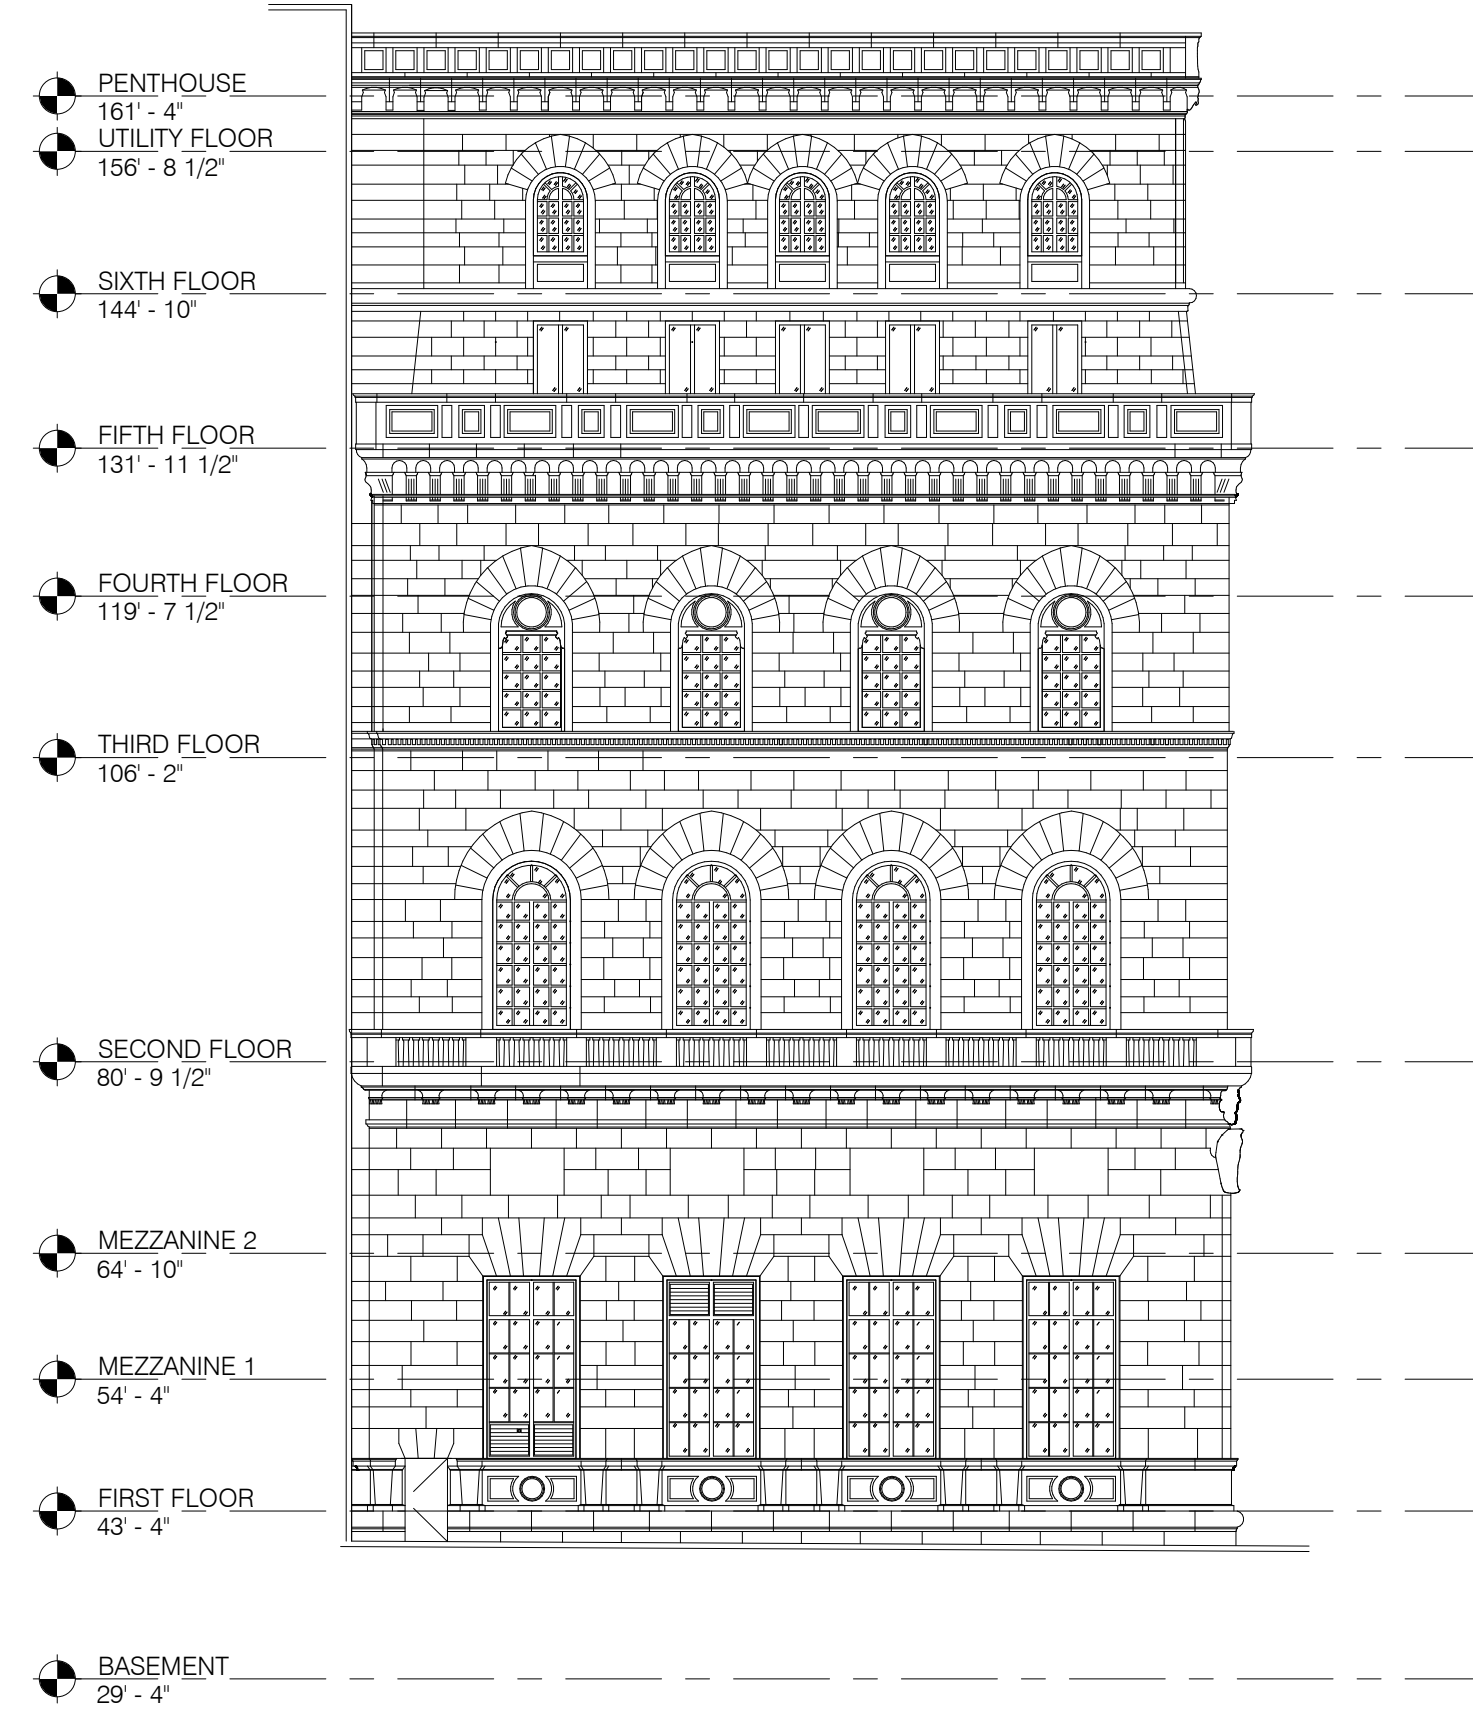
C MORAVIAN STREET ELEVATION (NORTH)
1/16" = 1'-0"

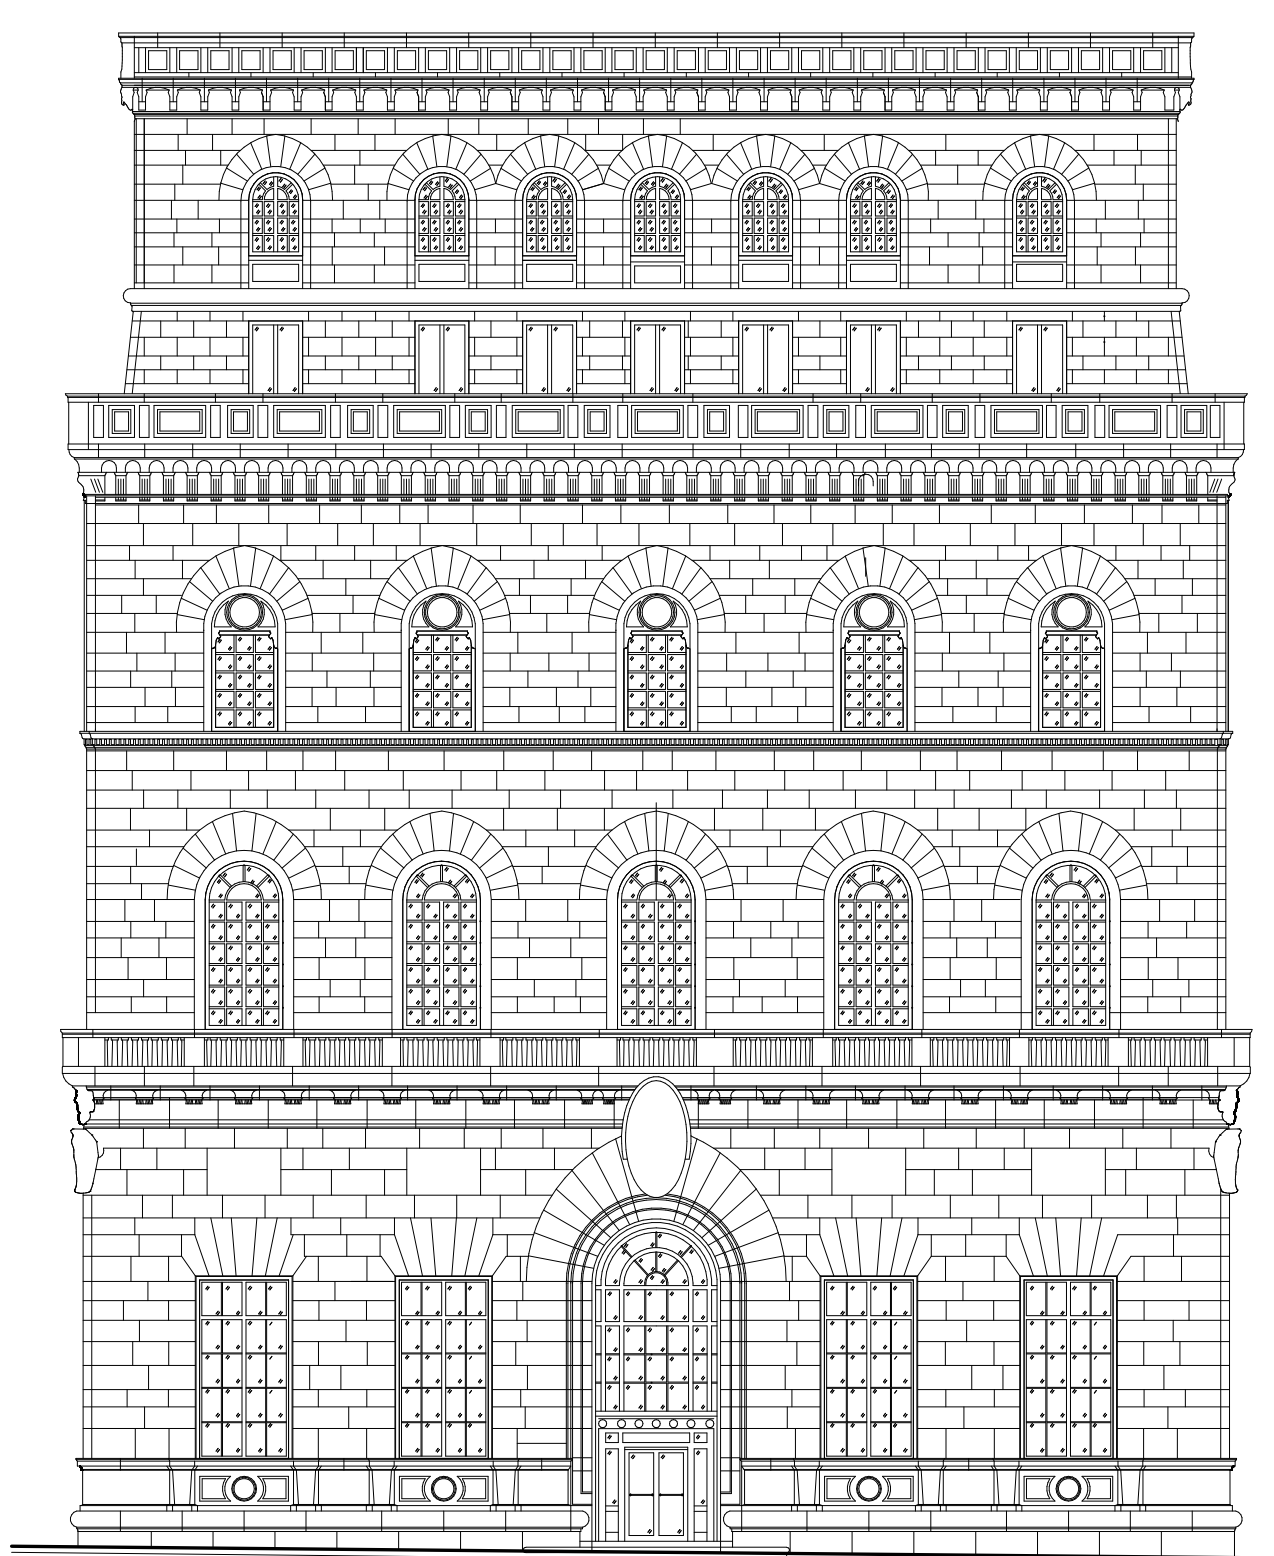
B 15TH STREET ELEVATION (WEST)
1/16" = 1'-0"

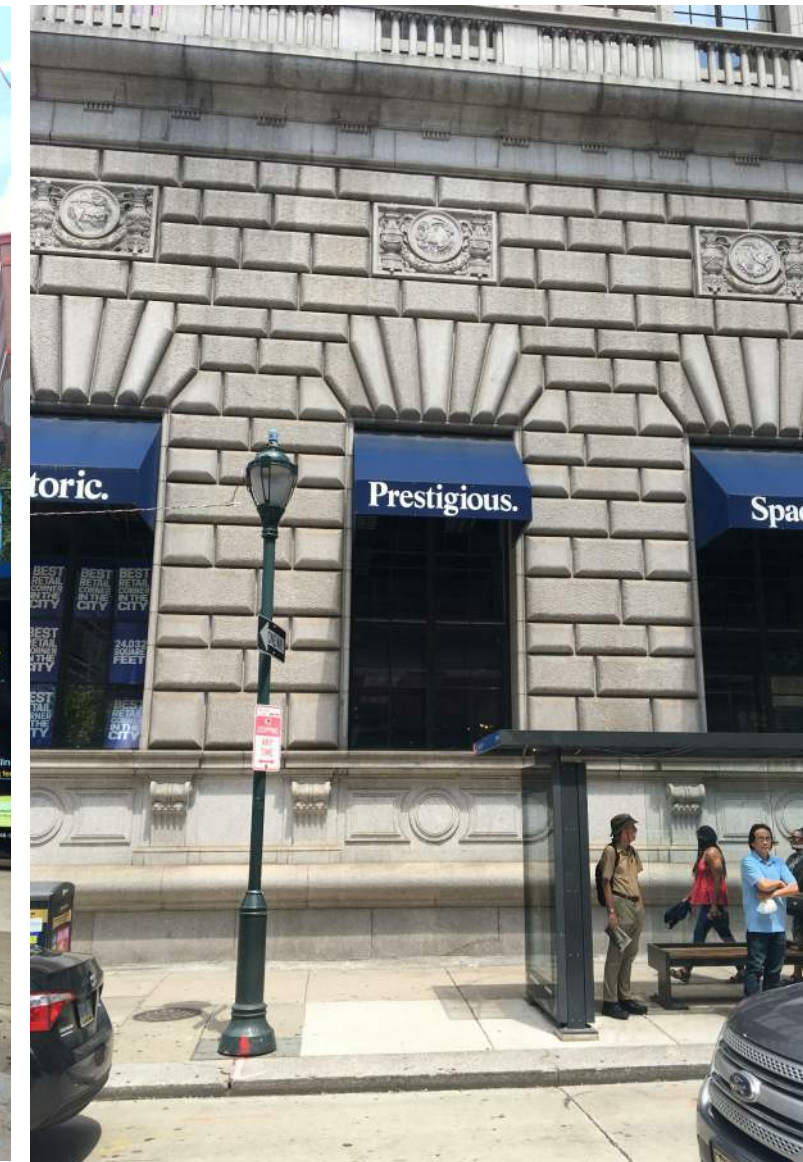
3 FACADE DETAIL ON WALNUT STREET

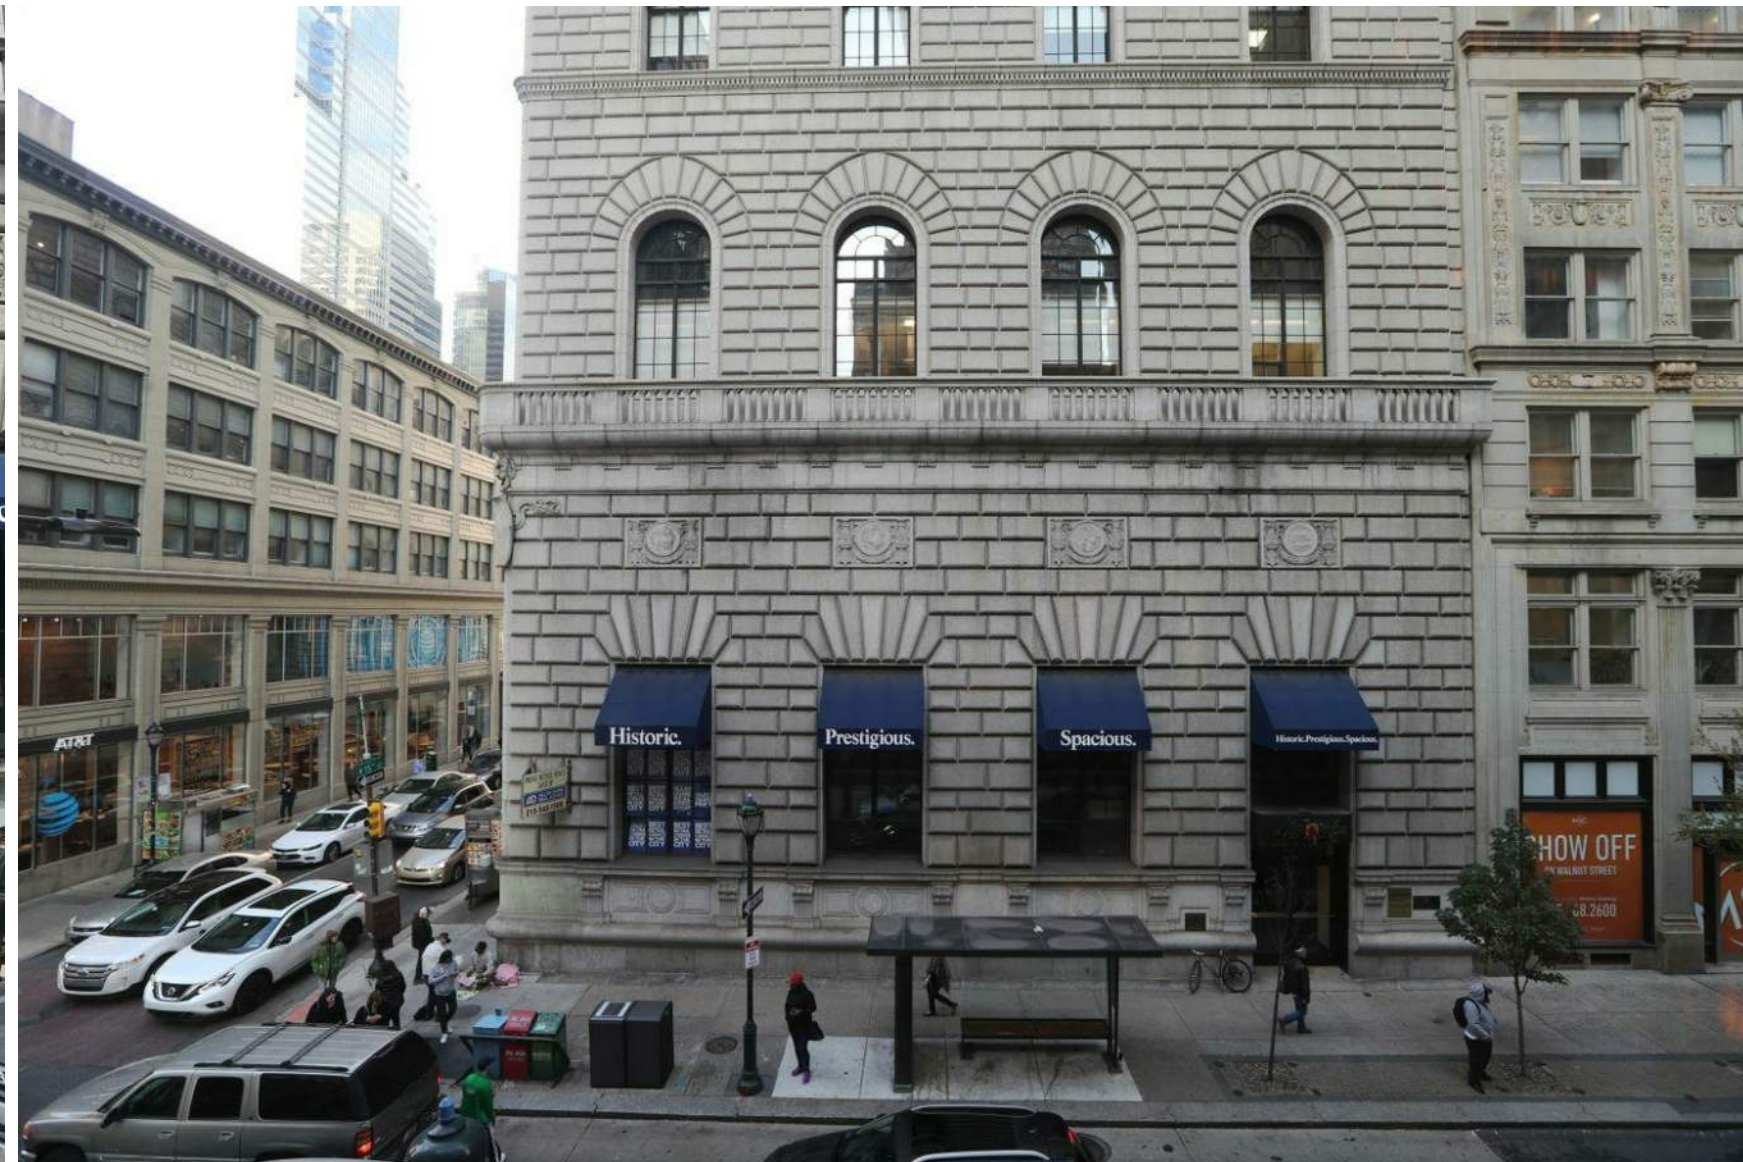
4 WALNUT STREET FACADE

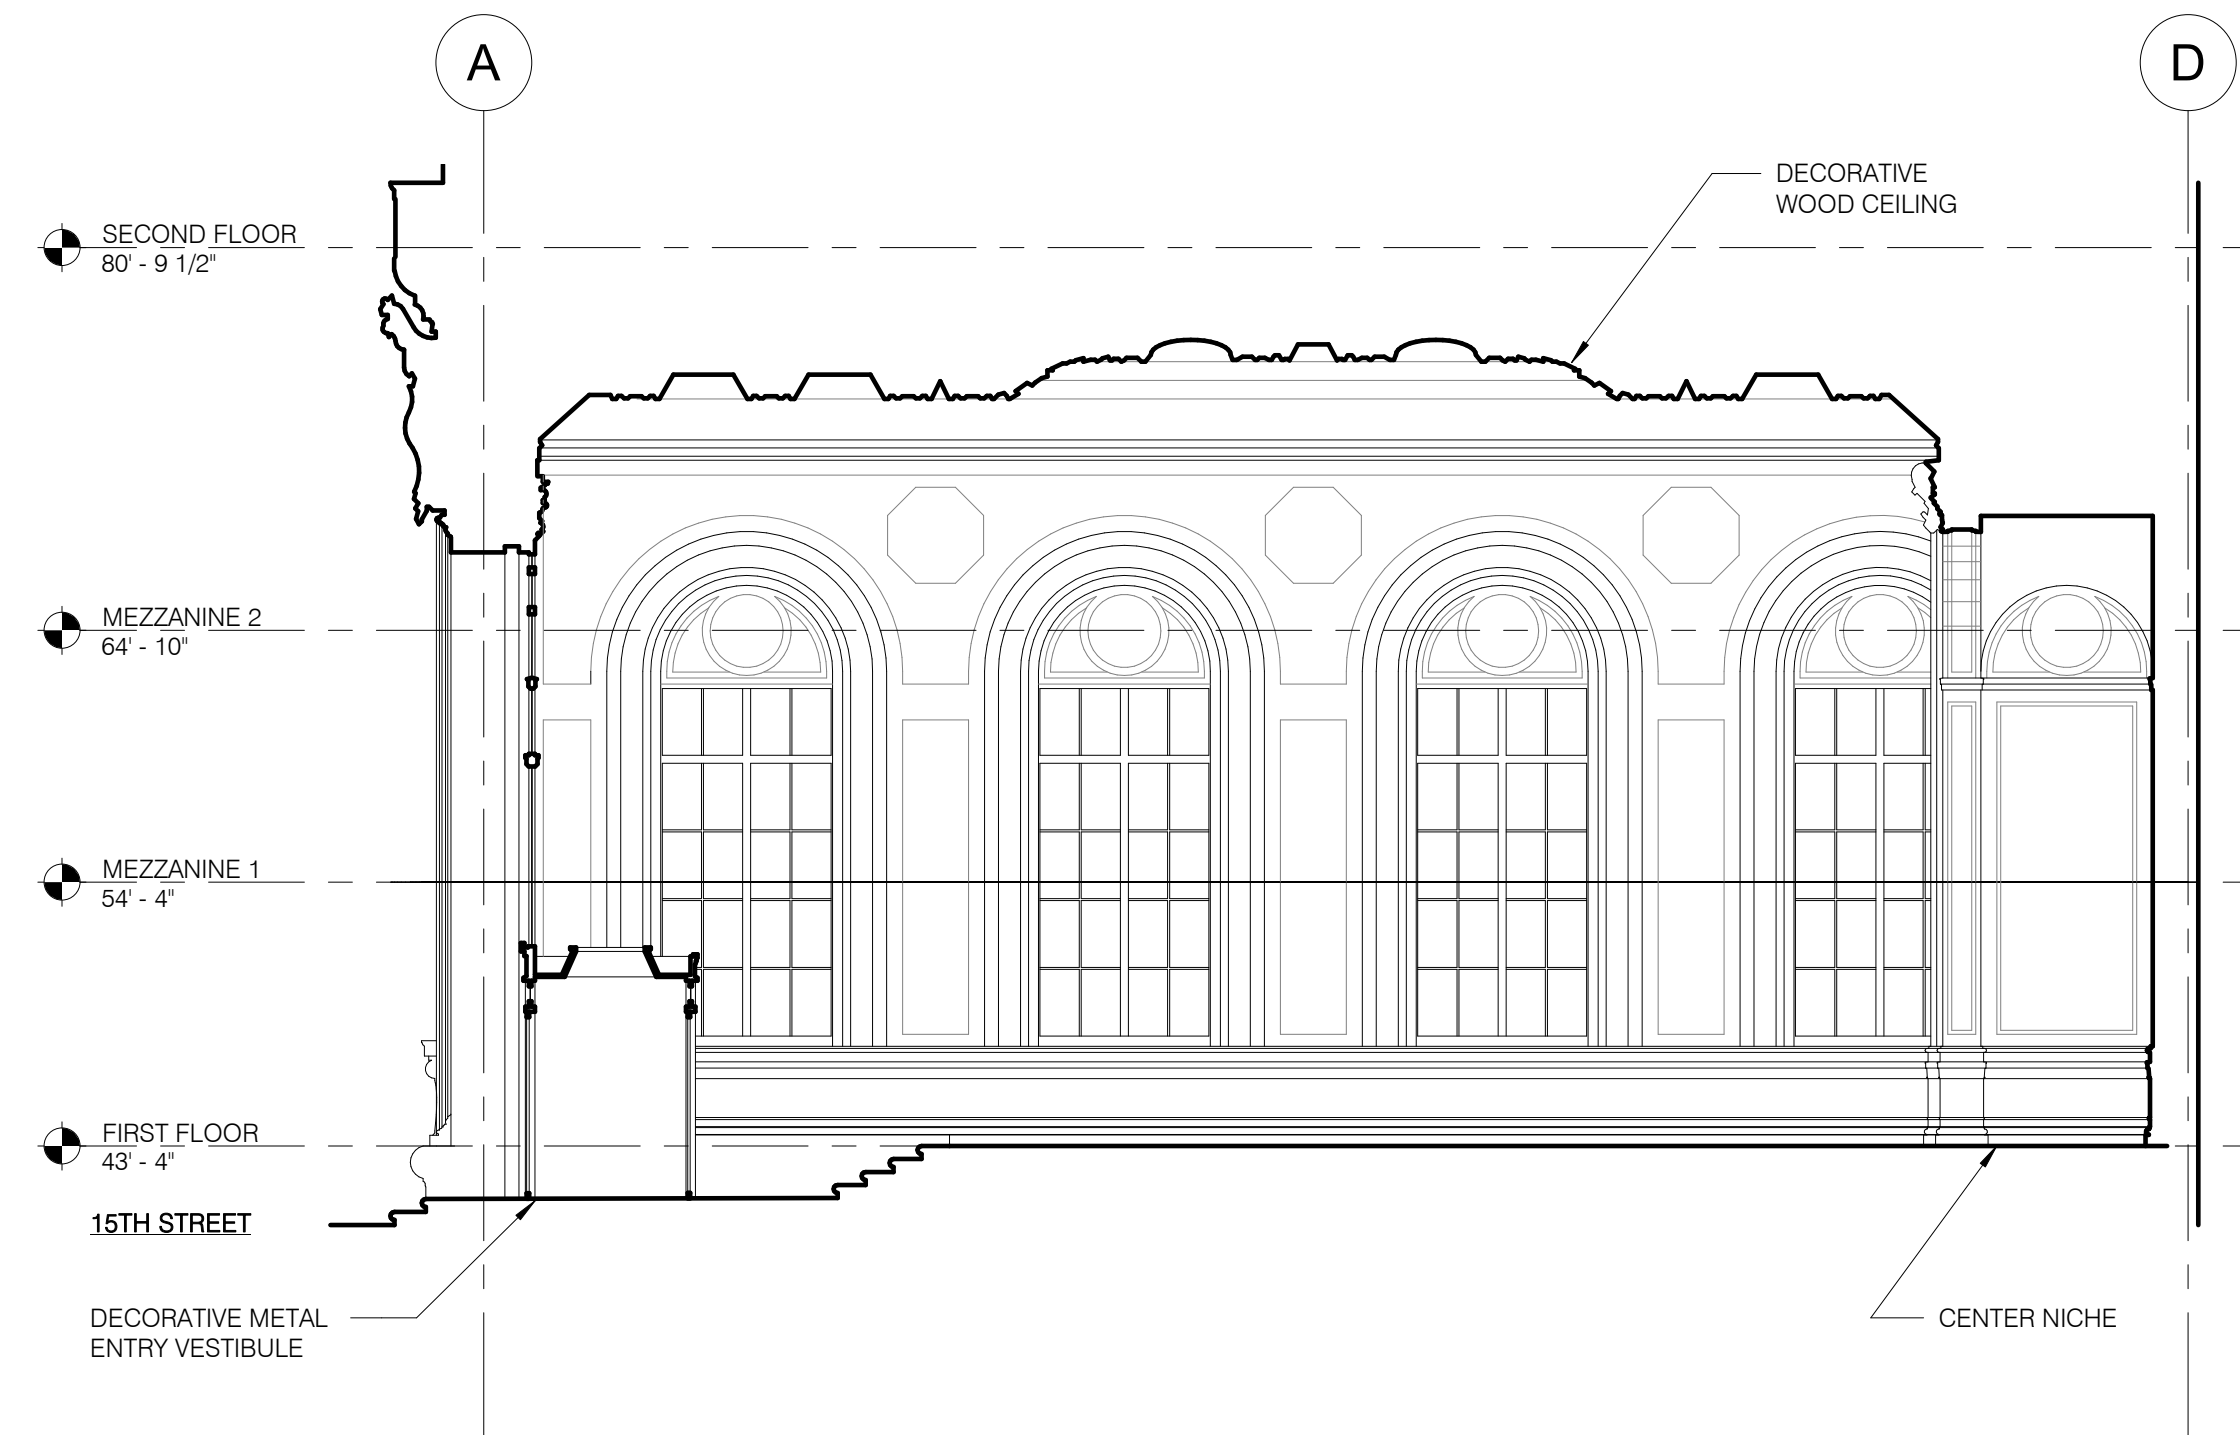
1 PARTIAL W-E SECTION - FORMER BANKING HALL
1/8" = 1'-0"

(COMMON LOBBY / MEZZANINE ADDITIONS NOT SHOWN)

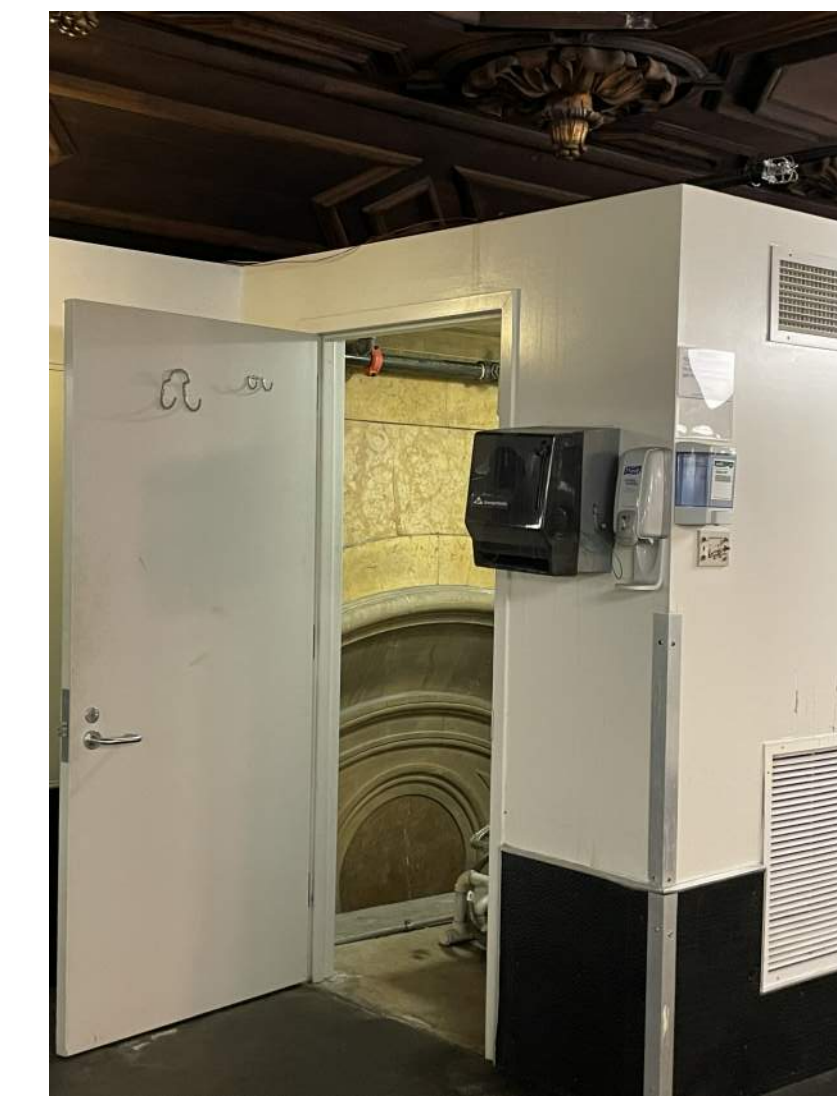
8 STONE ROUND TOP OF TYP. WINDOW VIEWED ON MEZZANINE 2 (2021)

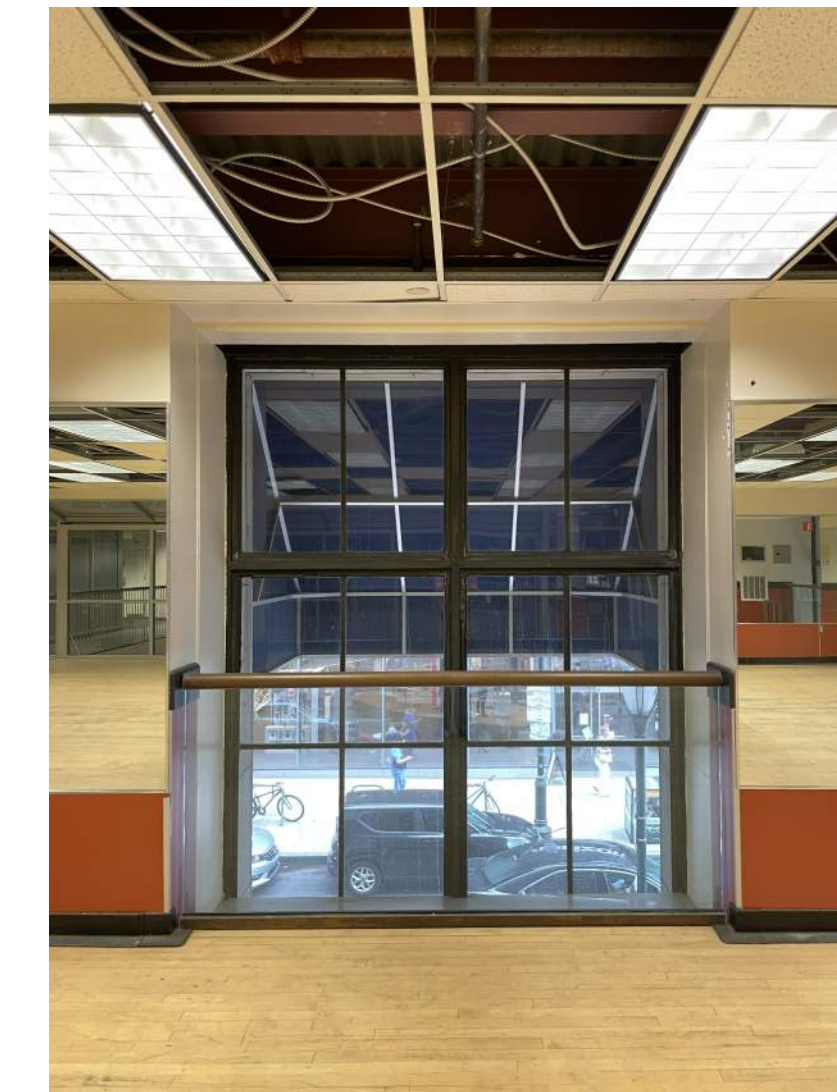
9 UPPER PORTION OF TYPICAL WINDOW AT MEZZANINE 1 (2021)

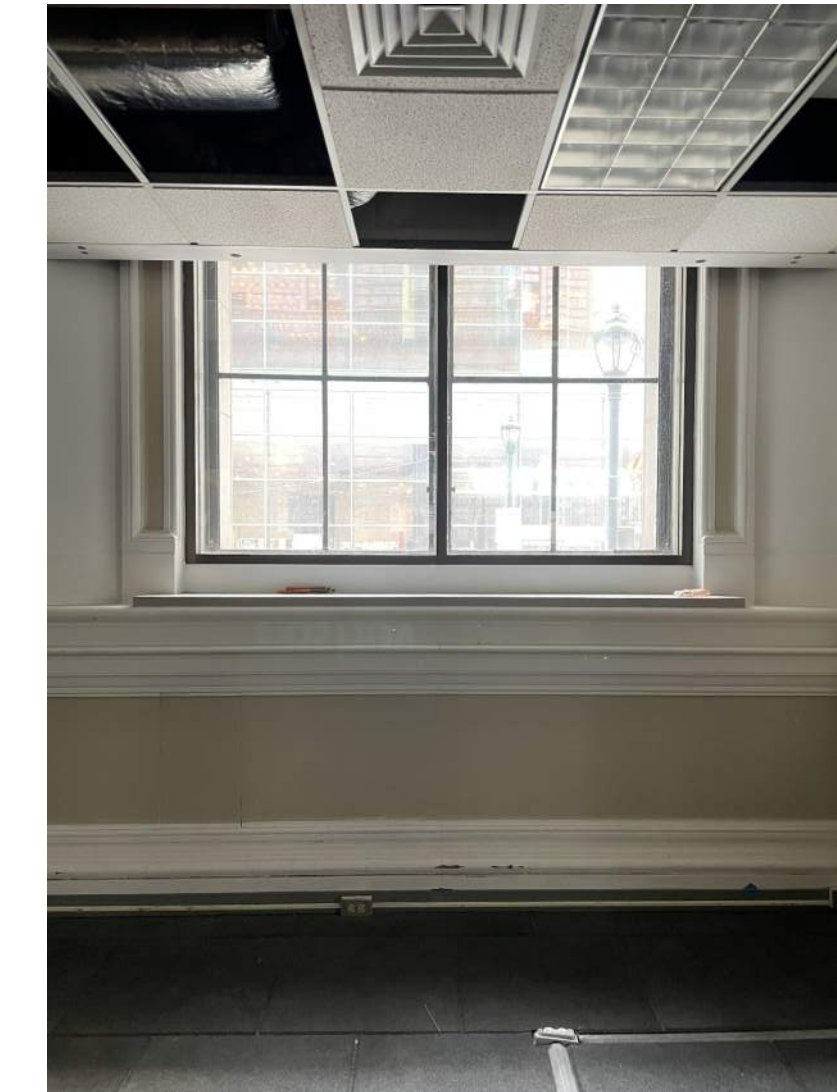
10 LOWER PORTION OF TYPICAL WINDOW AT FIRST FLOOR (2021)
