ADDRESS: 1435-41 WALNUT ST

Proposal: Cut window sills; install new windows

THE DREXEL BUILDING • EXTERIOR ALTERATIONS

THE DREXEL BUILDING, 15TH AND WALNUT, PROPOSED GROUND FLOOR WINDOW ALTERATIONS

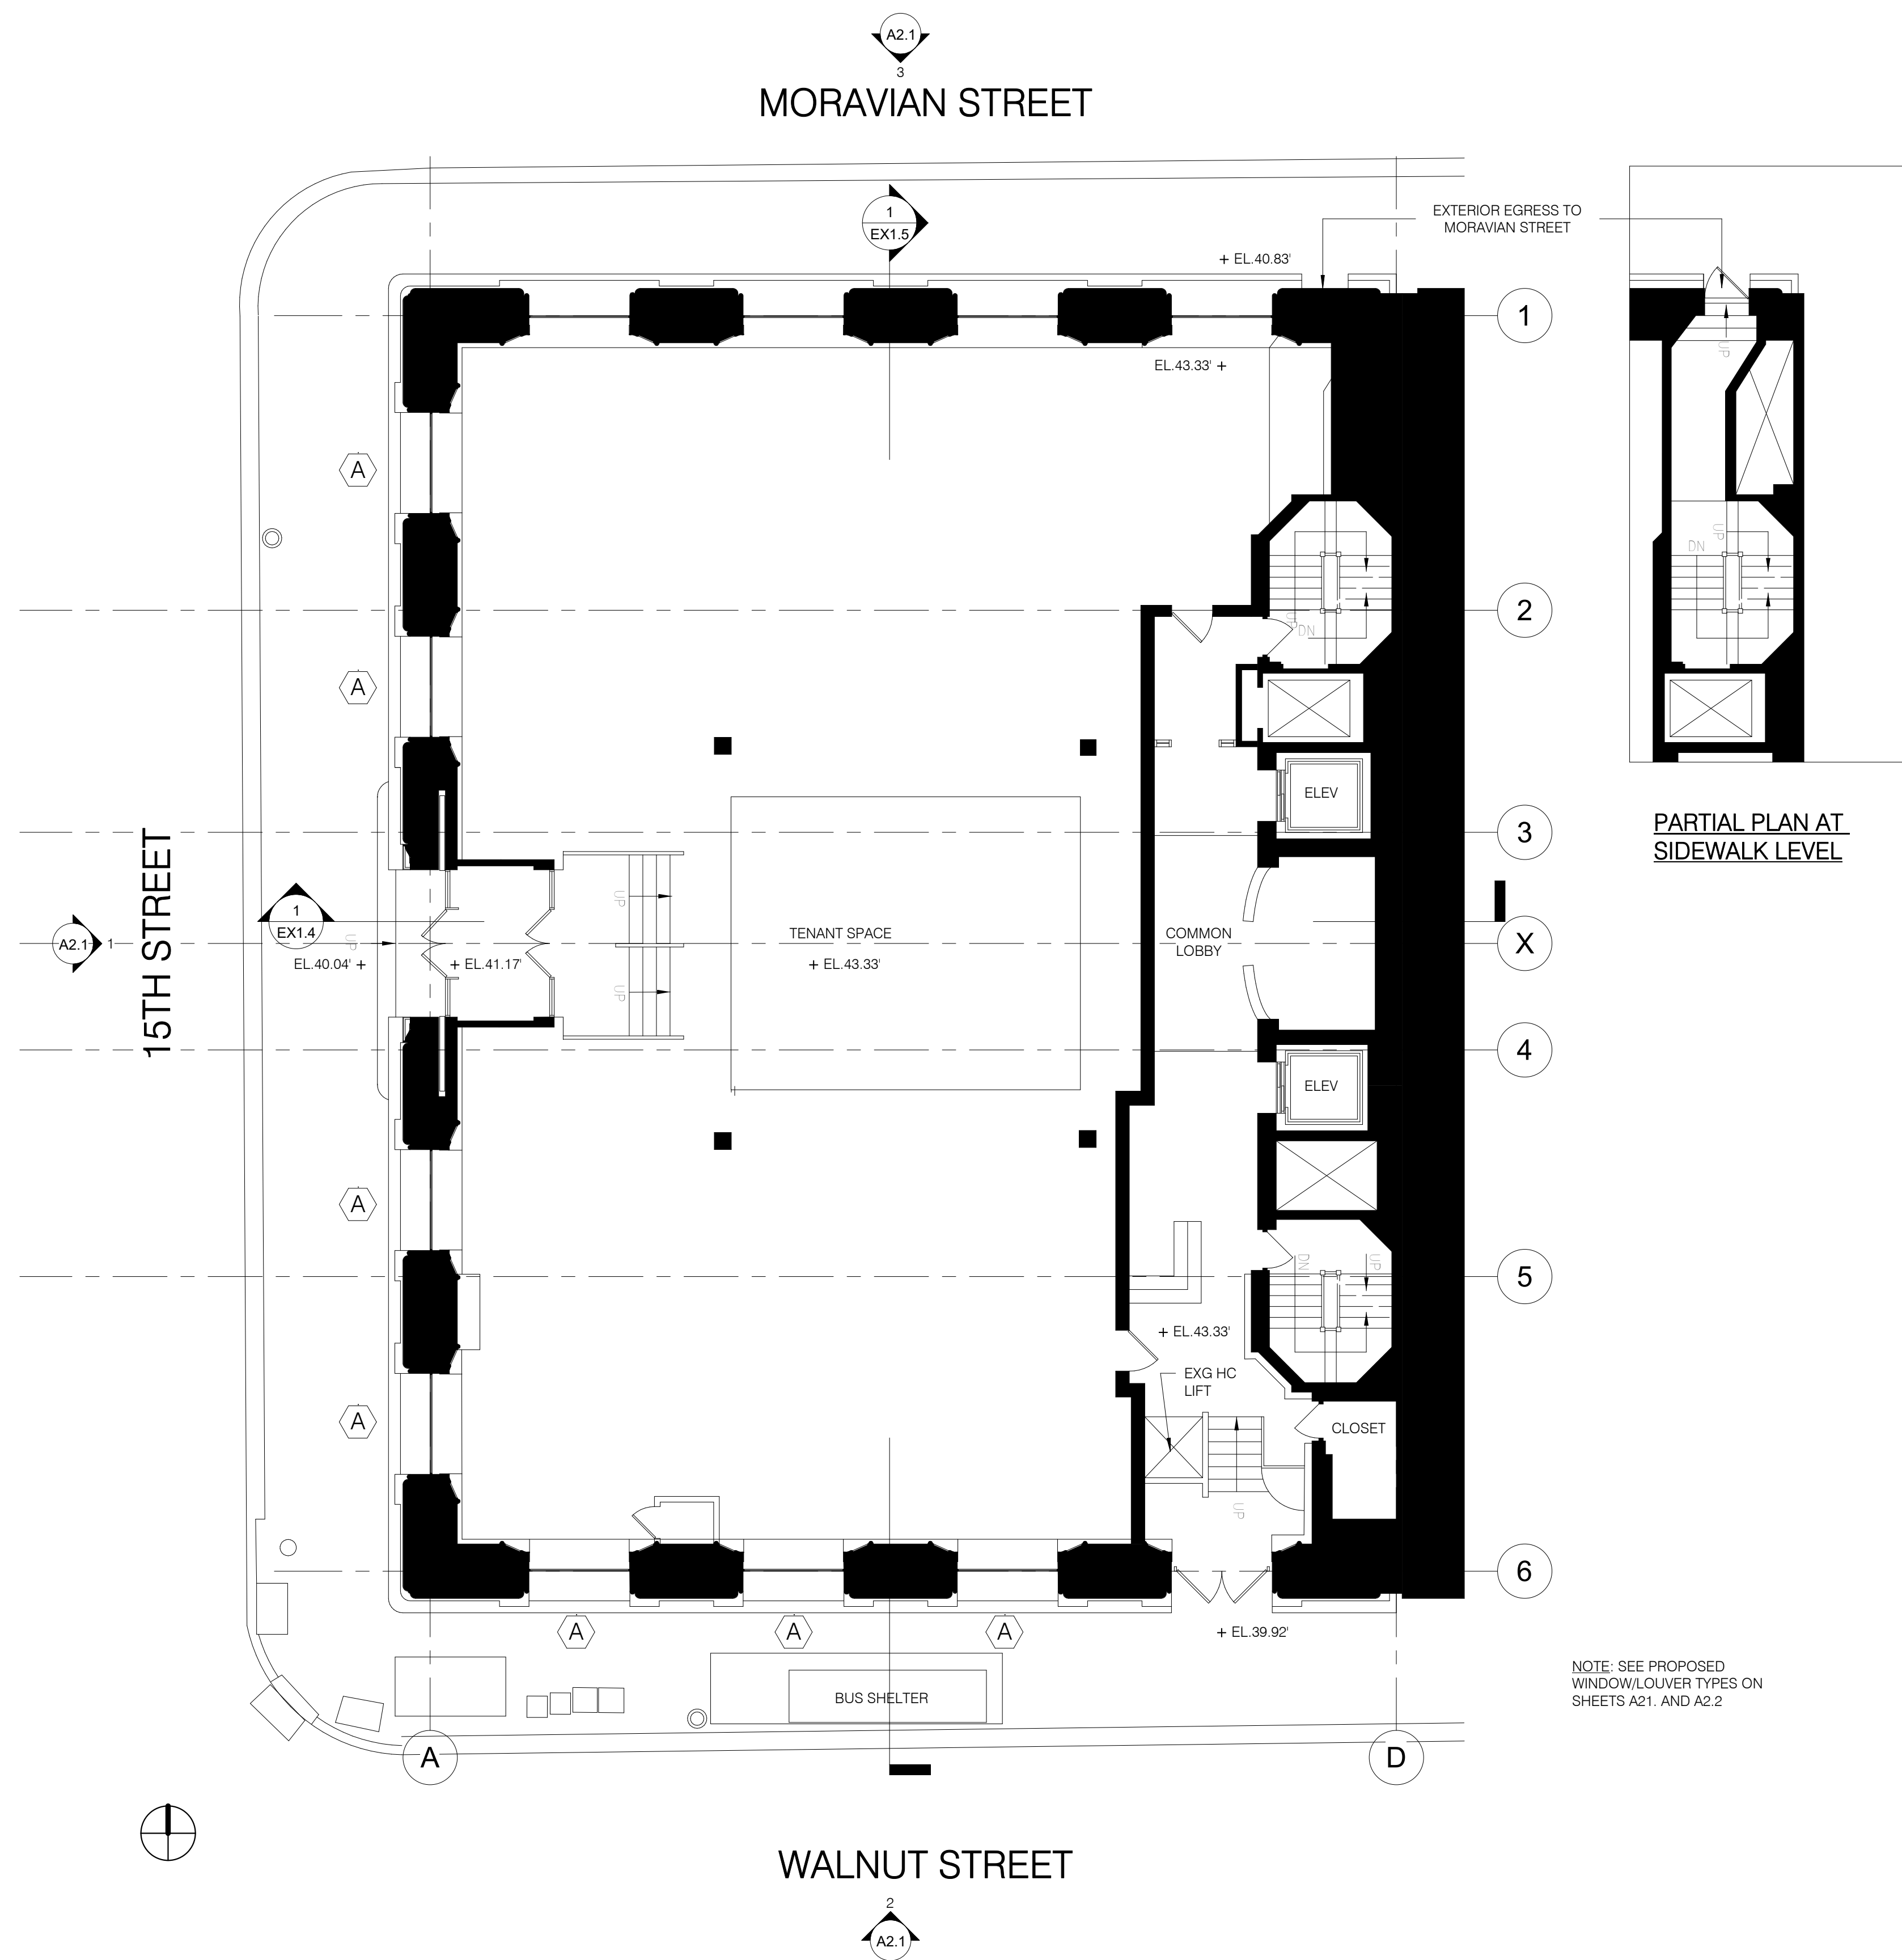
PARTIAL PLAN AT SIDEWALK LEVEL

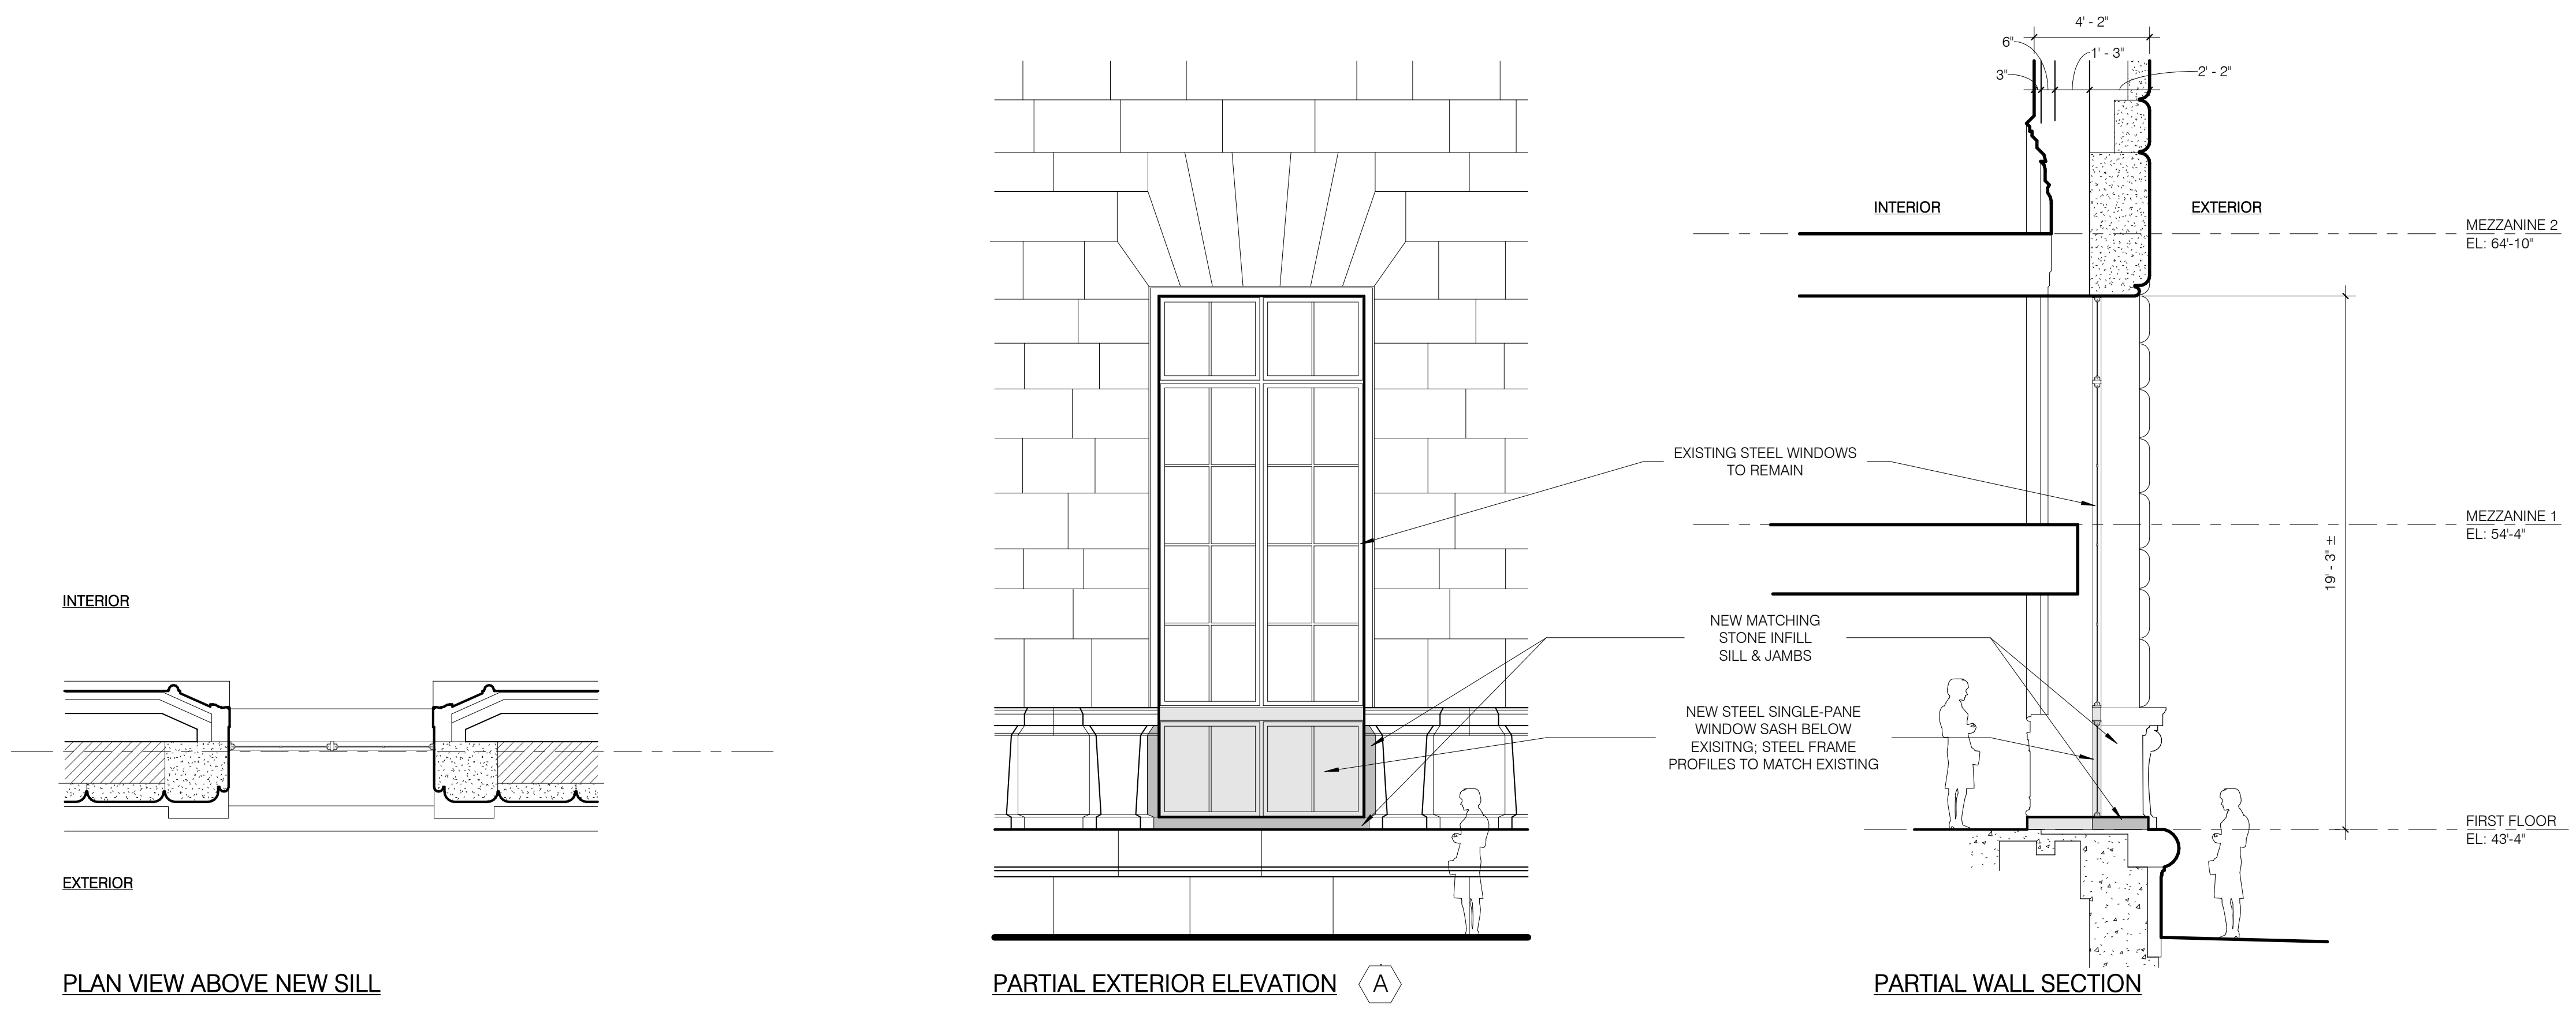
④ TYPICAL WINDOW 'A' ENLARGED VIEWS - ALTERED
1/4" = 1'-0"

The application proposes to remove the masonry panels below seven of the first-floor windows and install mullions and glazing in place of the panels to allow for views from the street into the interior space. The windows that would be changed are located on Walnut and 15th Streets. The Moravian Street windows would not be altered. The easternmost opening on Walnut Street is already altered; it was cut down for a doorway many years ago. After the stone panels below the windows are removed, new pieces of matching stone would be inserted at the jambs and new sills to square the openings and then the new openings would be glazed, with the new window systems fitting below the decorative historic windows. Non-historic storm windows would also be removed.

- Lower window sills and add glazing in seven openings.

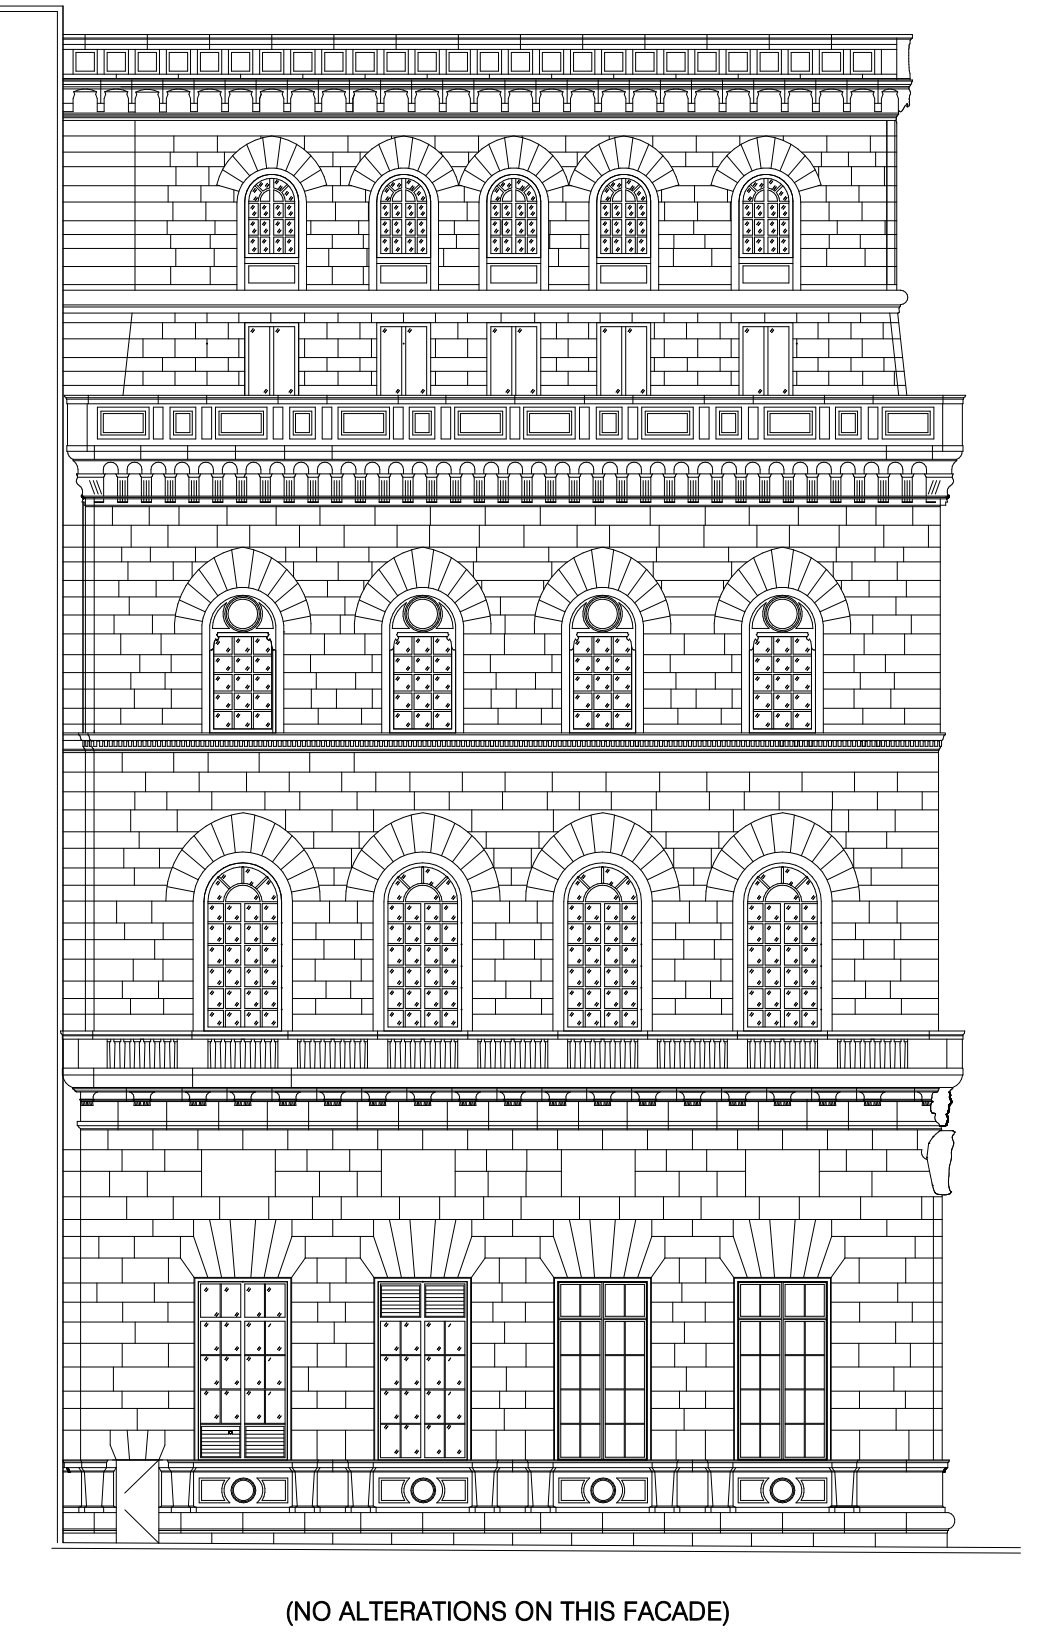
③ MORAVIAN STREET ELEVATION (NORTH)
1/16" = 1'-0"

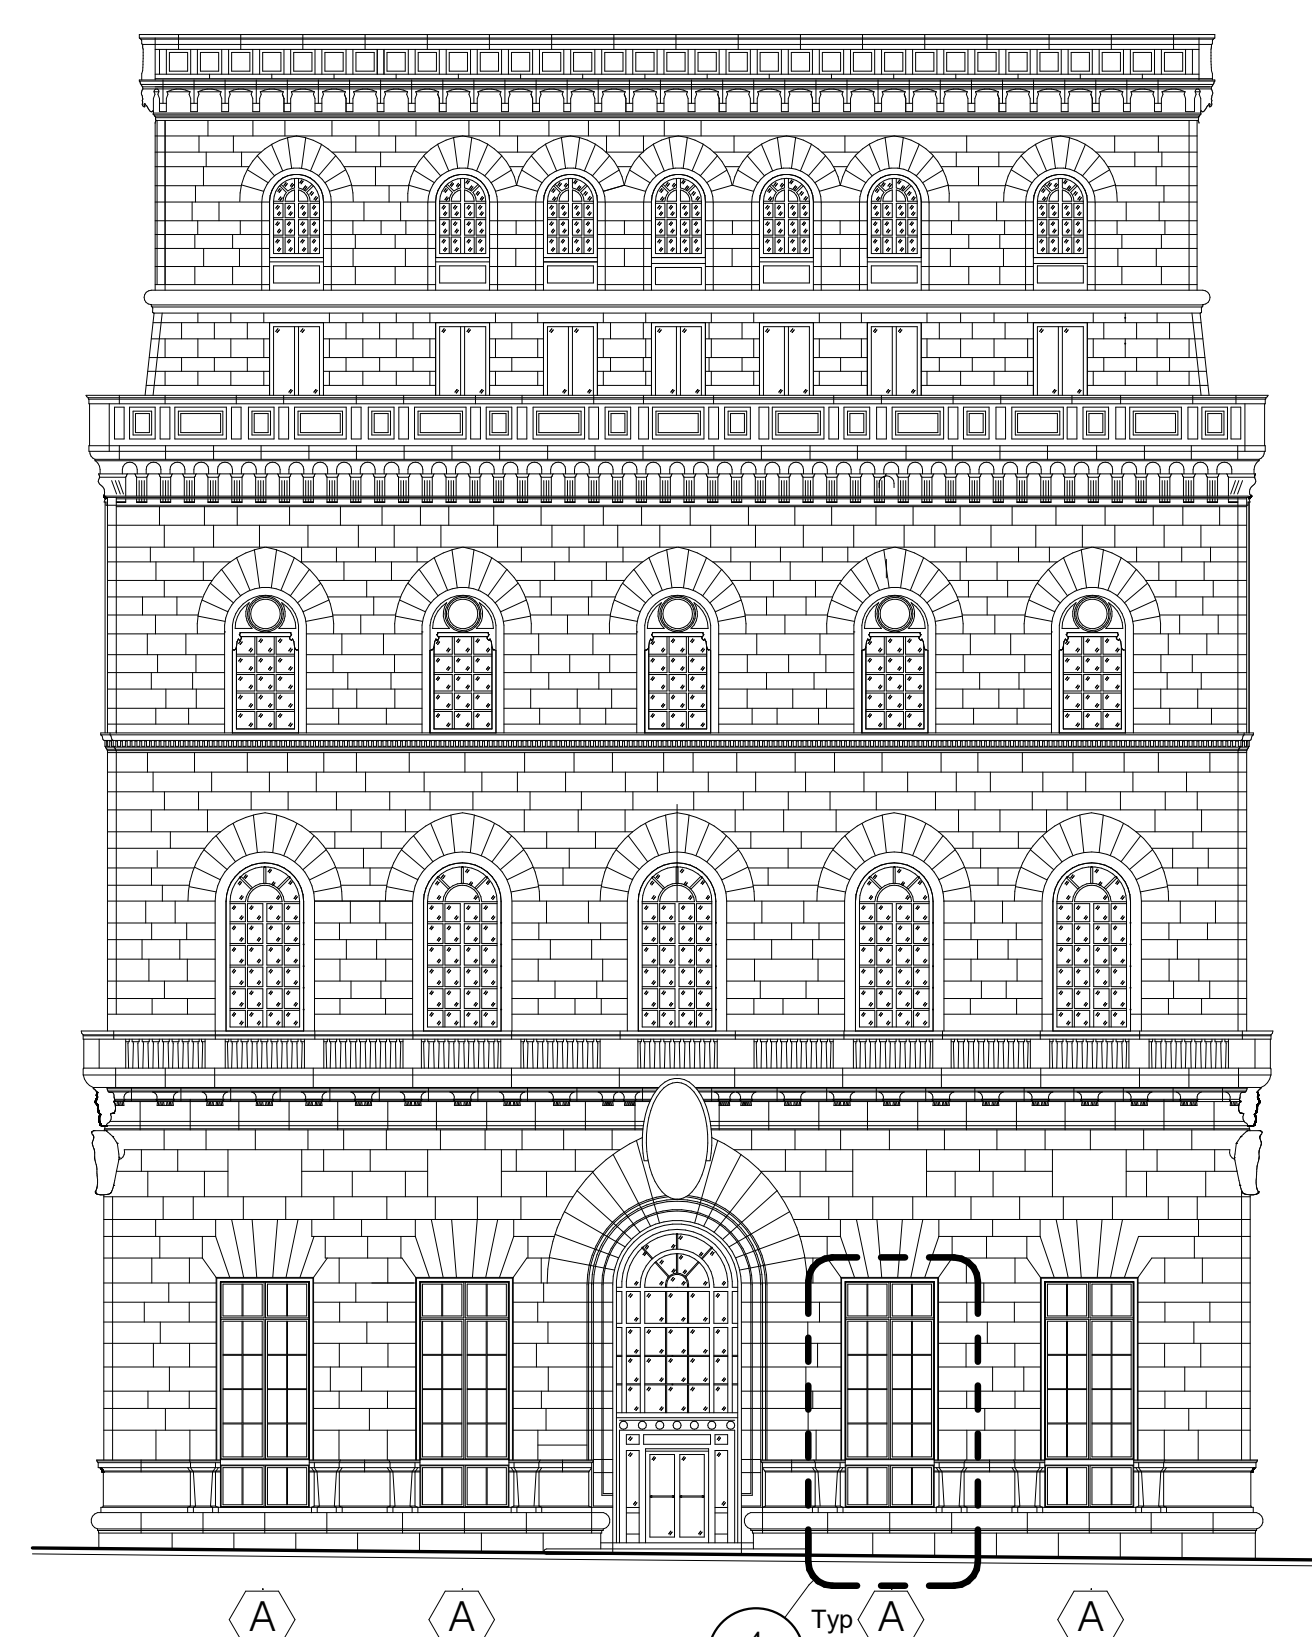
① 15TH STREET ELEVATION (WEST)
1/16" = 1'-0"
