**PHASE IA ARCHAEOLOGICAL SURVEY
PROPOSED ST. PETER'S PARISH HALL SITE
PARCEL B, THIRD AND LOMBARD STREETS
CITY OF PHILADELPHIA
PHILADELPHIA COUNTY, PENNSYLVANIA**

NOVEMBER 2016

MANAGEMENT SUMMARY

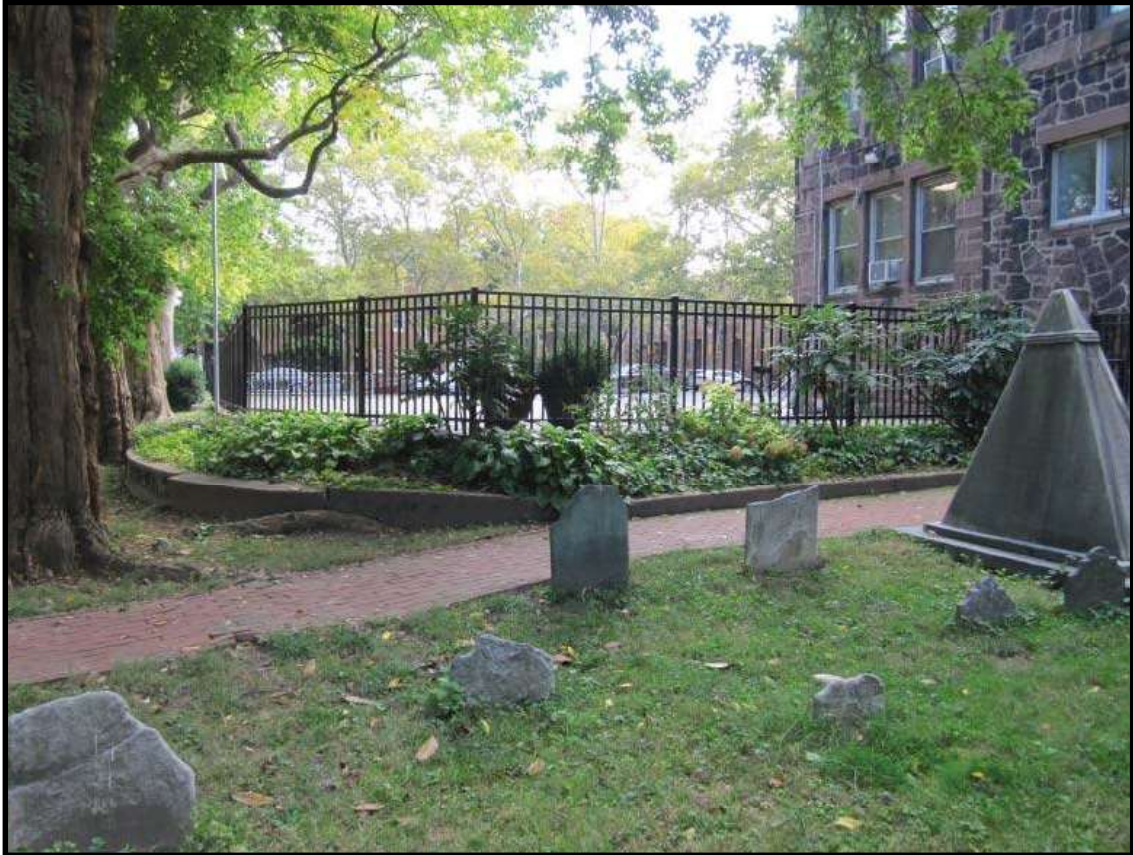
Photograph 3.7. Proposed site of St. Peter’s Parish Hall, corner of Third and Lombard Streets, view of northwest corner of site looking southeast from St. Peter’s Cemetery; note the approximately 18-inch difference in elevation between the cemetery and the parking lot where the proposed parish hall is to be constructed (Photographer: Richard Hunter, October 2016) [HRI Neg. #16054/D1:021].

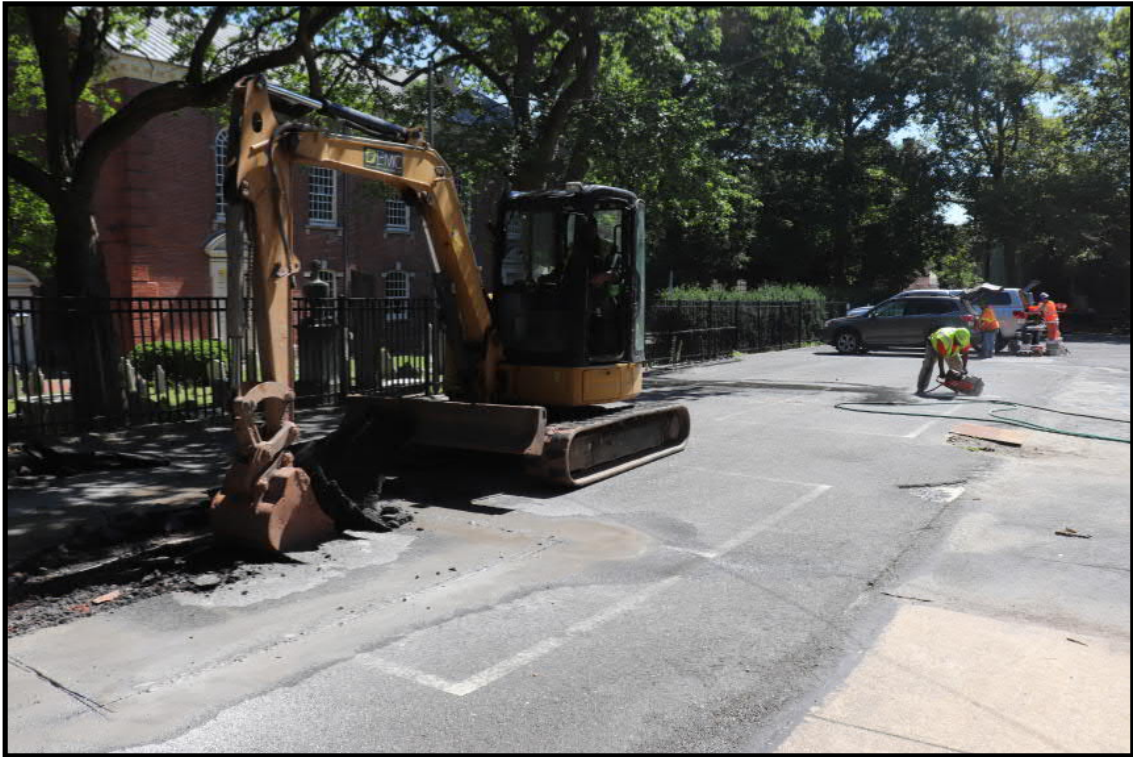
Photograph 3.1. View facing northeast showing the mechanical stripping of Test Pit A. At the mid-point of the frame the asphalt overlying Trench 1 is being cut with a road saw (Photographer: Andrew Martin, July 2019) [HRI Neg.# 19027/D1:034].

Test Pit A, which measured 10 feet north-south by 15 feet east-west, was placed in the northwest corner of the site to sample potential historic backyard deposits and features associated with the rear yard of the Reverend Richard Peters property (Figures 3.1-3.3, Photograph 3.3). Test Pit A was originally

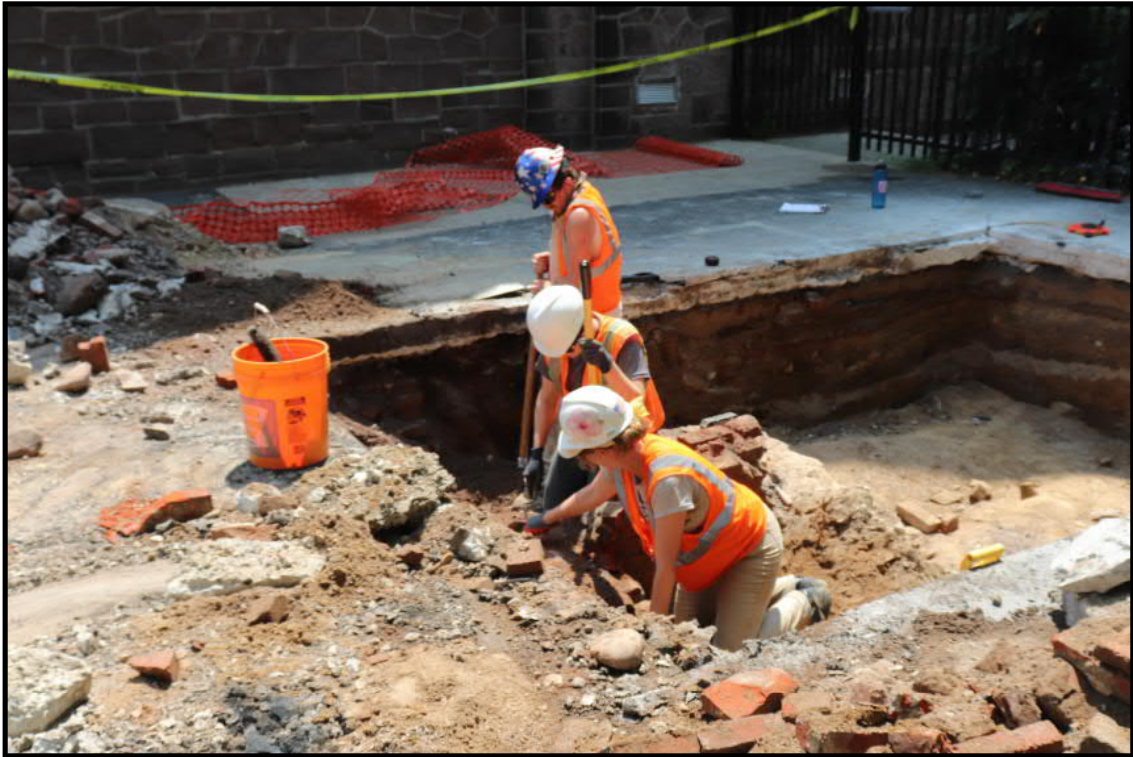
Photograph 3.2. View facing southwest showing manual clearing of the pricy feature in Test Pit A (Photographer: Andrew Martin, July 2019) [HRI Neg.# 19027/D1:111].

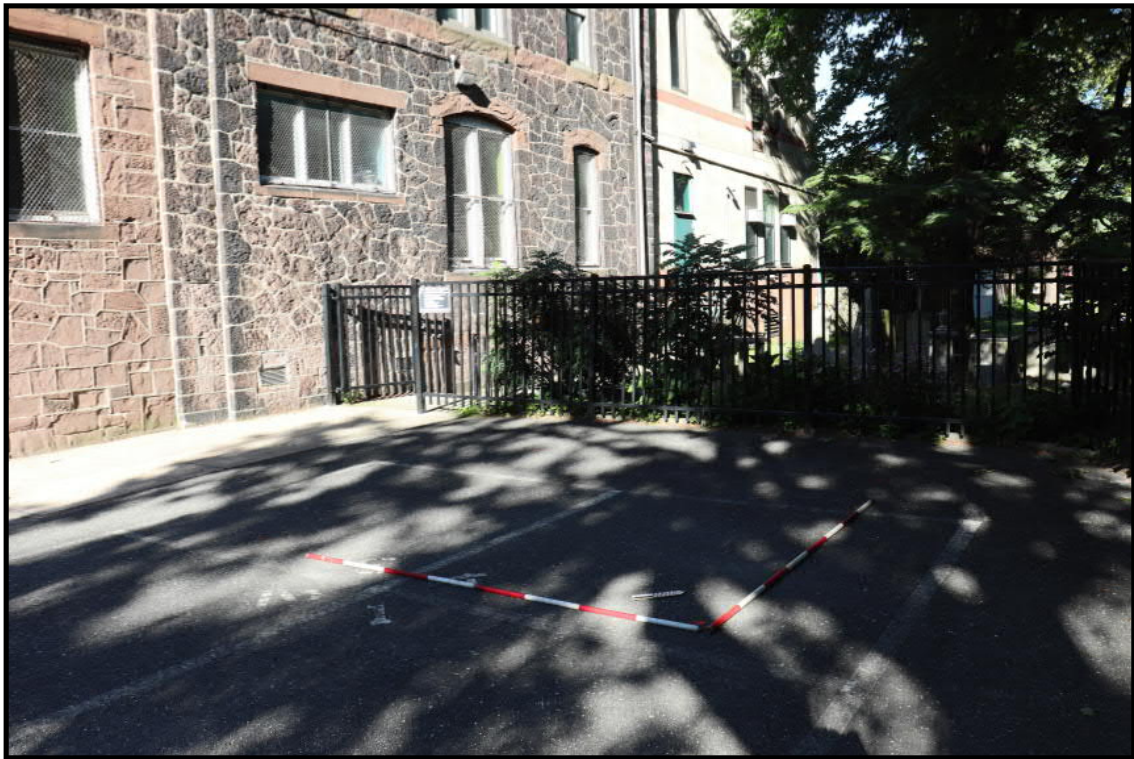
Photograph 3.3. View facing northwest showing the location of Test Pit A (Photographer: Michael Brown, July 2019) [HRI Neg.# 19027/D1:005].

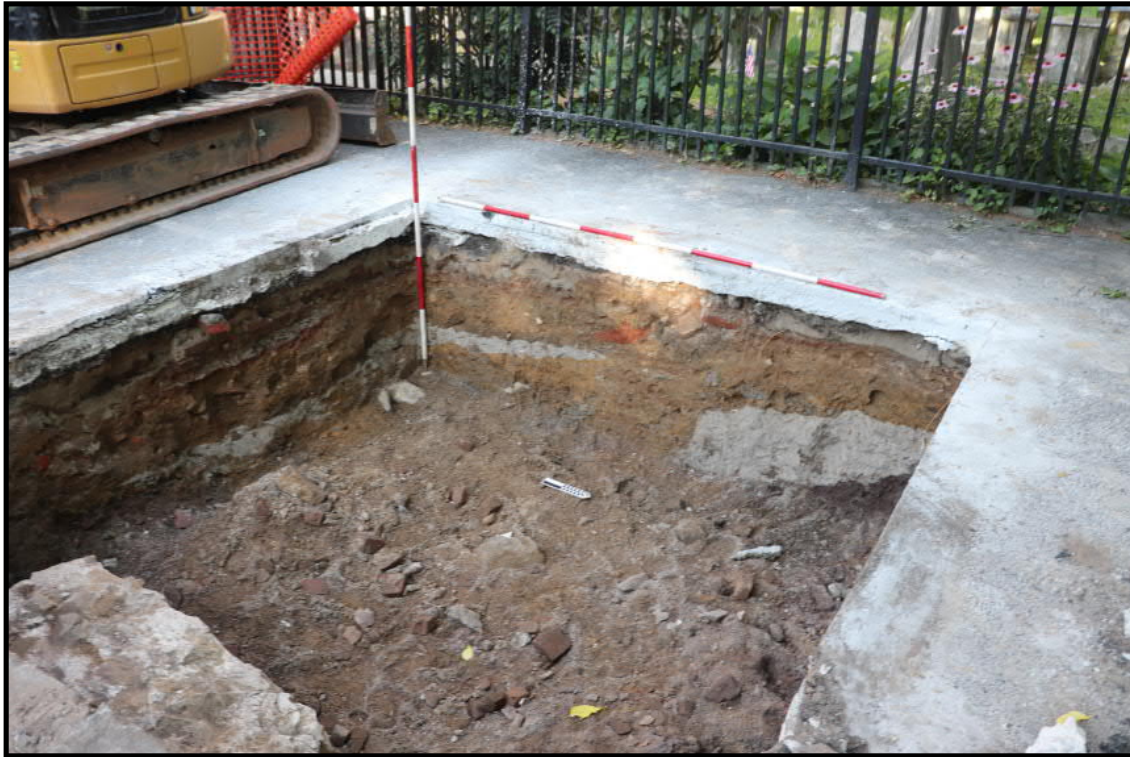
Photograph 3.4. View facing southwest showing the southern profile of Test Pit A. Note the articulated brick in the profile, this is likely the remnants of a brick driveway for the demolished school (Photographer: Michael Brown, July 2019) [HRI Neg.# 19027/D1:084].

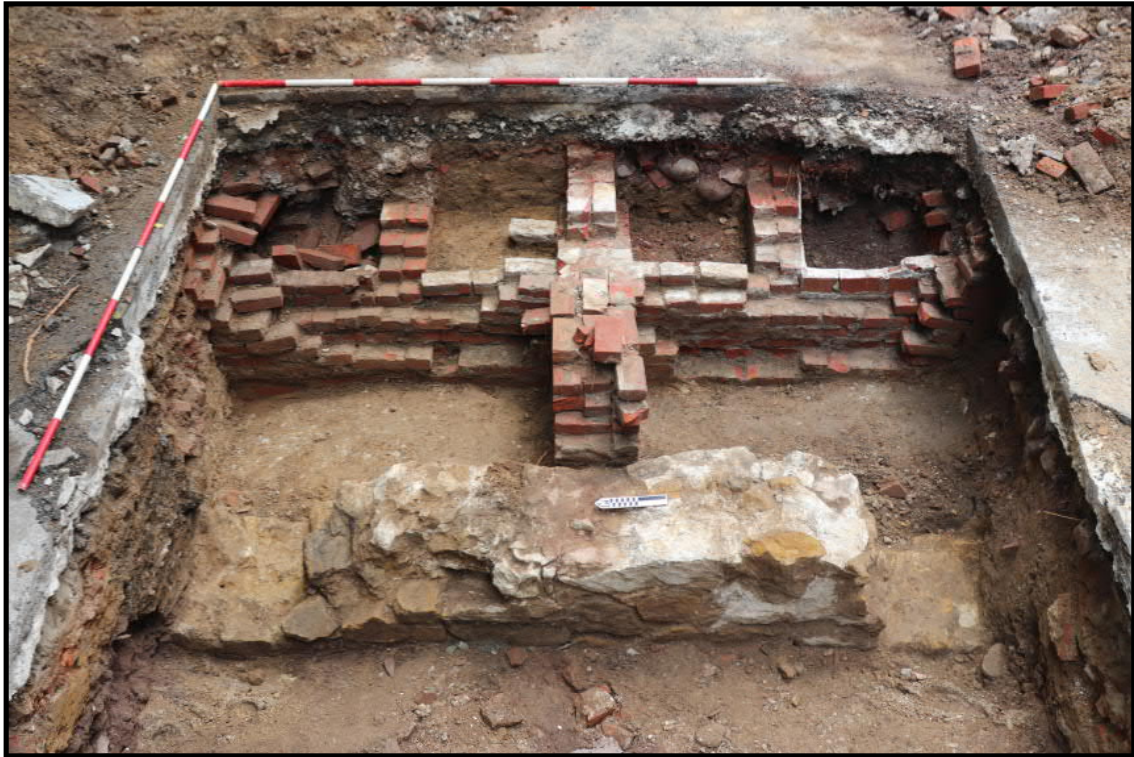
Photograph 3.5. View facing east showing the large brick and schist privy in Test Pit A (Photographer: Michael Brown, July 2019) [HRI Neg.# 19027/D1:162].

The restroom, which is depicted in both Bromley's 1910 *Atlas of Philadelphia* and the 1916 Sanborn fire insurance maps (see above, Figures 2.9 and 2.10), was found at 1.2 feet below the ground surface, immediately underlying the parking lot (Figure 3.2; Photographs 3.5 and 3.6). The outer walls of the restroom enclosed a series of internal brick dividing

The schist upper course of the restroom's west wall extended from 2 to 2.5 feet below the ground surface and measured 7.5 feet north-south by 1.6 feet in width. This masonry supported an interior central brick wall [105] that measured five feet in length and 0.9 feet in width. The full length of this wall is unknown because it continued east beyond the limit of excavation. Context 105 was joined by a north-south running wall [124], which measured 0.9 feet in width and at least ten feet in length and appeared to extend beyond the limit of excavation to both the north and the south. Two smaller walls [127 and 128] ran east from Context 124 and divided the restroom into at least four stalls. Each of these stalls was lined with a layer of mortar. Hand excavation of these stalls ended in compacted demolition fill impasses at between 3.5 and 3.75 feet below the ground surface. A small amount of possible night soil [137] was found in the stall formed by Contexts 127, 124 and 105, but all of the stalls showed signs of having been cleaned out before the building was demolished. The stalls were filled by a dense layer of brick and rubble and only yielded a handful of late 19th-century artifacts such as glass and nails. This dense rubble fill made hand excavation impossible and none of the stalls were fully excavated. This schist and brick restroom sat atop a brownstone foundation wall [111] that extended 6.5 feet below ground surface.

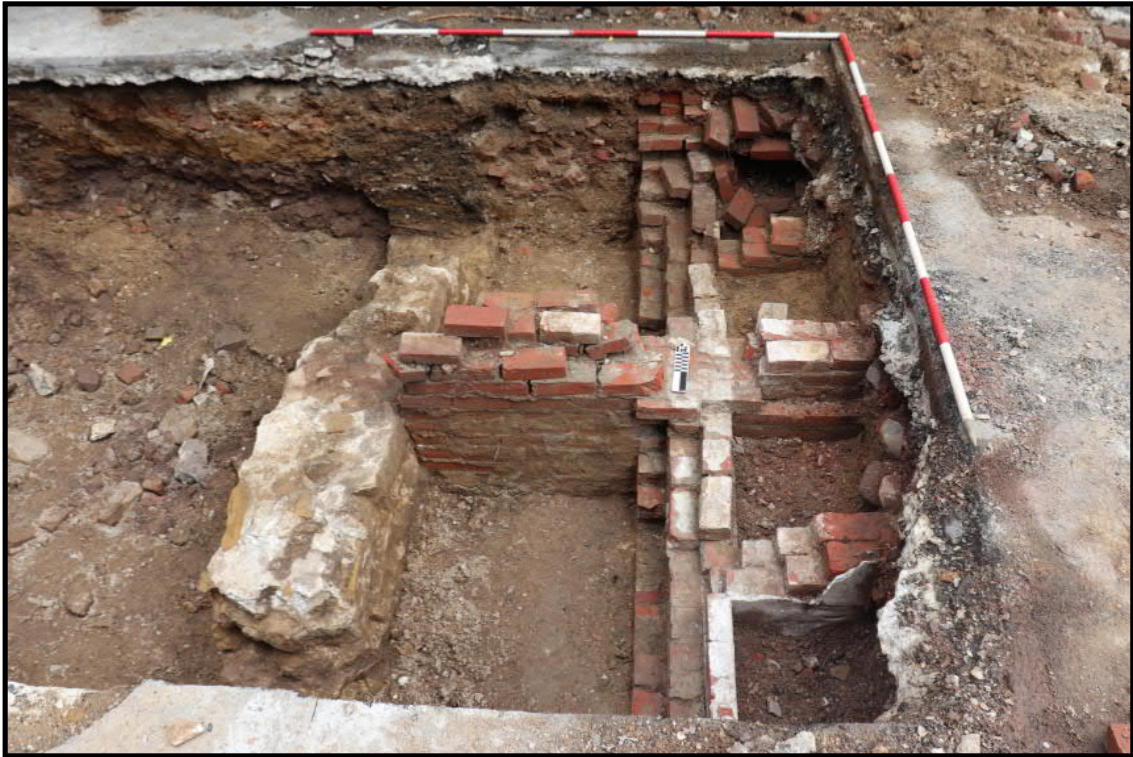
Photograph 3.6. View facing north showing the large brick and schist privy in Test Pit A (Photographer: Michael Brown, July 2019) [HRI Neg.# 19027/D1:150].

This demolition cut and fill episode was cut again by a trench containing a later utility [112]. The demolition cut was filled by a dump of rubble [113]. Due to the nature of the heavy disturbance encountered in Test Pit A, this cut was primarily observed in profile in the test pit's west wall after excavation was completed. Contexts 114/102 overlay a large sand fill deposit [115] that extended from 2.2 to 3.5 feet below the ground surface. This overlay a deep fill deposit composed of sandy loam with pebbles and crushed brownstone [103]. This fill deposit extended to almost nine feet below the ground surface where it overlay natural subsoil [138] (Photograph 3.7). This unusually thick fill deposit may have been placed to raise the ground level in this part of the property after the school building was removed.

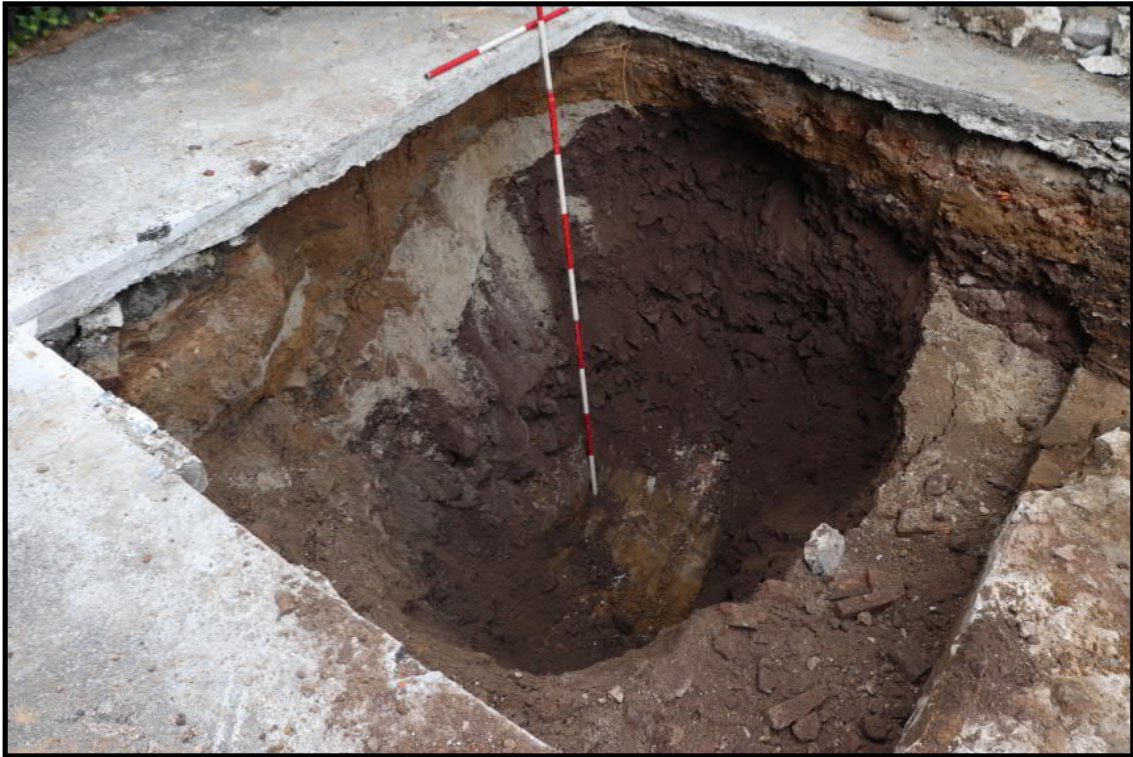
Photograph 3.7. View facing north showing the crushed brownstone and soil fill episode in the north wall profile of Test Pit A. Note the subsoil present at the bottom of the trench (Photographer: Andrew Martin, July 2019) [HRI Neg.# 19027/D1:212].

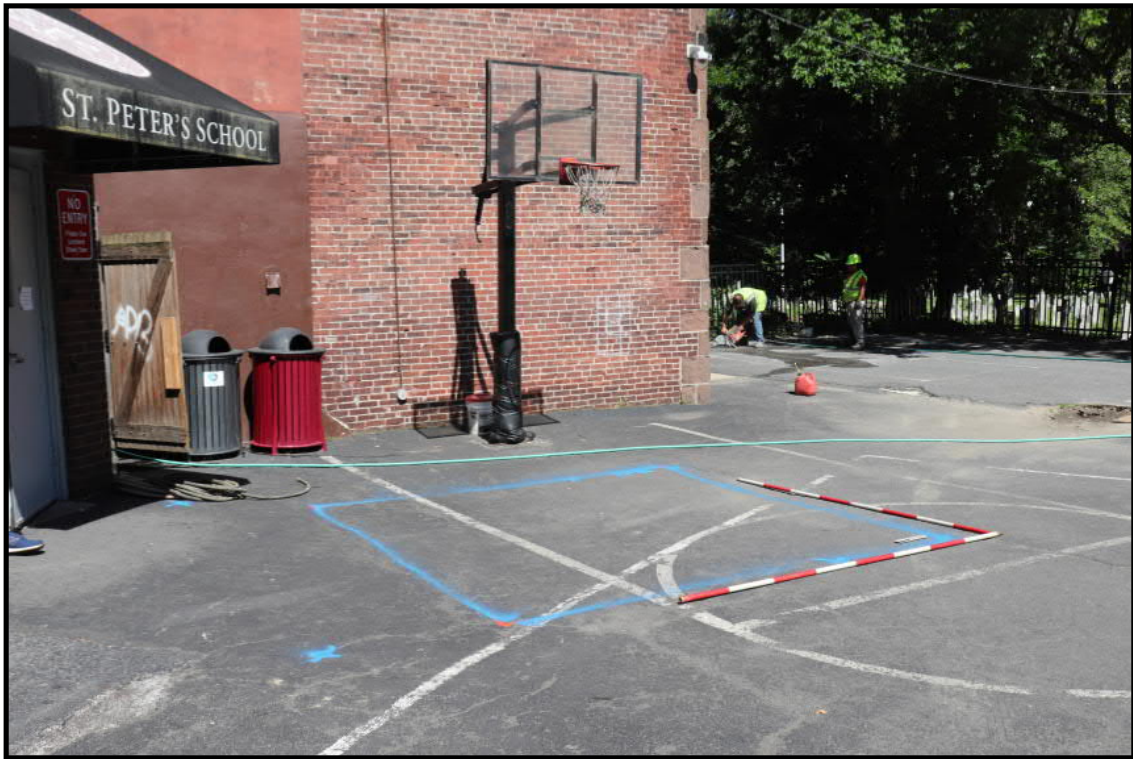
Photograph 3.8. View facing northwest showing the location of Test Pit B (Photographer: Michael Brown, July 2019) [HRI Neg.# 19027/D1:028].

Test Pit B, which measured ten feet square, was placed immediately east of the existing St Peter's School stair tower (Figures 3.1, 3.4 and 3.5; Photograph 3.8). This test pit aimed to examine potential historic backyard deposits and features associated with the rear yard of 315 Lombard Street. The overlying asphalt and modern deposits were excavated from the entire test pit using the backhoe. The underlying historic yard deposit was examined by means of a manually excavated 2.5-foot-square excavation unit (Excavation Unit 1000). Soil removed from Excavation Unit 1000 was screened and all artifacts found were retained according to their context.

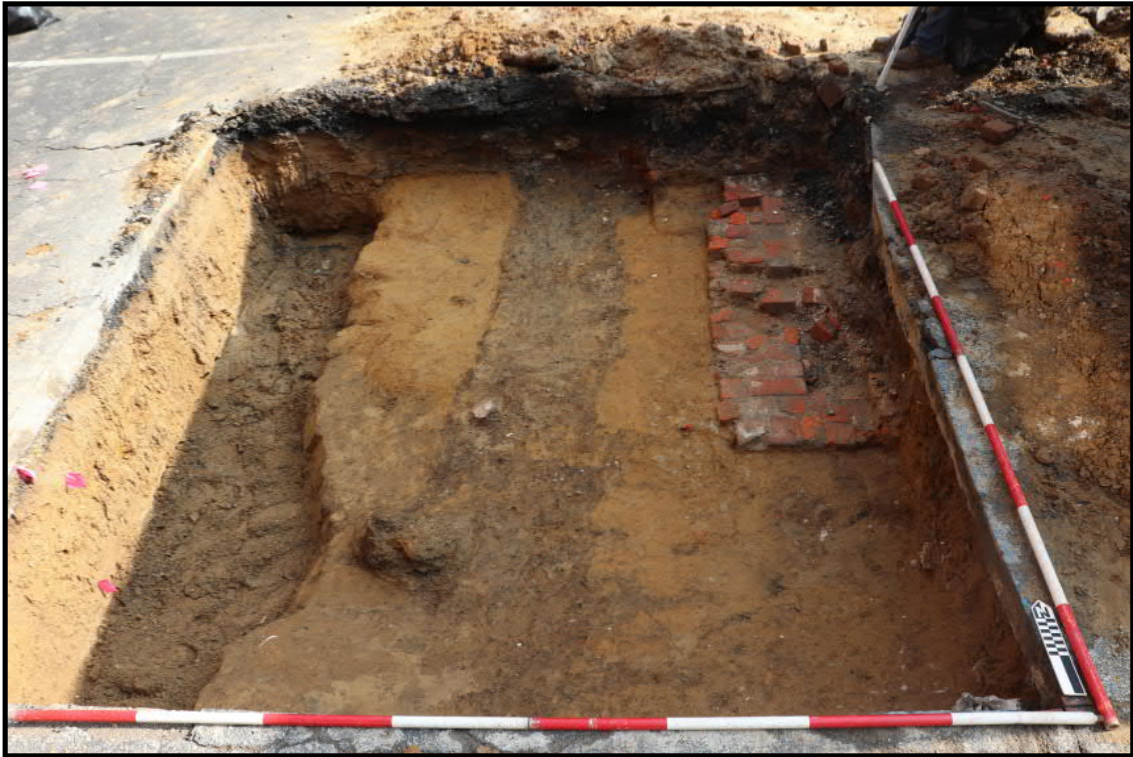
Photograph 3.9. View facing north showing Test Pit B. The disturbed area along the western profile was a back filled trench dug by Hunter Research personal. The dark band of soil running down the center of the test was a demolished utility. The foundation of a rear addition to 313 Lombard Street is visible in the northeast corner of the test pit (Photographer: Michael Brown, July 2019) [HRI Neg.# 19027/D1:303].

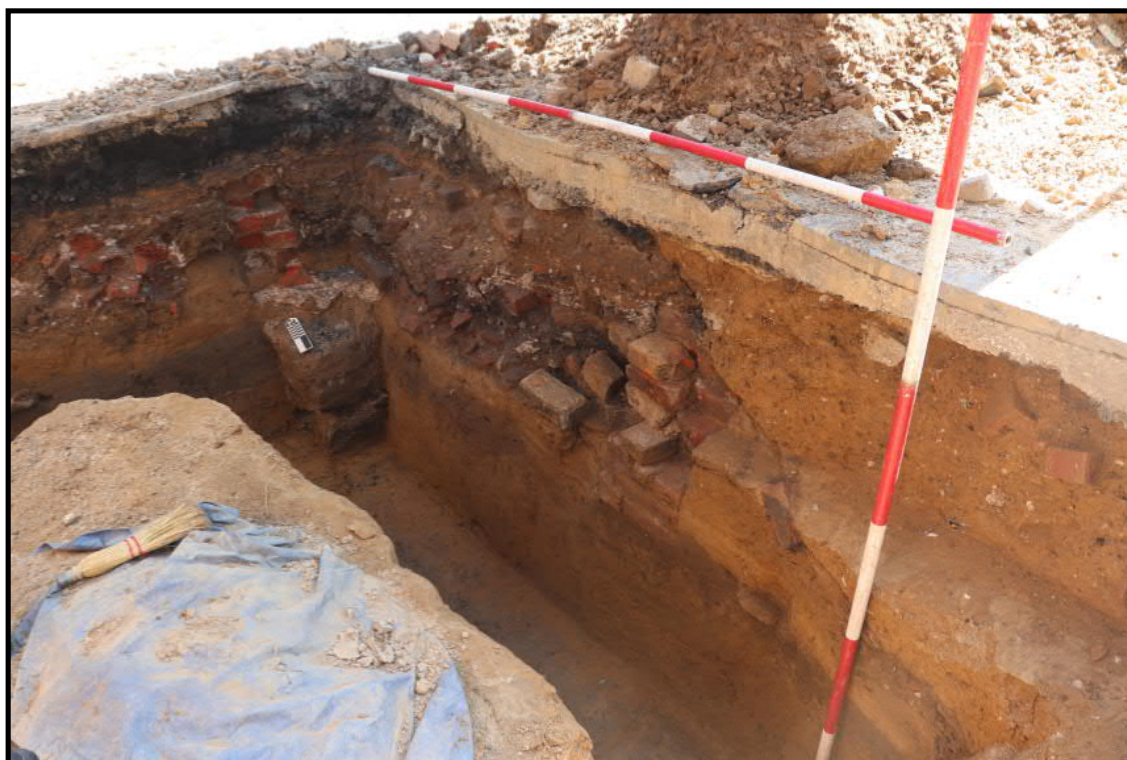
Photograph 3.10. View facing north showing the east profile of Test Pit B. Note the foundation of the rear addition to 313 Lombard Street and the presence of the buried A beneath it (Photographer: Michael Brown, July 2019) [HRI Neg.# 19027/D1:562].

A shallow brick foundation [208] was observed in the northeast corner of Test B (Photograph 3.10). Five feet of this foundation's western wall and one foot of its south wall were encountered 1 to 1.2 feet below the ground surface. This feature was bisected mechanically and found to only extend to a depth of 2.2 feet below the ground surface and was filled by a deposit of dark, coarse sandy loam and coal ash [210]. This deposit yielded both 18th- and 19th-century artifacts (Figure 3.5). Although originally interpreted as the base of a privy, its shallow depth, especially in relation to the buried A horizon found beneath it, suggest it was the crawlspace of a small rear addition to the house at 313 Lombard Street. The artifacts within the feature and the large dump of brick and debris [214] immediately west of it were likely deposits resulting from its demolition.

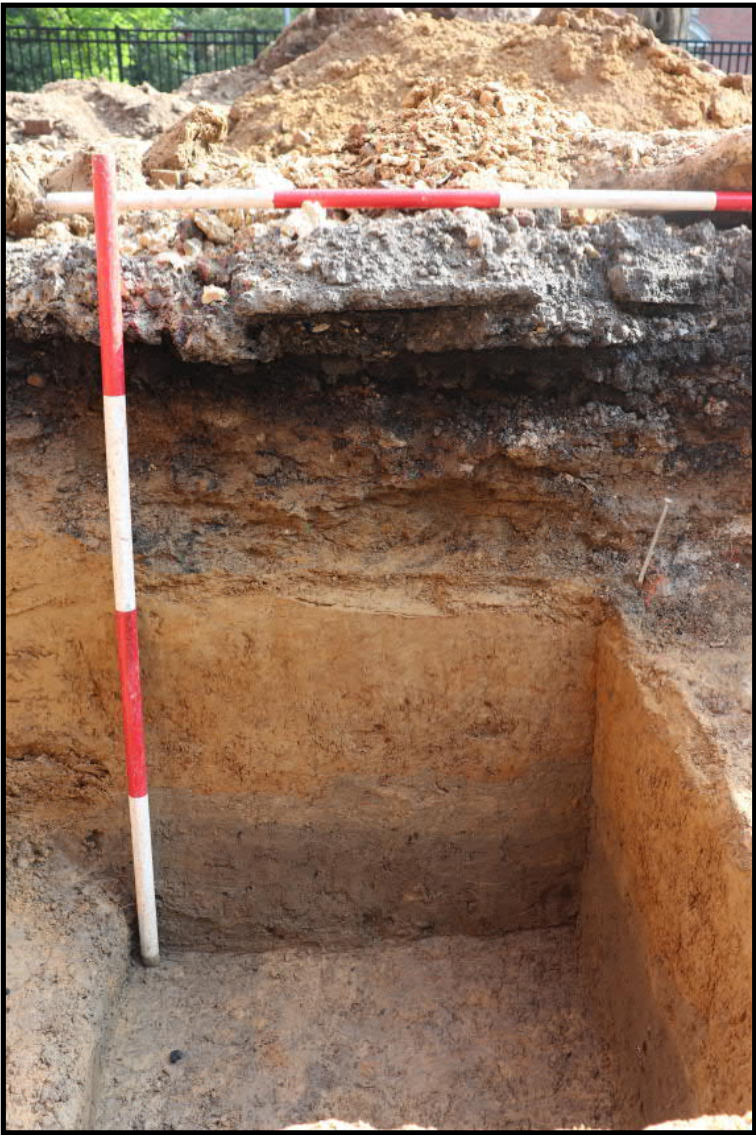
Photograph 3.11. View facing north showing the buried A horizon in Test Pit B (Photographer: Michael Brown, July 2019) [HRI Neg.# 19027/D1:346].

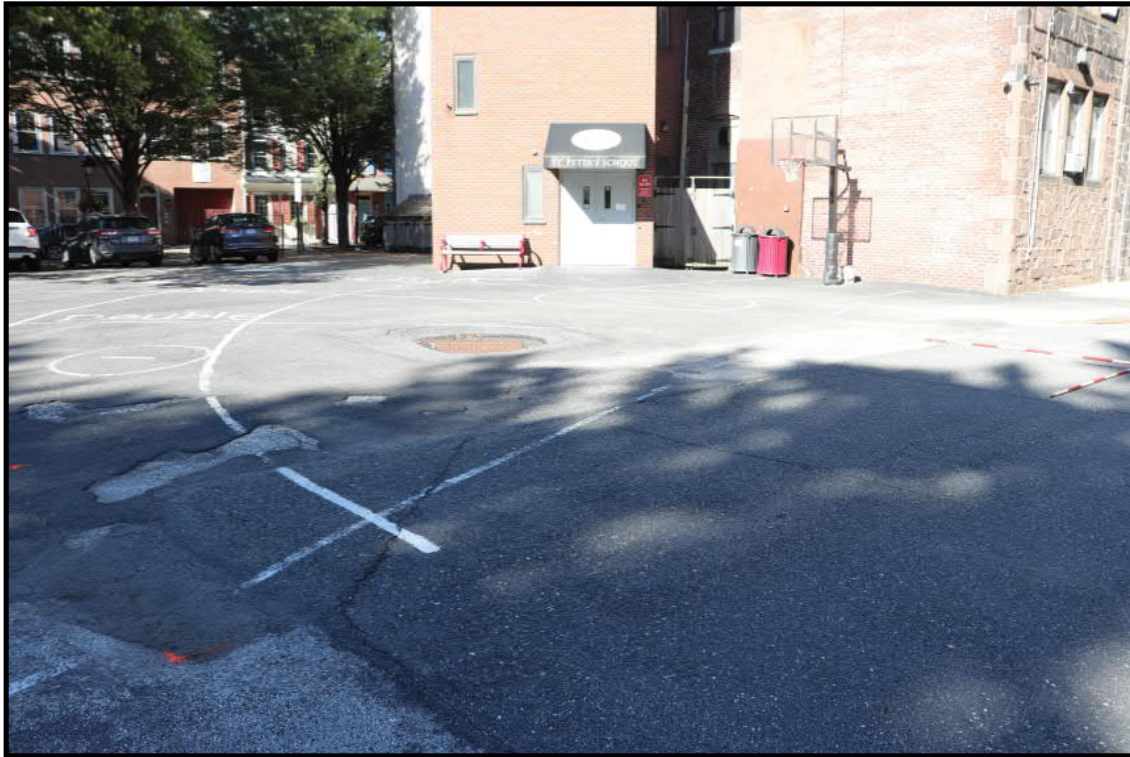
Photograph 3.12. View facing southwest showing the location of Trench 1 (Photographer: Michael Brown, July 2019) [HRI Neg.# 19027/D1:012].

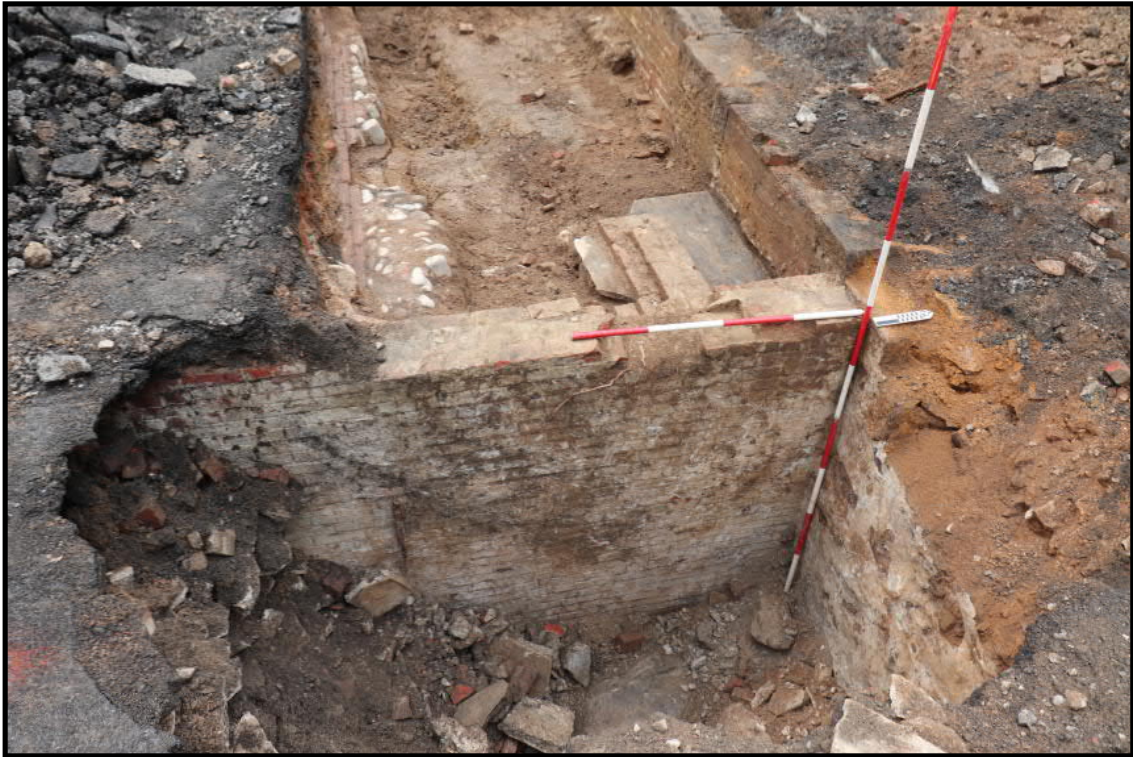
Photograph 3.13. View facing northwest showing the brick and brownstone walls of the Wharton Public School basement (Photographer: Michael Brown, July 2019) [HRI Neg.# 19027/D1:272].

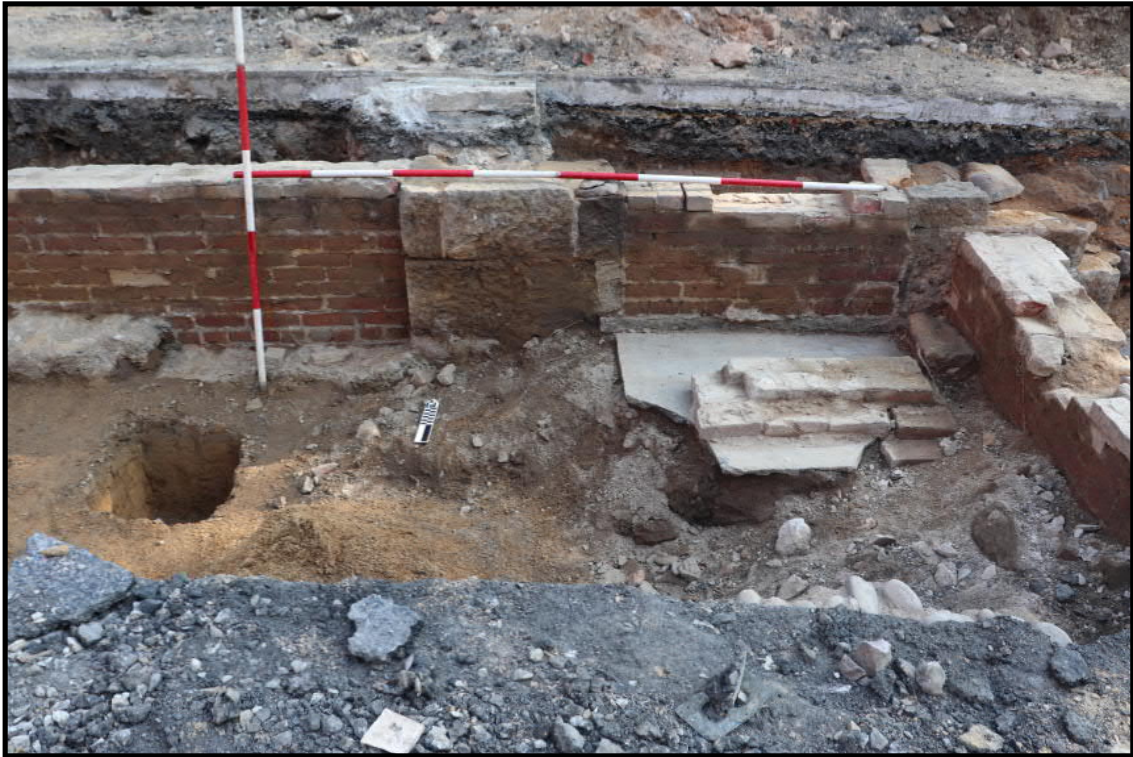
Photograph 3.14. View facing north showing the blocked entrance in the Wharton Public School (Photographer: Michael Brown, July 2019) [HRI Neg.# 19027/D1:401].

ing (Photograph 3.14). Adjoining Context 323 was a blocked entrance or doorway that had been cut into the brownstone wall [326]. This entrance was blocked with a single-course-wide brick wall [317].

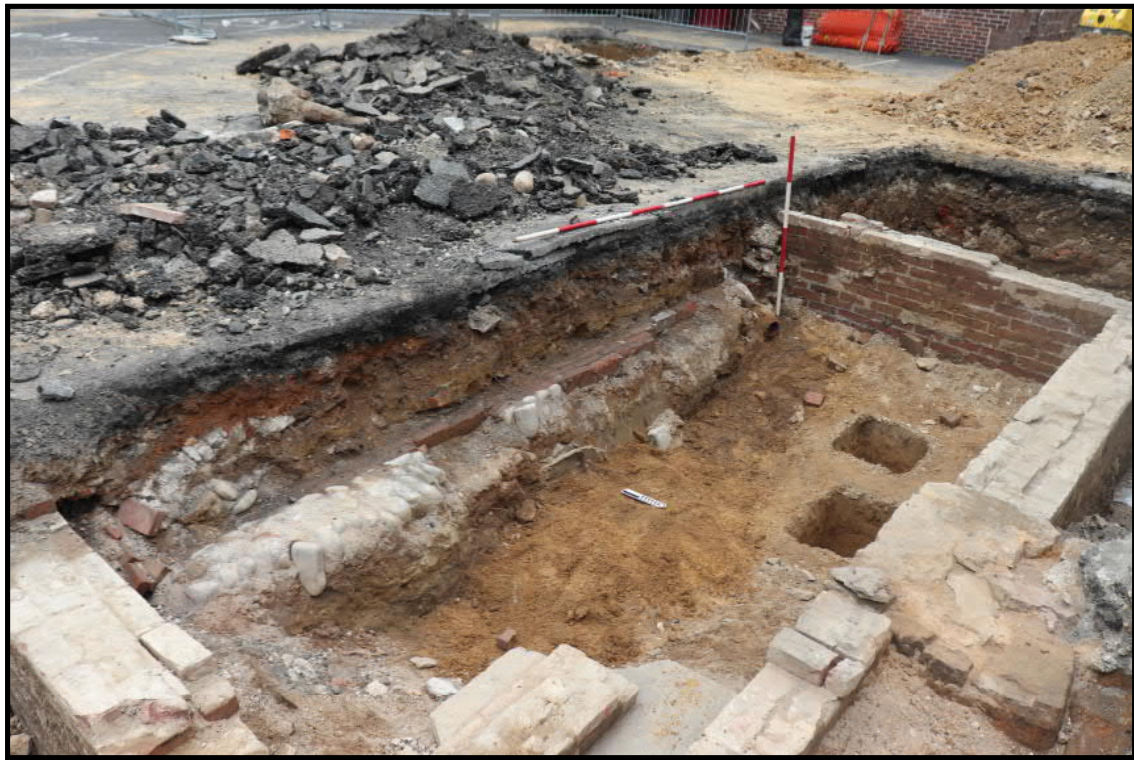
Photograph 3.15. View facing west showing the brick walls that may have formed a courtyard at the western end of the Wharton Public School in Trench 1 (Photographer: Michael Brown, July 2019) [HRI Neg.# 19027/D1:422].

Within the limits of the courtyard the aggregate layer, Context 304, overlay a substantial brick demolition deposit that was contained within the boundaries of the brick courtyard formed by the east-west and north-south running brick walls [respectively 305 and 303]. This deposit extended to a depth of 1.7 feet below the ground surface where it overlay a thin clay deposit [332]. This clay fill deposit extended to a depth of two feet below the ground surface where it overlay a brick path [306] that was lined with cobble stones [319] (Photograph 3.16). This path followed a similar alignment to the brick path identified in Test Pit A and the two paths could be part of the same construction; however, it seems more likely that this brick and cobble stone path is related to a demolished structure within the courtyard. The path was truncated and disturbed by an angled cut [310] that began just beneath the aggregate layer. The cut was filled by a densely packed mix of concrete rubble and brick [311] that overlay a vertical iron pipe [312]. The brick and cobble stone path overlay mottled fill that appeared to be a heavily disturbed yard deposit [308]. This

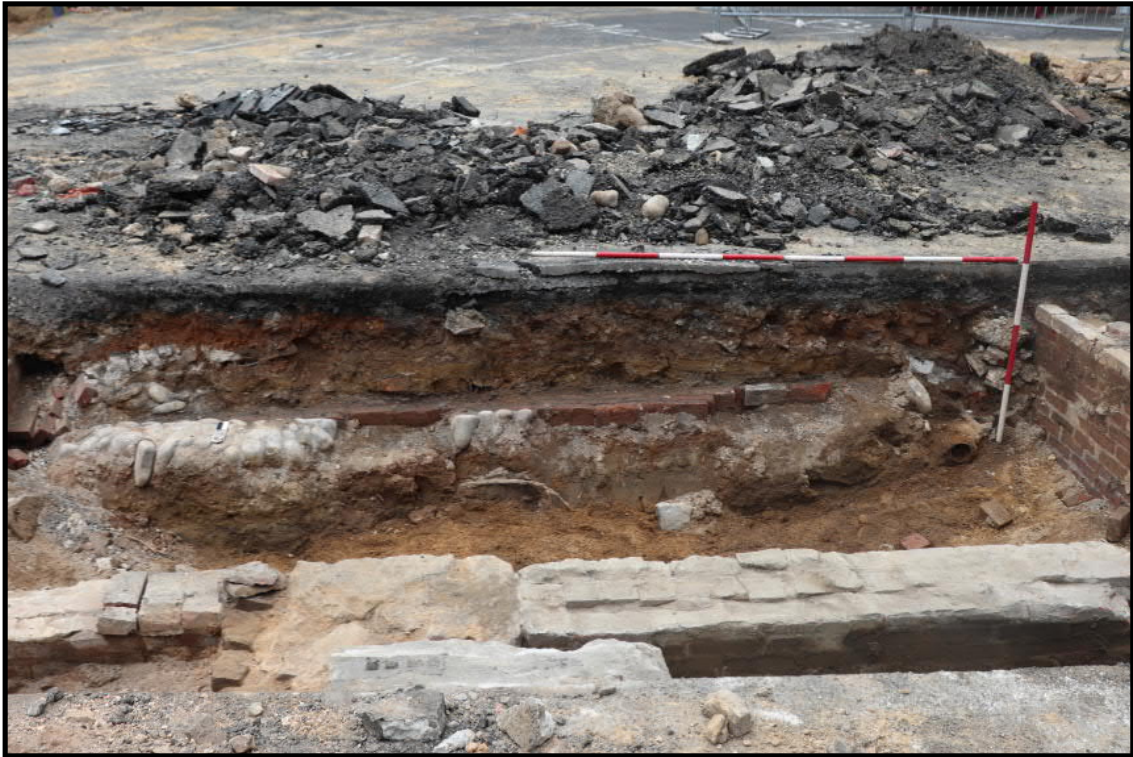
Photograph 3.16. View facing south showing the south profile of Trench 1. Note the articulated brick and cobble stone path running along the profile (Photographer: Michael Brown, July 2019) [HRI Neg.# 19027/D1:426].

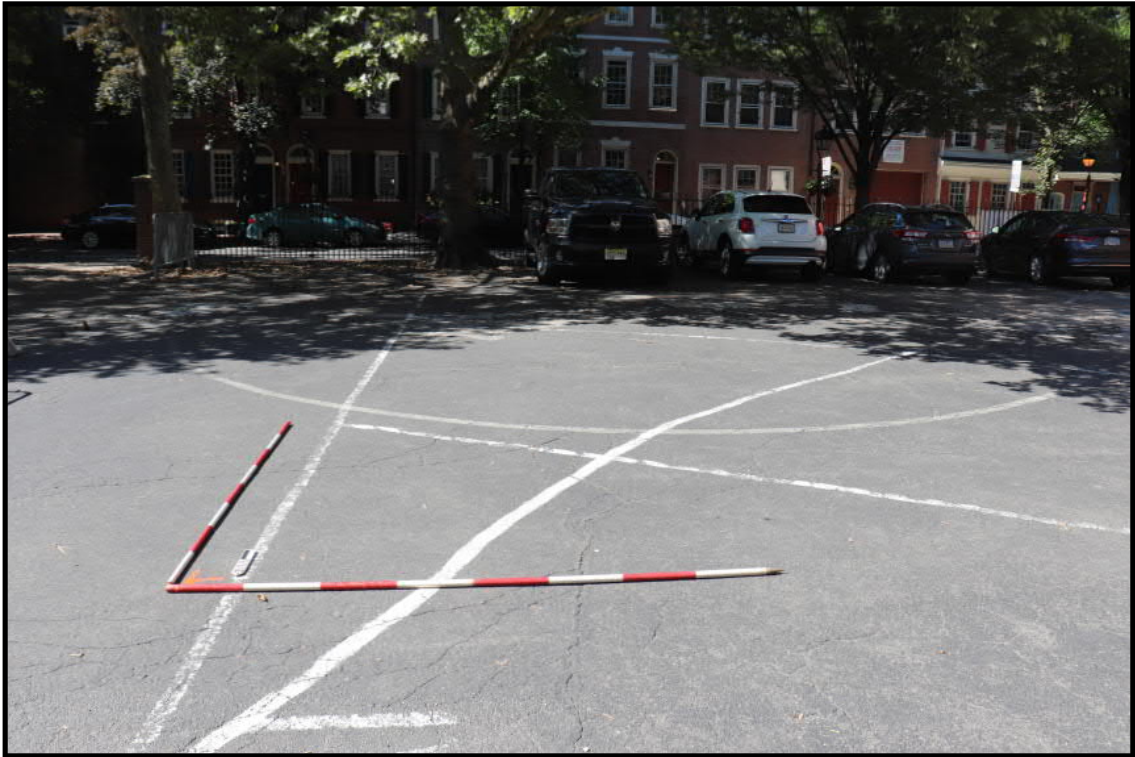
Photograph 3.17. View facing south showing the location of Trench 2 (Photographer: Michael Brown, July 2019) [HRI Neg.# 19027/D1:019].

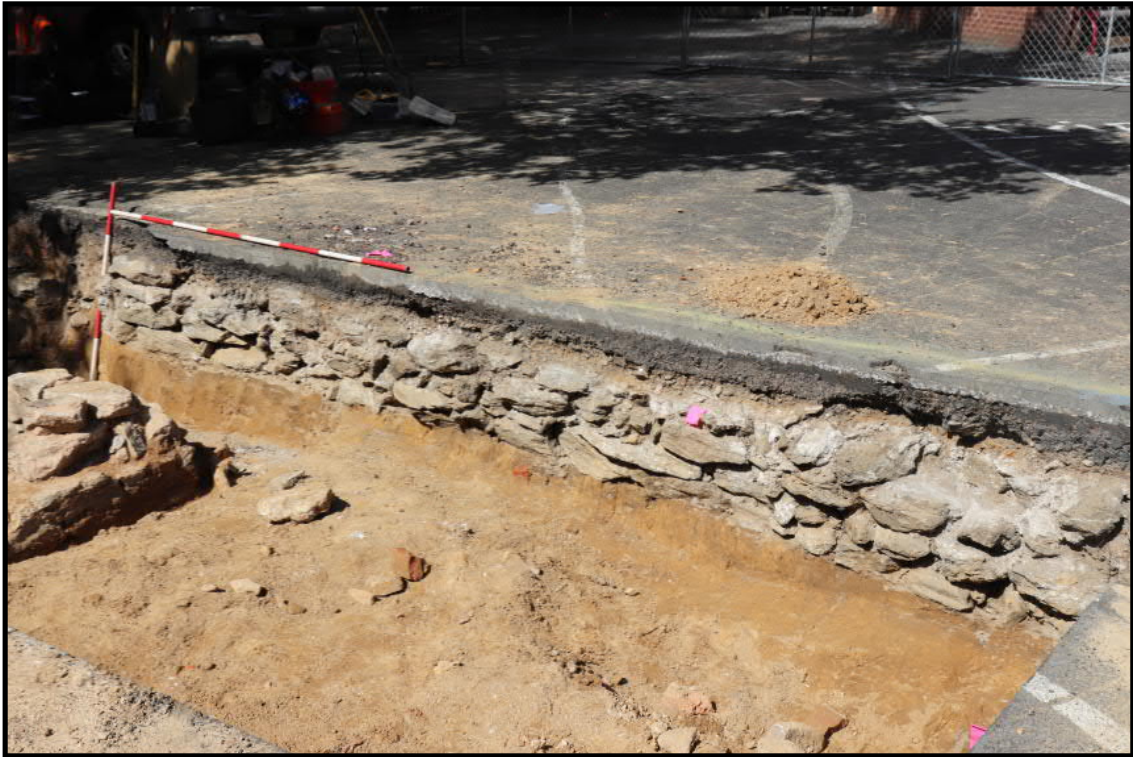
Photograph 3.18. View facing southwest showing the mica-schist east wall of 311 Lombard Street in the west wall of Trench 2 (Photographer: Michael Brown, July 2019) [HRI Neg.# 19027/D1:502].

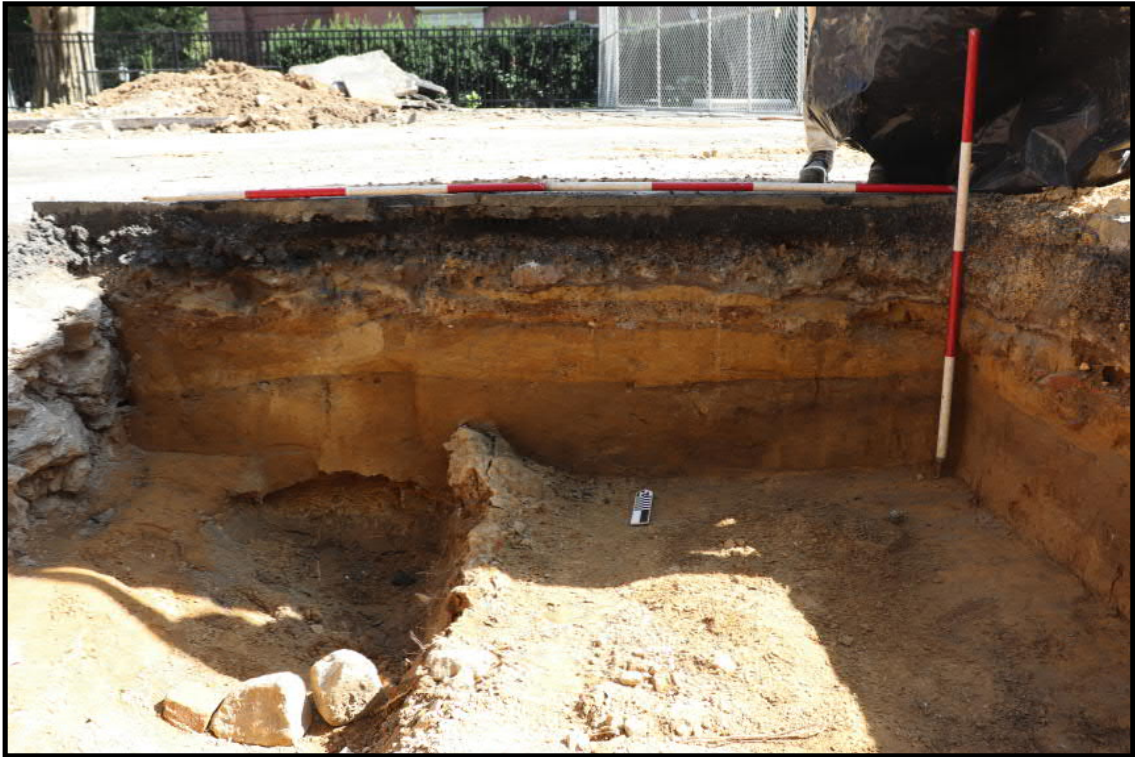
Photograph 3.19. View facing north showing the north profile of Trench 2. Note the buried A present in the profile (Photographer: Michael Brown, July 2019) [HRI Neg.# 19027/D1:481].

In the north profile, to the east of the northern end of this schist wall, was a sequence of fill deposits [421, 413] that overlay a somewhat ephemeral buried A horizon [404] (Photograph 3.19). This deposit extended from two to three feet below the current ground surface and overlay the natural B-horizon subsoil [405]. Context 404 was sampled in two locations and yielded 18th-century artifacts. The sequence of fill deposits overlying this buried yard deposit continued into the east profile. At 5.5 feet south of the northern limit of the trench, this sequence was cut from 0.7 to 2.5 feet below the ground surface and subsequently filled [419 and 420]. This cut and fill episode was likely related to a later utility. At eight feet south of the northern limit of the trench, the sequence of fill overlying the buried A horizon was truncated by a large deposit of fill [403] (Photographs 3.20 and 3.21). This deposit extended from 0.6 feet below the ground surface, immediately under the asphalt grading material, to a depth of 3.5 feet below the ground surface, where it overlay the B-horizon subsoil. This deposit is likely related to the demolition of the building that formerly stood at 309 Lombard Street.

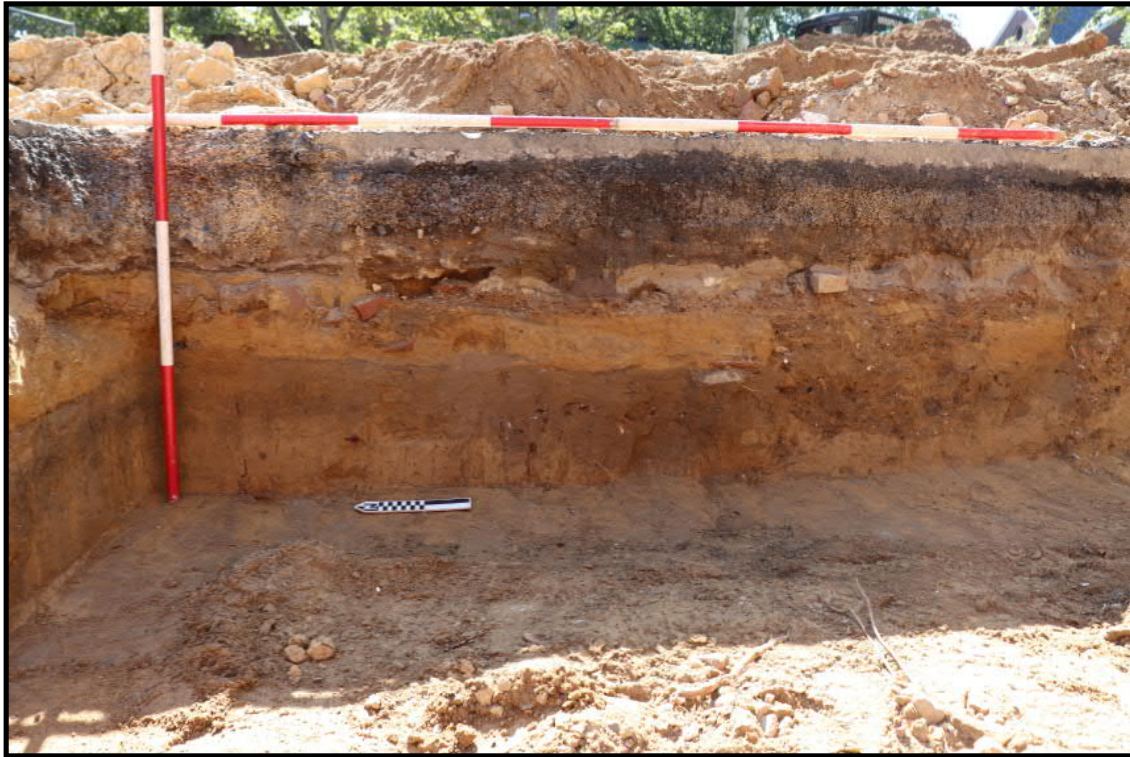
Photograph 3.20. View facing east showing the east profile of Trench 2. Note the buried A present in the profile and that has been truncated by later disturbance at the right hand end of the frame (Photographer: Michael Brown, July 2019) [HRI Neg.# 19027/D1:467].

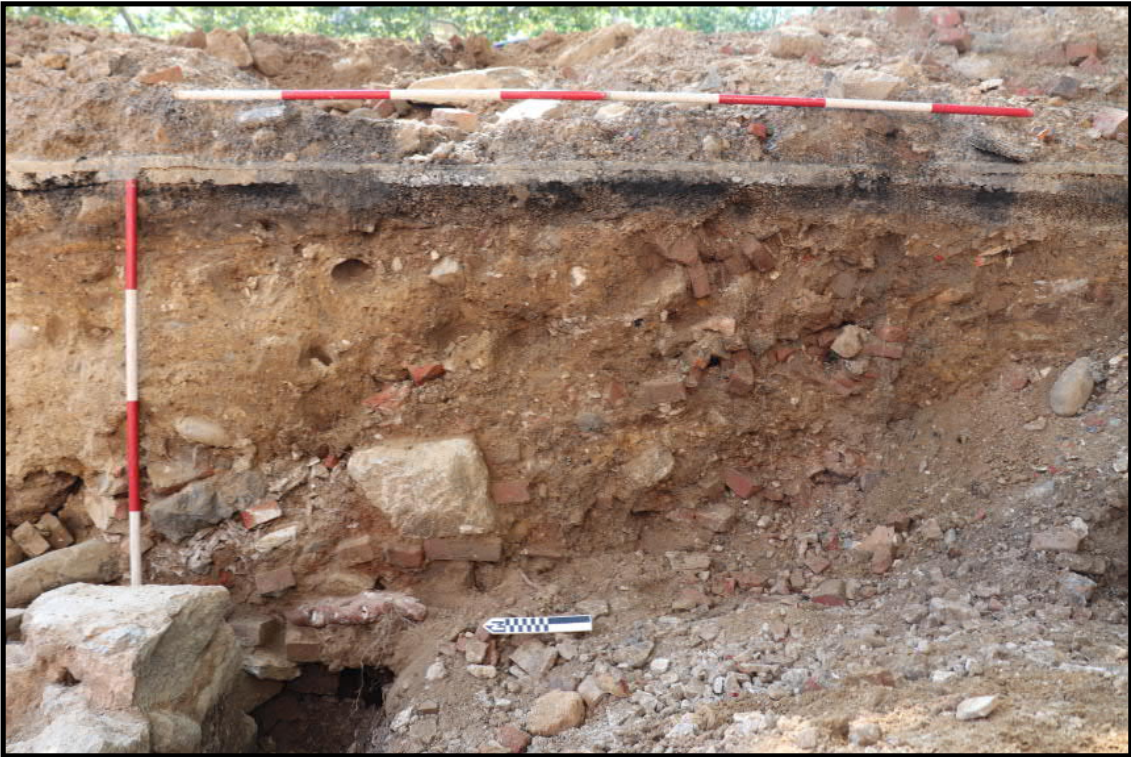
Photograph 3.21. View facing east showing the fill deposits related to the demolition of 309 Lombard Street (Photographer: Michael Brown, July 2019) [HRI Neg.# 19027/D1:476].
