**PHASE IA ARCHAEOLOGICAL SURVEY
PROPOSED ST. PETER'S PARISH HALL SITE
PARCEL B, THIRD AND LOMBARD STREETS
CITY OF PHILADELPHIA
PHILADELPHIA COUNTY, PENNSYLVANIA**

NOVEMBER 2016

MANAGEMENT SUMMARY

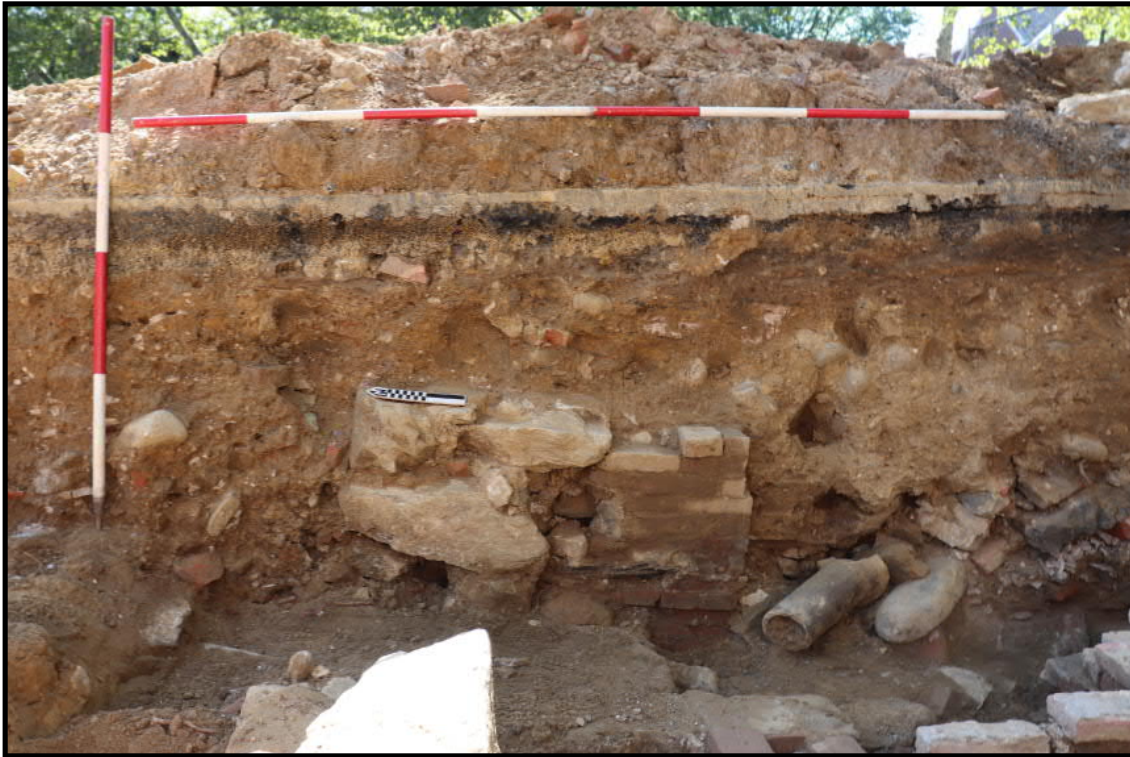
Photograph 3.22. View facing east showing the east profile of Trench 2. Note the truncated schist wall and brick liner of the chimney and demolition fill related to the demolition of 309 Lombard Street (Photographer: Michael Brown, July 2019) [HRI Neg.# 19027/D1:472].

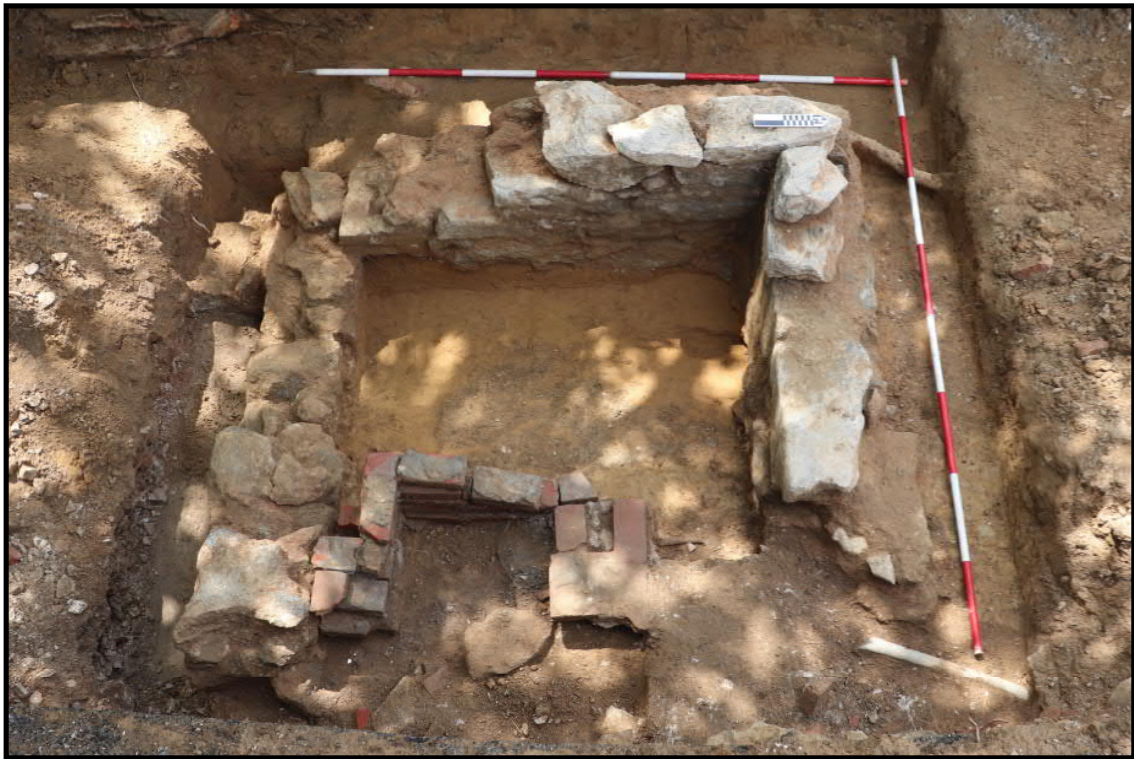
Photograph 3.23. View facing west showing the schist foundation and brick chimney in Trench 2 (Photographer: Michael Brown, July 2019) [HRI Neg.# 19027/D1:447].

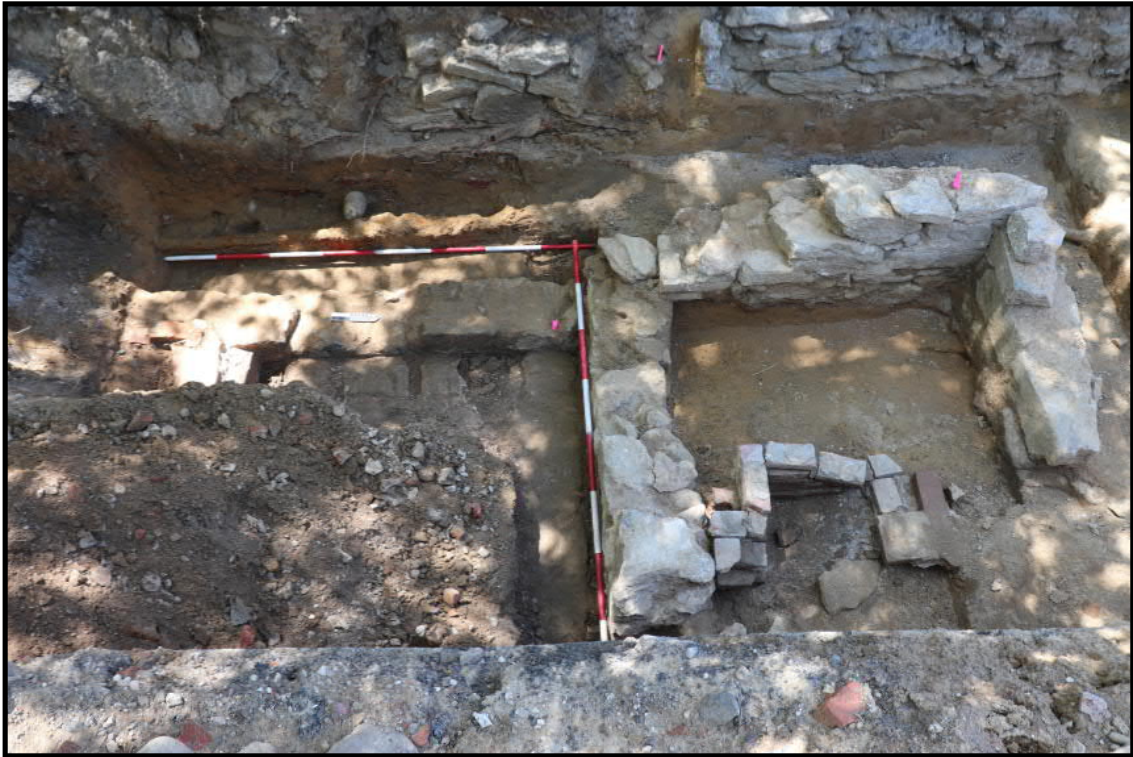
Photograph 3.24. View facing west showing the schist foundation and brick chimney and its relationship to the schist wall for 309 Lombard Street. Note the schist wall for the 311 Lombard Street in the west profile (Photographer: Michael Brown, July 2019) [HRI Neg.# 19027/D1:515].

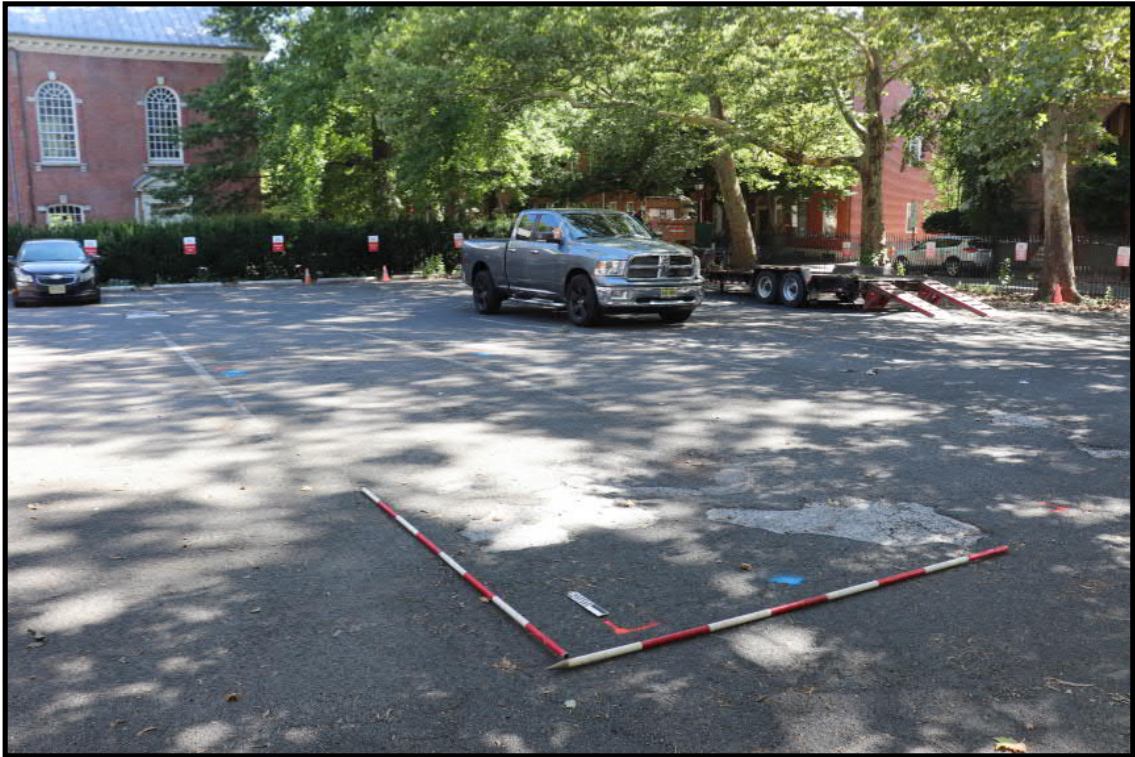
Figure 3.10. Trench 3, Plan View.

Trench 3 measured 24 feet north-south by 10 feet east-west and was placed just to the east of the existing entrance to the St Peter's Episcopal Church parking lot (Figures 3.1, 3.10 and 3.11; Photograph 3.25). Trench 3 was placed in this location to examine to examine potential historic deposits and features associated with the rear yards of 428 and 430 Third Street. The overlying asphalt and historic fill were excavated from the entire trench using the excavator. Structural elements were exposed mechanically with cleaning and further investigation being done by hand, followed by documentation.

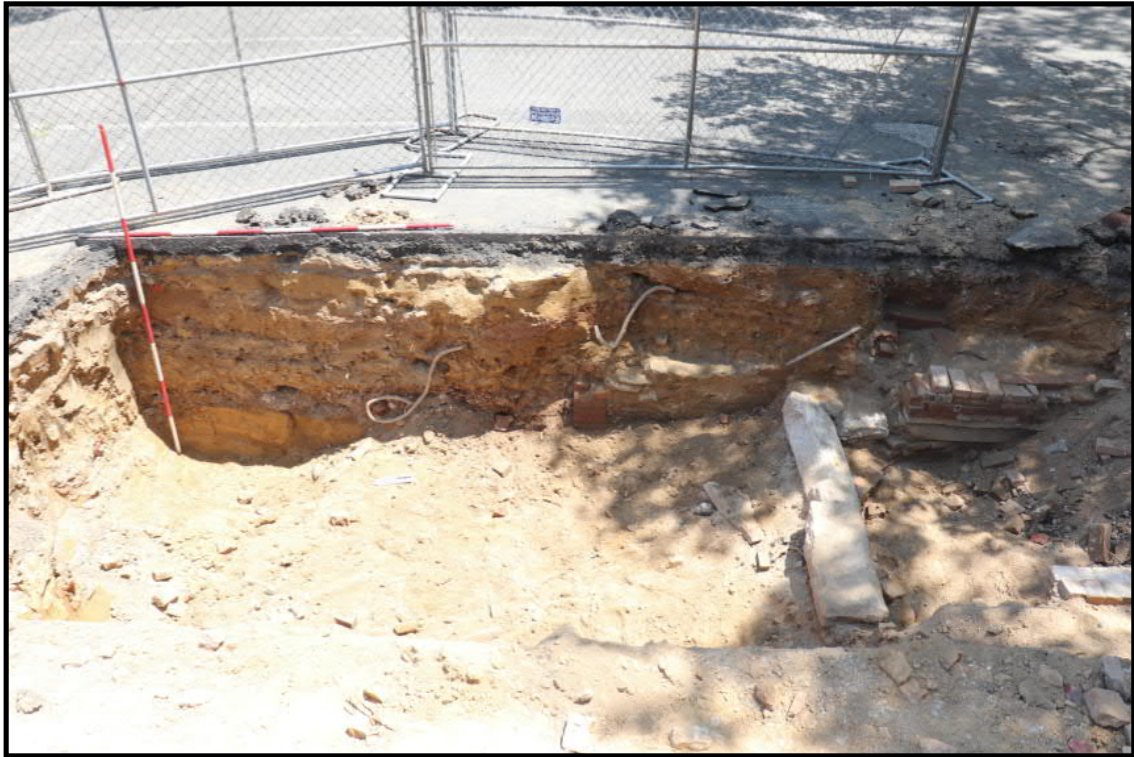
Figure 3.11. Trench 3, East Profile.

The existing asphalt parking lot [500] and underlying aggregate layer [501] extended to a depth of 0.8 feet below the ground surface across the entire trench (Photograph 3.26). In the northwest corner of the trench, three feet below the ground surface, a concrete foundation [515] was encountered. This is believed to be related to the construction of the Wharton Public School, which lay directly to the north of the trench. Within the northern end of the trench the aggregate layer overlay a thick, compact sandy silt fill deposit [502]. This deposit extended from 0.8 feet to a maximum depth of 2.9 feet below the ground surface where it overlay a large deposit of compact sandy silt with brick fragments [503]. This latter fill deposit extended the full length of the trench and extended

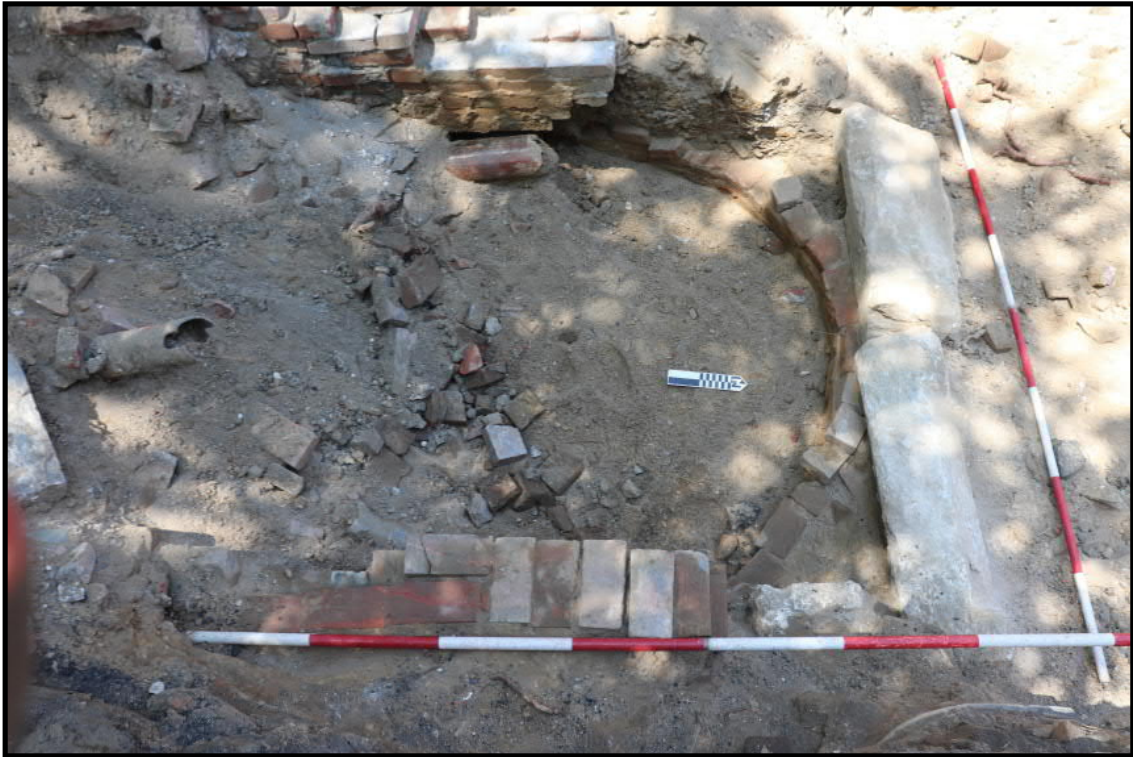
Photograph 3.27. View facing west showing the cistern found in Trench 3 in the rear yards of 428 and 432 Third Street (Photographer: Michael Brown, July 2019) [HRI Neg.# 19027/D1:577].

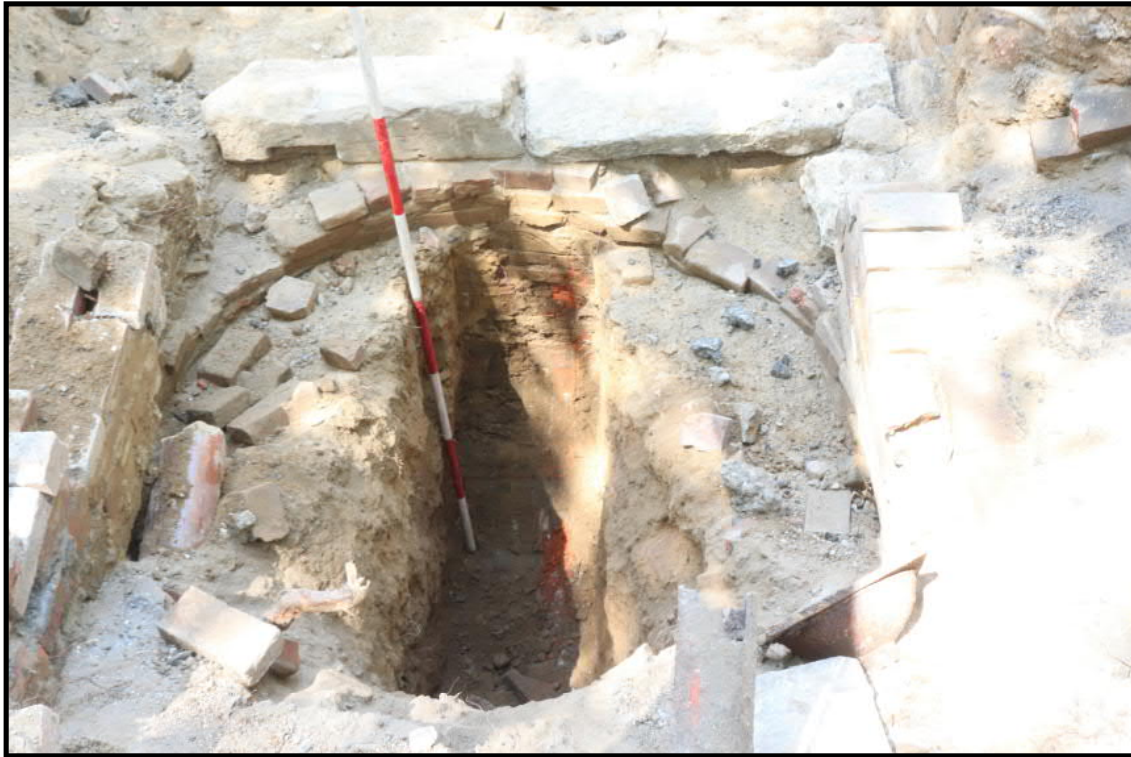
Photograph 3.28 . View facing south showing the extent of the cistern found in Trench 3 in the rear yards of 428 and 432 Third Street (Photographer: Michael Brown, July 2019) [HRI Neg.# 19027/D1:616].

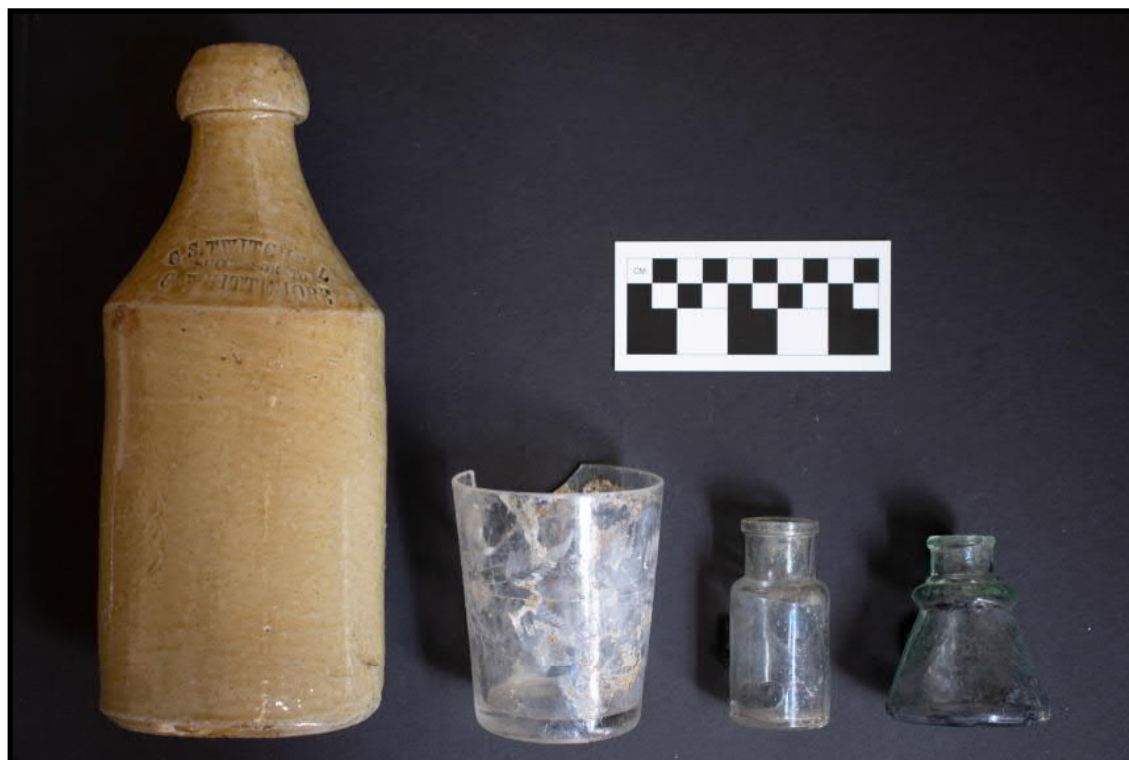
Photograph 3.29. A sample of artifacts collected from the general provenience of the site. Left to right: salt glazed stoneware mead bottle, reading “G.S.TWITCHELL SUCCESSOR TO C. WHITTEMORE” (circa 1875) [Cat. #22.37]; glass cup with a fern pattern etched on the body [Cat. #24.2]; small bottle embossed with “H.B. & W.” on the base [Cat. #28.10]; glass ink bottle [Cat. #22.30] (Photographer: Alexis Alemy, October 2019) [HRI Neg.# 19027/D3:014].

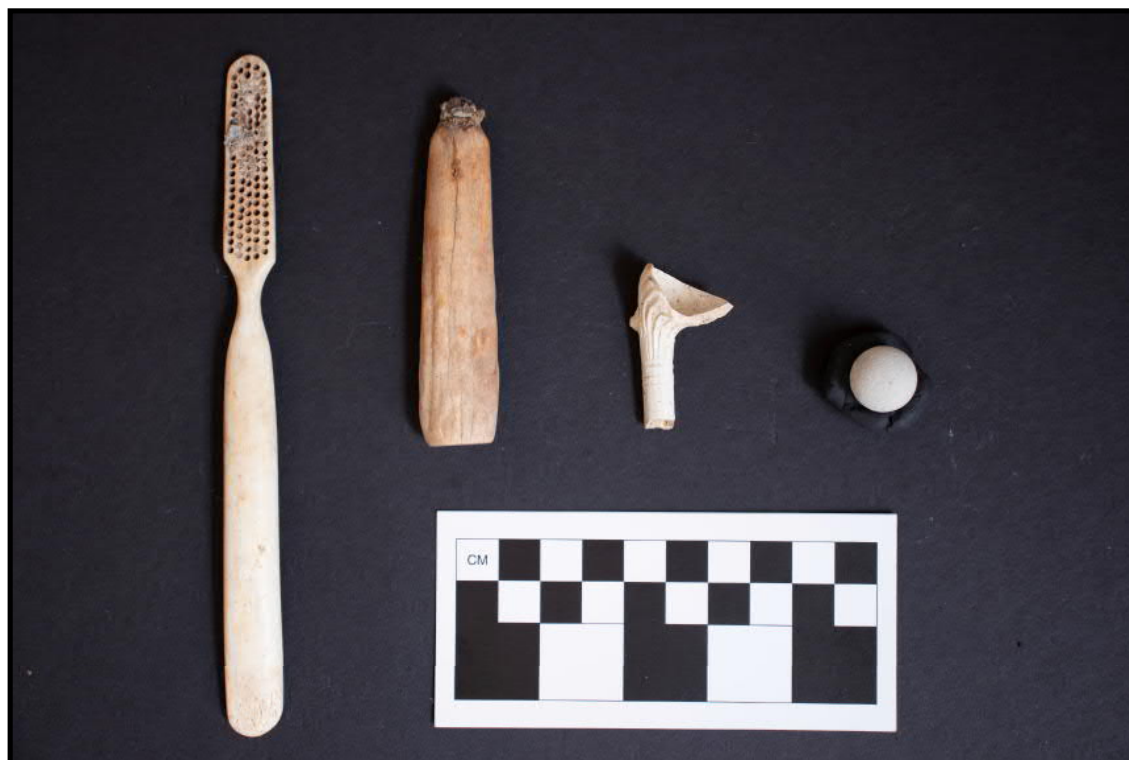
Photograph 3.30. Assorted small finds collected from the general provenience of the site. Left to right: bone toothbrush [Cat. #23.1]; antler and ferrous metal utensil handle [Cat. #1.2]; clay tobacco pipe with incised stem and burred bowl [Cat. #22.107]; unglazed clay marble [Cat. #1.19] (Photographer: Alexis Alemy, October 2019) [HRI Neg.# 19027/D3:021].

The bulk of the material culture assemblage derives from the late 18th- to early 20th-century occupation of the properties along Lombard and Third Streets. Of the 1,342 cataloged items, 796 (59.3%) were recovered from Test Pit B, excavated within the rear yard of 315 Lombard Street and a small portion of the adjoining 313 Lombard Street property. Trench 2, excavated within the rear portion of the 309 Lombard Street house lot, yielded 329 items of material culture or 24.5% of the total collection. Smaller quantities were recovered from Test Pit A and Trench 1, both located within the limits of the former Reverend Richard Peters property, and from Trench 3, located within the rear yards of 428 and 430 Third Street: 137 (10.2%), 38 (2.8%) and 42 (3.1%) artifacts respectively. The small amounts of cultural material recovered from both Test Pit A and Trench 1 can, in part, be attributed to the fact that intact historic soil horizons were truncated or entirely removed as a result of construction of the nearby Wharton Public School and related land alteration. Similarly, the sparsity of material recovered from Trench 3 is likely a result of the utility installations and school-related construction. A representative selection of whole vessels and noteworthy small finds has been photographed for this report (Photographs 3.29 and 3.30).

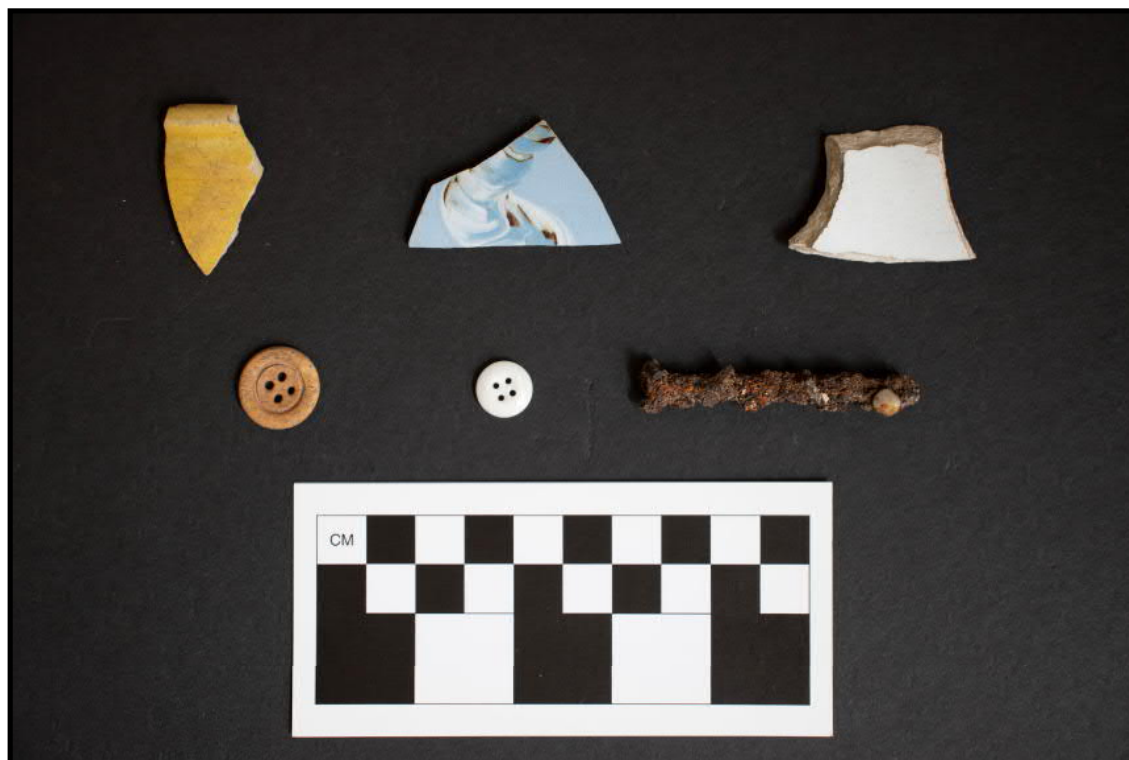
Photograph 3.31. A sample of artifacts collected from Context 210, the fill within the rear addition in Test Pit B. Top left: Staffordshire rim sherd (1670-1795) [Cat. #13.43]. Top center: whiteware sherd decorated with a common cabled design (1815-1940) [Cat. #13.42]. Top right: pearlware sherd (1780-1890) [Cat. #13.37]. Bottom left: four-holed bone button [Cat. #13.45]. Bottom center: glass button [Cat. #13.44]. Bottom right: machine-cut nail (1805-1950) [Cat. #13.4] (Photographer: Alexis Aley, October 2019) [HRI Neg.# 19027/D3:033].

The brick foundation [208] in Test Pit B contained a fill layer [210] that yielded 148 items of material culture. Artifacts from this deposit were broadly representative of the 18th- to 20th-century occupation of the various historic properties on the site with many being recovered from soils mixed and disturbed by demolition activity (Photograph 3.31). Ferrous metal artifacts predominate in Context 210 (68 artifacts or 45.9%), comprising 59 mostly indeterminate corroded nail artifacts (51 fragment and eight whole), 20 of which are identifiable as machine-cut. Thirty-seven glass items are from this context comprising 30 pieces of flat window glass, four fragments of bottle glass, two indeterminate fragments and a single glass button. Fifteen classifiable ceramic vessel sherds were found in this deposit consisting of common redware (three sherds), red-bodied slipware (1), buff-bodied Staffordshire (1), creamware (2), pearlware (3), white-ware (3) and ironstone (2). Twenty pieces of faunal material were found and comprise mammal (13) and bird (3) remains, as well as two indeterminate bone fragments and a clam shell. One bone button back was also recovered. Other artifacts found in this deposit include two fragments of brick, a piece of architectural stone debris and a charcoal fragment.

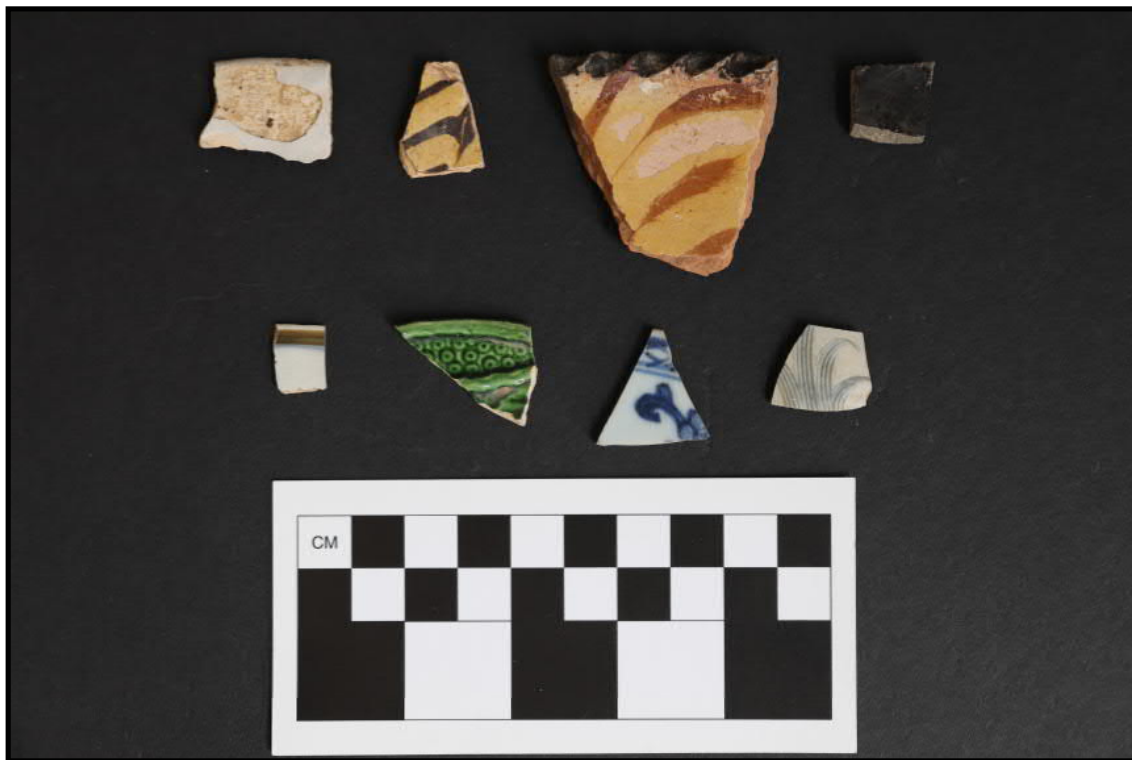
Photograph 3.32. Assorted ceramic fragments collected from Context 203, the buried A horizon in Test Pit B. Top, left to right: sherd of tin-enameled earthenware (1600-1802) [Cat. #14.55]; Staffordshire ware sherd with a combed slip interior (1670-1795) [Cat. #14.48]; redware rim sherd with a slip-trailed interior (1700-1900) [Cat. #11.24]; Jackfield-type sherd (1740-1850) [Cat. #14.18]. Bottom, left to right: pearlware sherd with slip-banded rim on the interior and exterior (1780-1890) [Cat. #11.35]; sprig-molded, green-glazed refined earthenware (1759-1785) [Cat. #14.59]; underglaze hand-painted Chinese export porcelain (1660-1860) [Cat. #11.36]; scratch blue white salt-glazed stoneware (1735-1778) [Cat. #14.45] (Photographer: Alexis Alemy, October 2019) [HRI Neg.# 19027/D3:104].

ware (9), Jackfield-type ware (5), creamware (2) and pearlware (1) (Photograph 3.32). Most of the ceramics in the assemblage, however, are sherds of glazed redwares (181), a type of pottery commonly made and used throughout the 18th to 20th centuries. Eleven fragments of Albany slip stoneware, in use between the early 19th and early 20th century, were found in Context 203; however, no refined whiteware (1815-1940) or ironstone (1840-1950) was recovered. Thirty-six items of faunal material were found in this deposit comprising mammal (10), bird (1) and indeterminate (23) bone fragments and two pieces of oyster shell. Also represented in this assemblage are 19 glass artifacts (comprising nine fragments each of window and bottle glass and one piece of a lamp chimney), 25 indeterminate nail fragments, two corroded bolts, six small fragments of charcoal and three pieces of mica.
