WASHINGTON SQUARE WEST HISTORIC DISTRICT

Proposed Action: Designation Property Owner: Multiple

REPORT OF THE COMMITTEE ON HISTORIC DESIGNATION OF THE PHILADELPHIA HISTORICAL COMMISSION

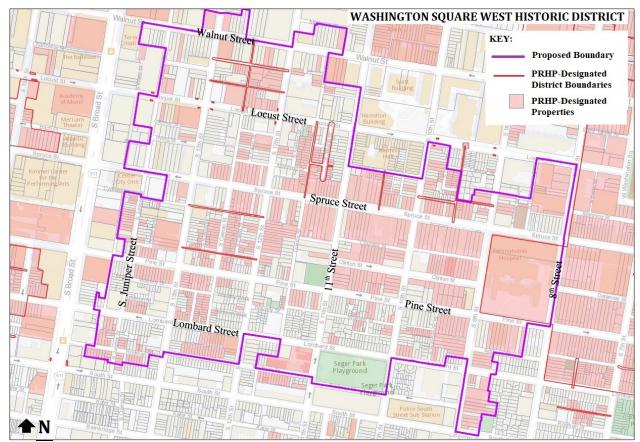
Boundary Figure 2: Proposed boundary for the Washington Square West Historic District.

South: Rodman Street between Broad and 10th Streets, including some properties on the south side of Rodman between Broad and 13th Streets and south of Rodman Street on S Juniper Street; Lombard Street between 10th and 9th Streets, including properties south of Lombard on the east side of 9th Street between Lombard and South Streets.

East: 8th Street between Locust and Pine Streets; 9th Street between Addison and South Streets.

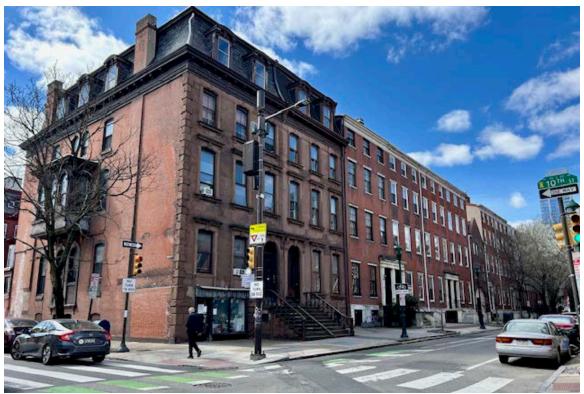
Photograph 7: Looking southwest from 10^{th} and Spruce Streets at Second Empire brownstones by John Stewart and the William Lewis development row.

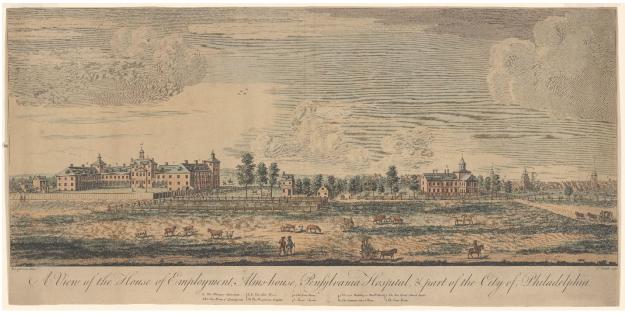
Figure 1: James Hulett after Nicholas Garrison, A View of the House of Employment, Alms-house, Pennsylvania Hospital & Part of the City of Philadelphia (London: 1769). Source: New York Public Library. This view shows the buildings from the south.

The first developments in the district were completed in the mid-eighteenth century, when Pennsylvania Hospital and the former Alms House and House of Employment, some of the earliest examples of government-sponsored care for the poor in the U.S., set the pattern for a series of Philadelphia philanthropic institutions constructed at the periphery of development of the city (Figure 1). The peripheral location of the area of the District at the time also made it the locus for the establishment of the first Jewish burying ground in the city: Mikveh Israel, which survives to the present in the 800 block of Spruce Street.

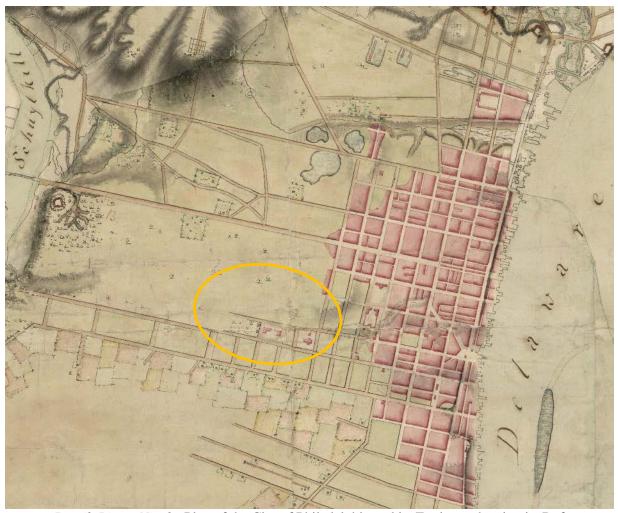
Figure 2: Detail, Pierre Nicole, Plan of the City of Philadelphia and its Environs shewing its Defences During the Years 1777 & 1778 Source: Library of Congress. Areas in red indicate the developed portion of the city. Yellow oval indicates Pennsylvania Hospital and the House of Employment and surrounding lack of development.

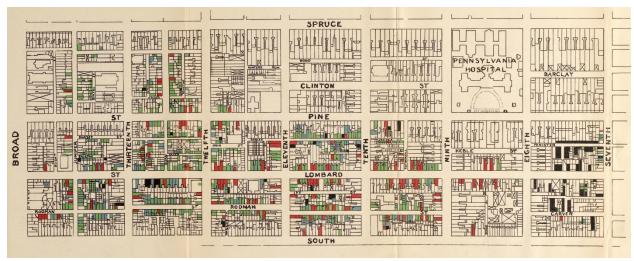
Figure 3: Detail showing area east of Broad Street in late 1890s, "Map of the Seventh Ward, showing distribution of Negro inhabitants throughout the ward, and their social condition," p. I, W. E. B. Dubois, The Philadelphia Negro (Philadelphia: University of Pennsylvania, 1899). Key as it appears in original text: White – "Residences of Whites, Stores, Public Buildings, etc."; Red – "Grade 1: The 'Middle Classes' and those above"; Green – "Grade 2: The Working People-Fair to Comfortable"; Blue – "Grade 3: The Poor"; Black – "Grade 4: Vicious and Criminal Classes."

became an area of concentrated Black residence, famously documented by W. E. B. Dubois in his study of the Seventh Ward (Figure 3).

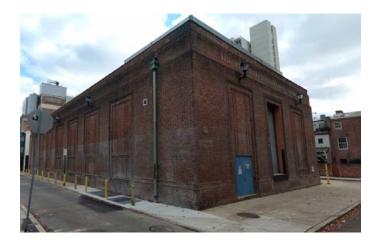
Philadelphia Electric Company, Waverly substation

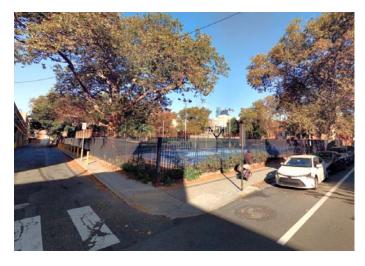
1-story contemporary building; fence, playground, tennis and basketball courts. Former location of Black residences and "Equity Hall"; significant under Criterion I for archaeological potential. Also significant as community park.

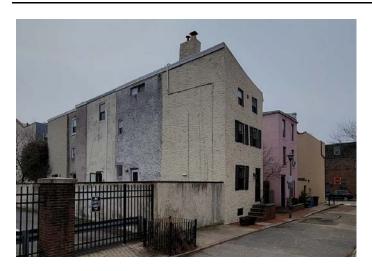
Brick sills.

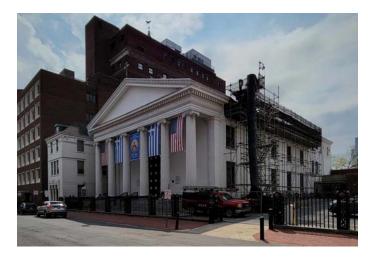
Stained glass windows on Census of Stained Glass Windows in America. Three-story rear Sunday School and vestry building built in 1840.

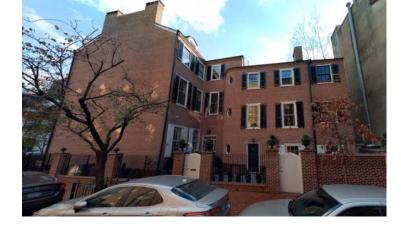
Marble steps, watertable, and sills; shutters with hardware; side entrance on Clinton.
