ADDRESS: 1435-41 WALNUT ST

Proposal: Cut window sills; install new windows

THE DREXEL BUILDING • EXTERIOR ALTERATIONS

THE DREXEL BUILDING, 15TH AND WALNUT, PROPOSED GROUND FLOOR WINDOW ALTERATIONS

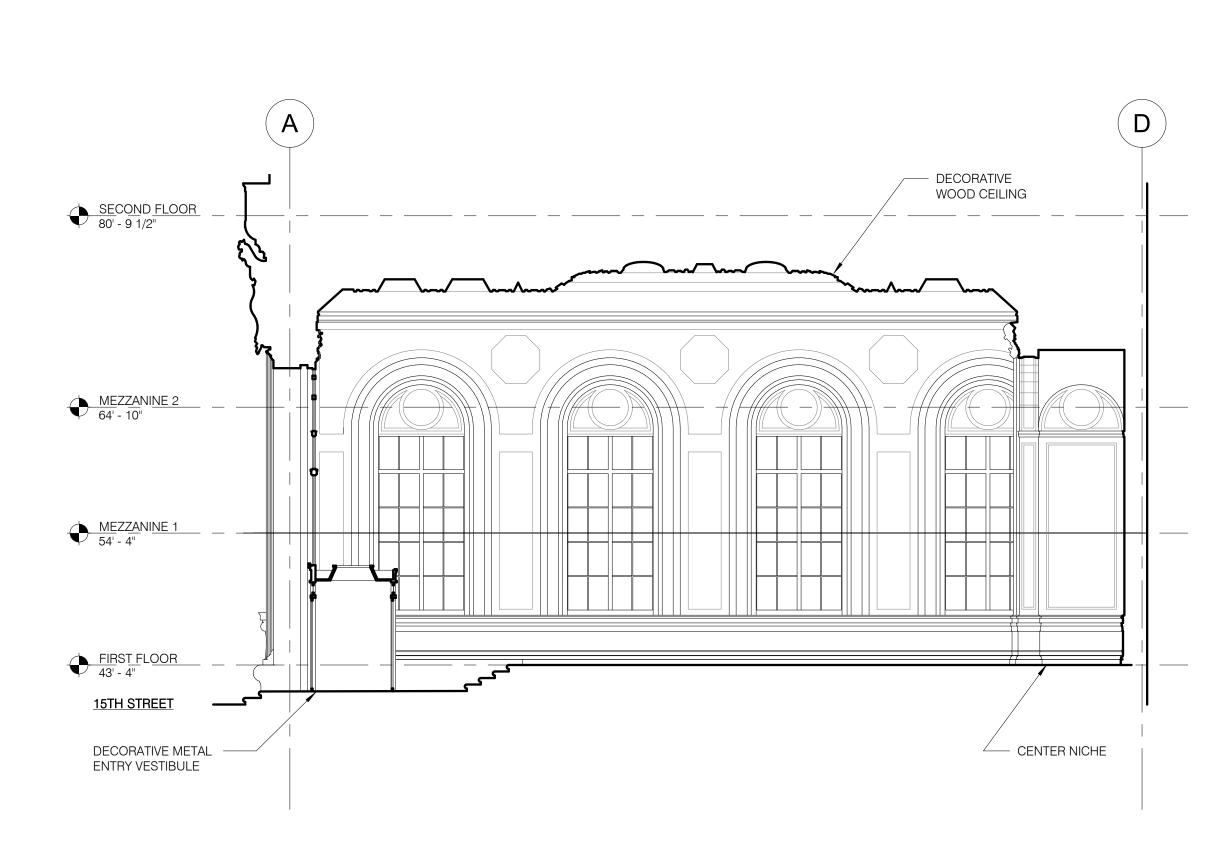
PARTIAL W-E SECTION - FORMER BANKING HALL

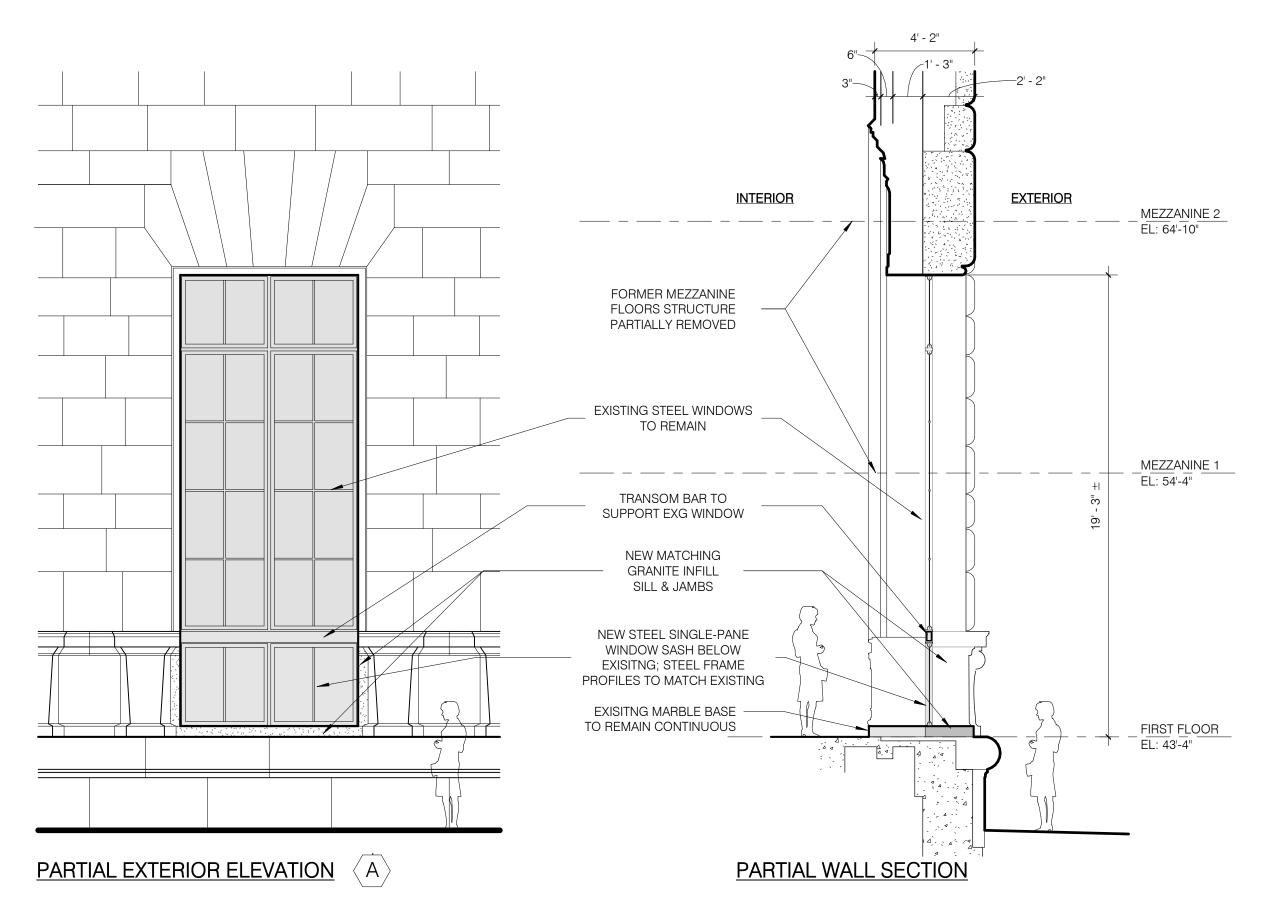
TYPICAL WINDOW 'A' ENLARGED VIEWS - PROPOSED ALTERATION

- O Revised alteration plans reflecting the recommendations of the Architectural Committee, which reduced the number of altered windows from seven (7) to five (5) windows, including the three (3) windows located along Walnut Street and two (2) windows located along S. 15th Street. The Application further adhered to the Committee's recommendation to align the mullion bars of the new windows with the sill of the historic windows and the Owner agreed to store any components removed in the alteration for future potential reinstallation.

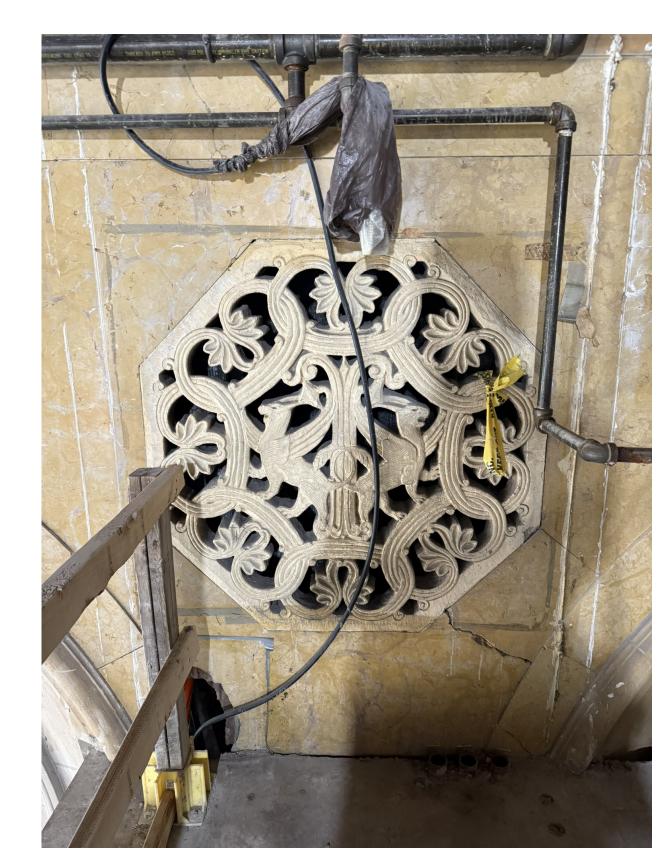
VENT DETAIL BETWEEN WINDOW ARCHES (2025)

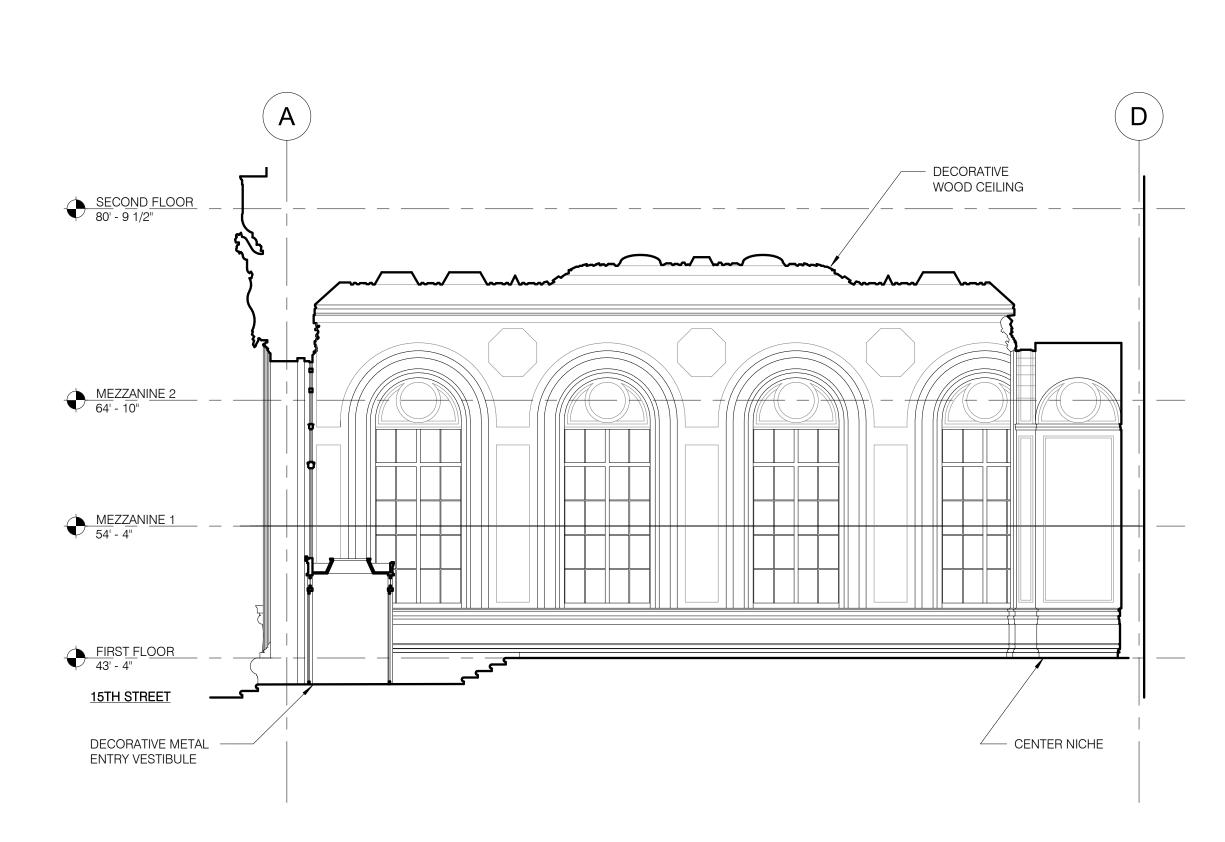
PARTIAL W-E SECTION - FORMER BANKING HALL

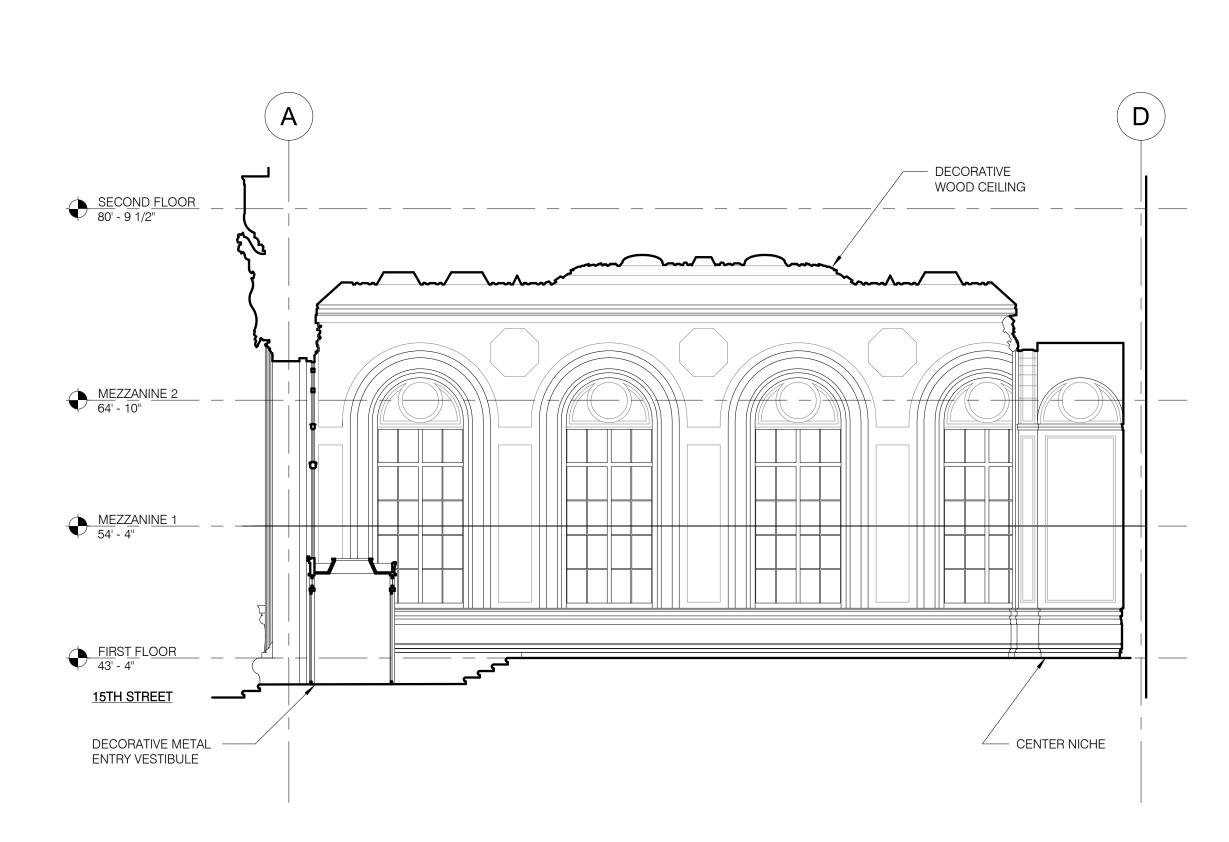
PARTIAL W-E SECTION - FORMER BANKING HALL

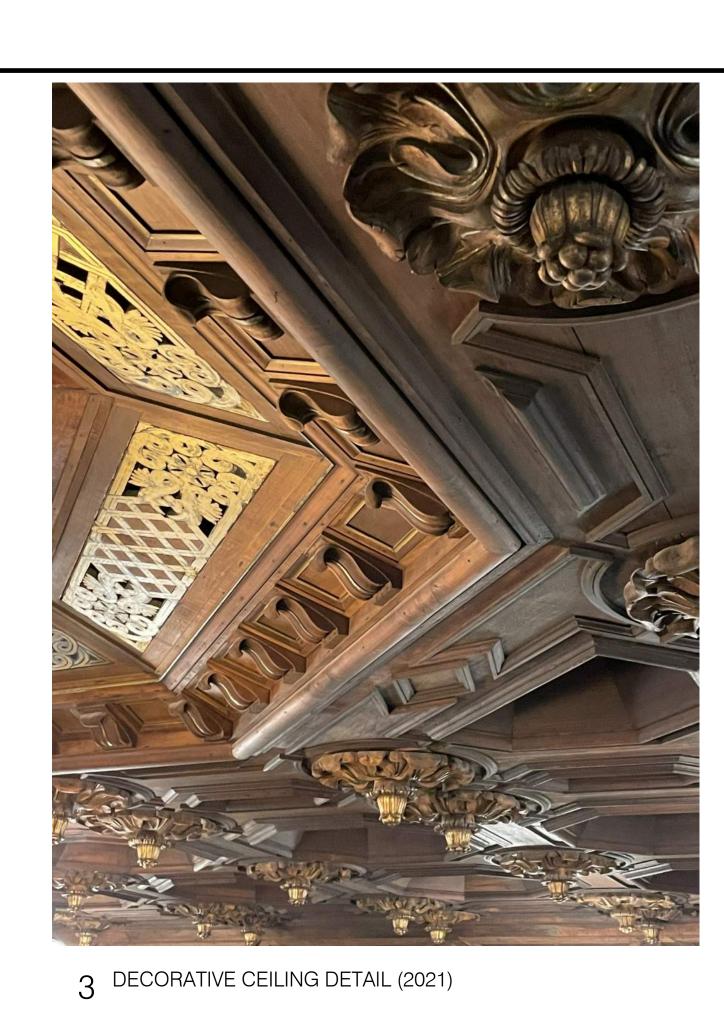
PARTIAL N-S BUILDING SECTION - FORMER BANKING HALL
